**WATERSHED
MANAGEMENT PLAN
FOR THE HOVENSA
WATERSHED
ST. CROIX, USVI
JUNE 2022**

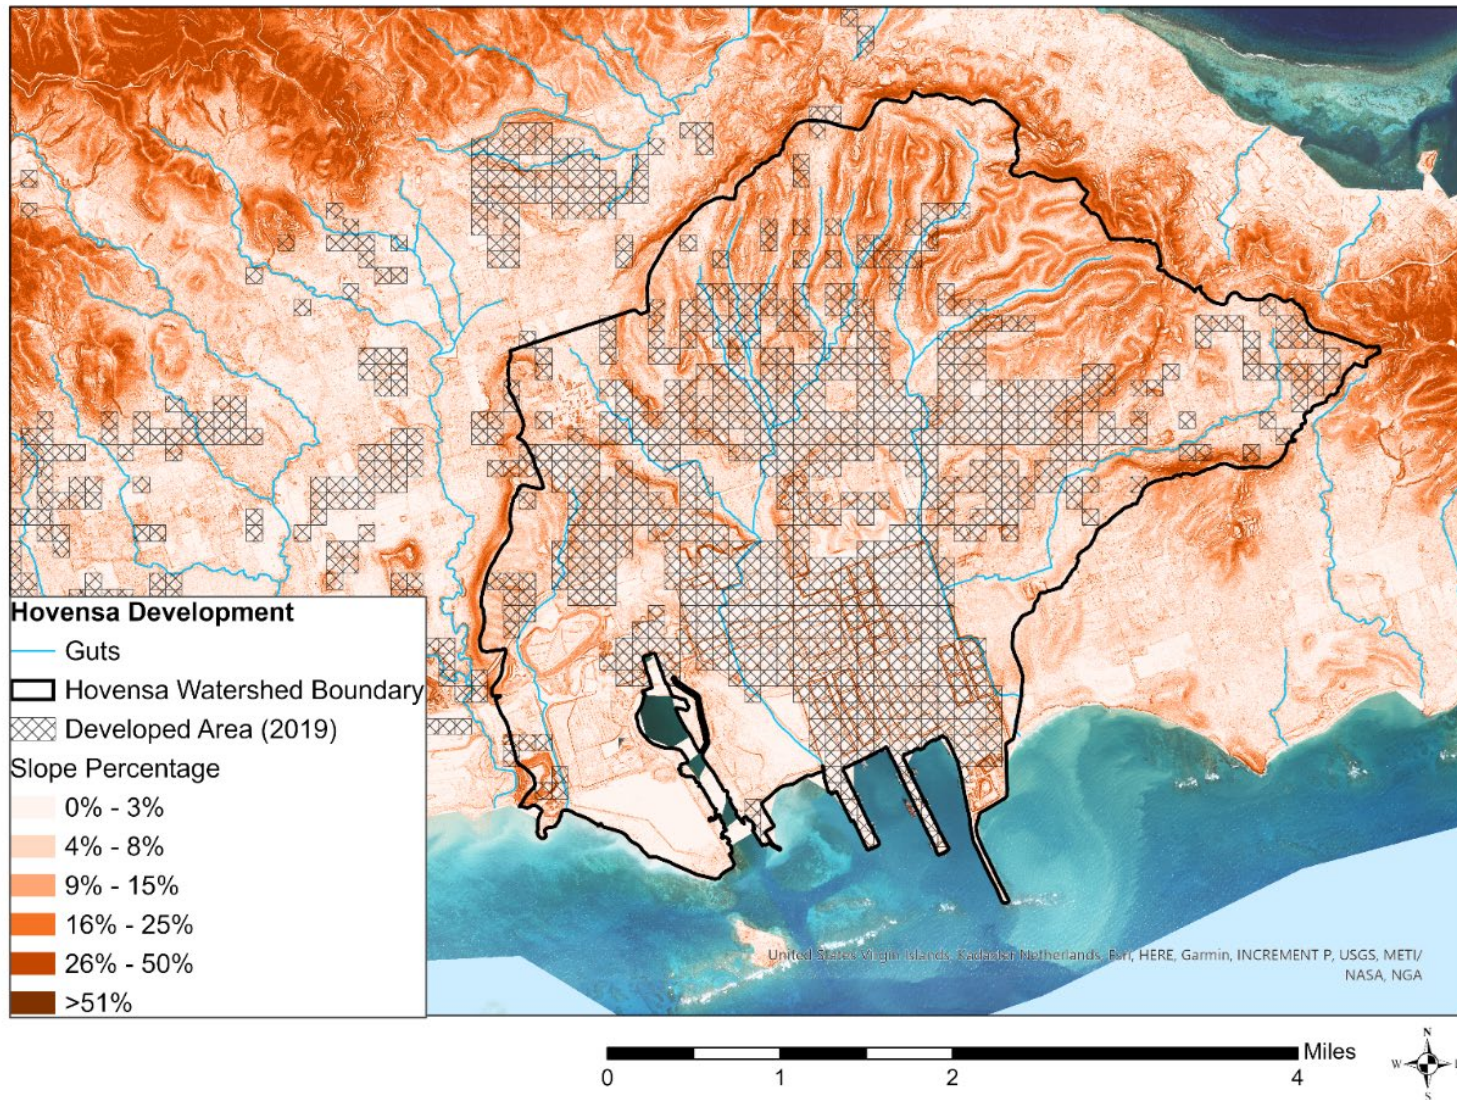
Figure 18 . Developed areas and slope percentages in the Hovensa watershed

Soil surveys produced by the U.S. Department of Agriculture categorize soil types, in part, based on typical slope ranges shown in Table 5 below. These ranges, along with a slope data layer developed for this project using 2018 topographical data, were used to summarize slopes in the Hovensa watershed, which are also outlined in Table 5 and displayed on Figure 18. Slopes in the watershed are predominantly below 8%. Table 5 shows the greatest slopes are in the northeastern portion of the watershed associated with the gut headwaters. The soils associated with the steeper slopes have low infiltration and high runoff potential. During a rain event, the runoff flows down these slopes to the floodplain below, often resulting in flooding. Figure 24 shows the locations of floodplains in the Hovensa watershed (Section 3.2.2.6).

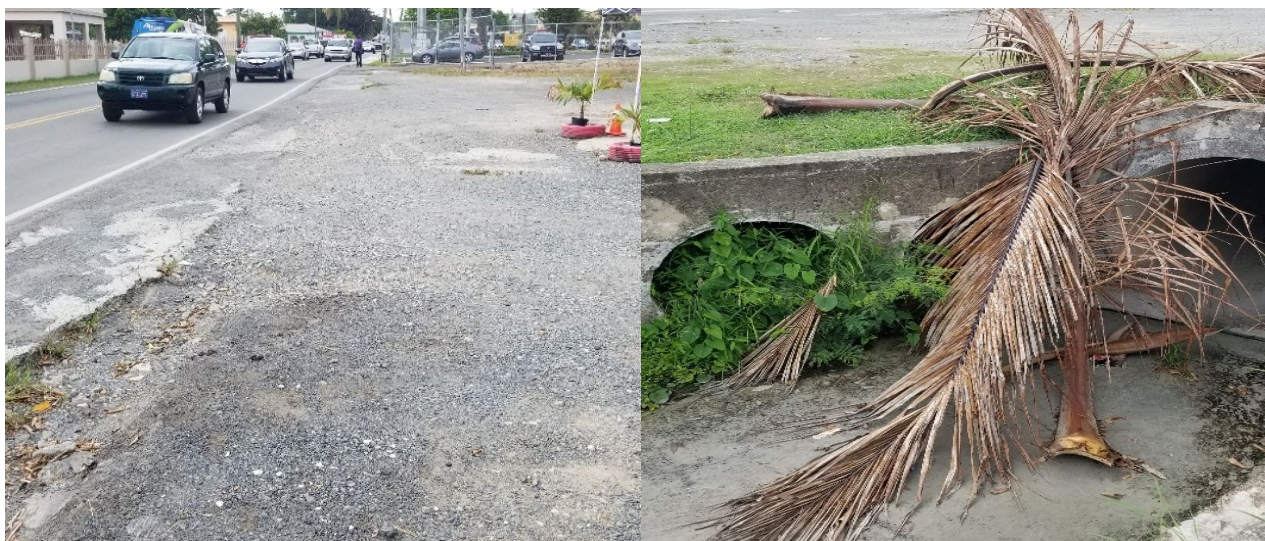
Figure 38. Road erosion (left) and clogged stormwater infrastructure (right).

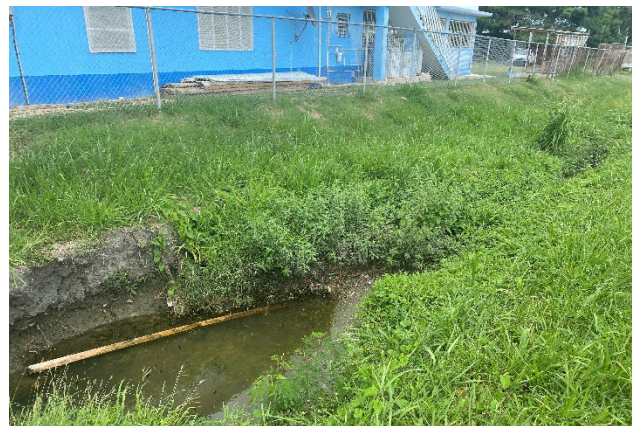
Figure 40. Suspected illicit discharge in gut.

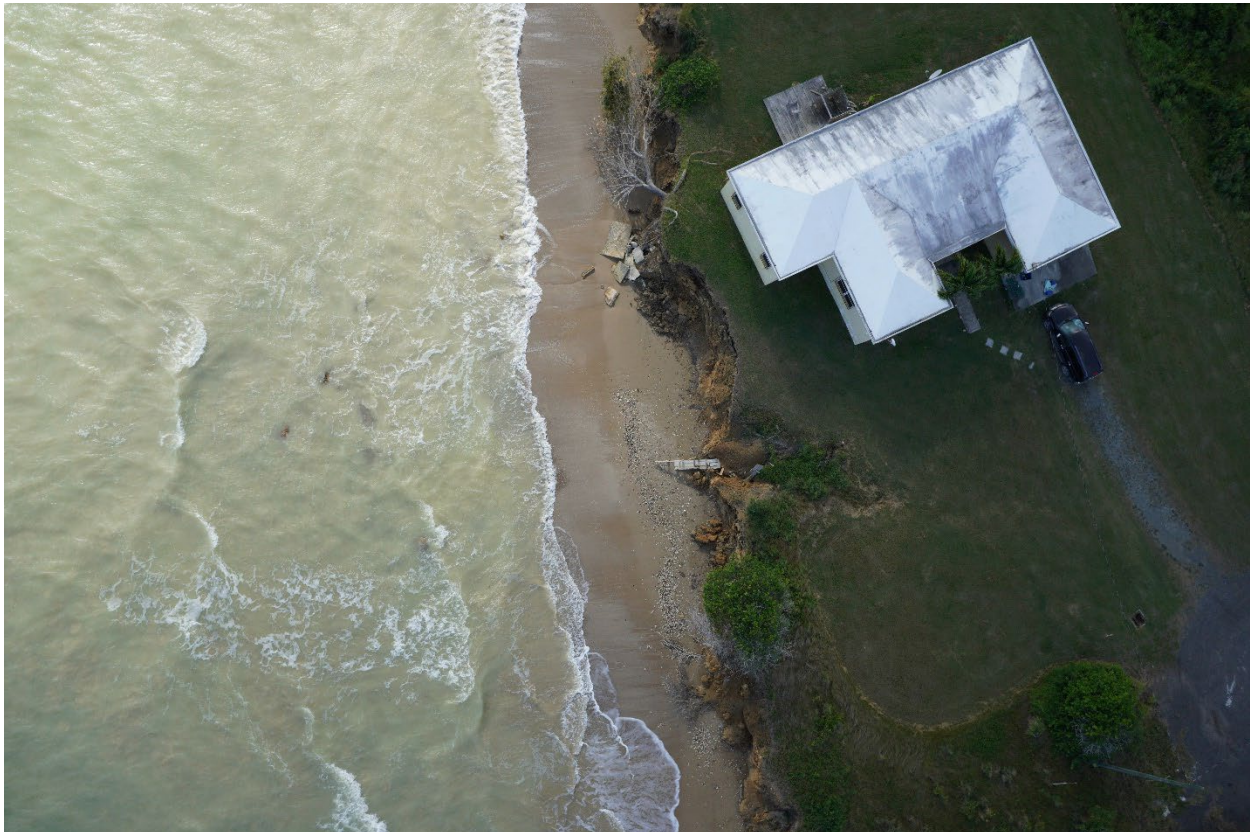
Figure 46. Coastal erosion due to sea level rise threatens stability of homes near the coast.

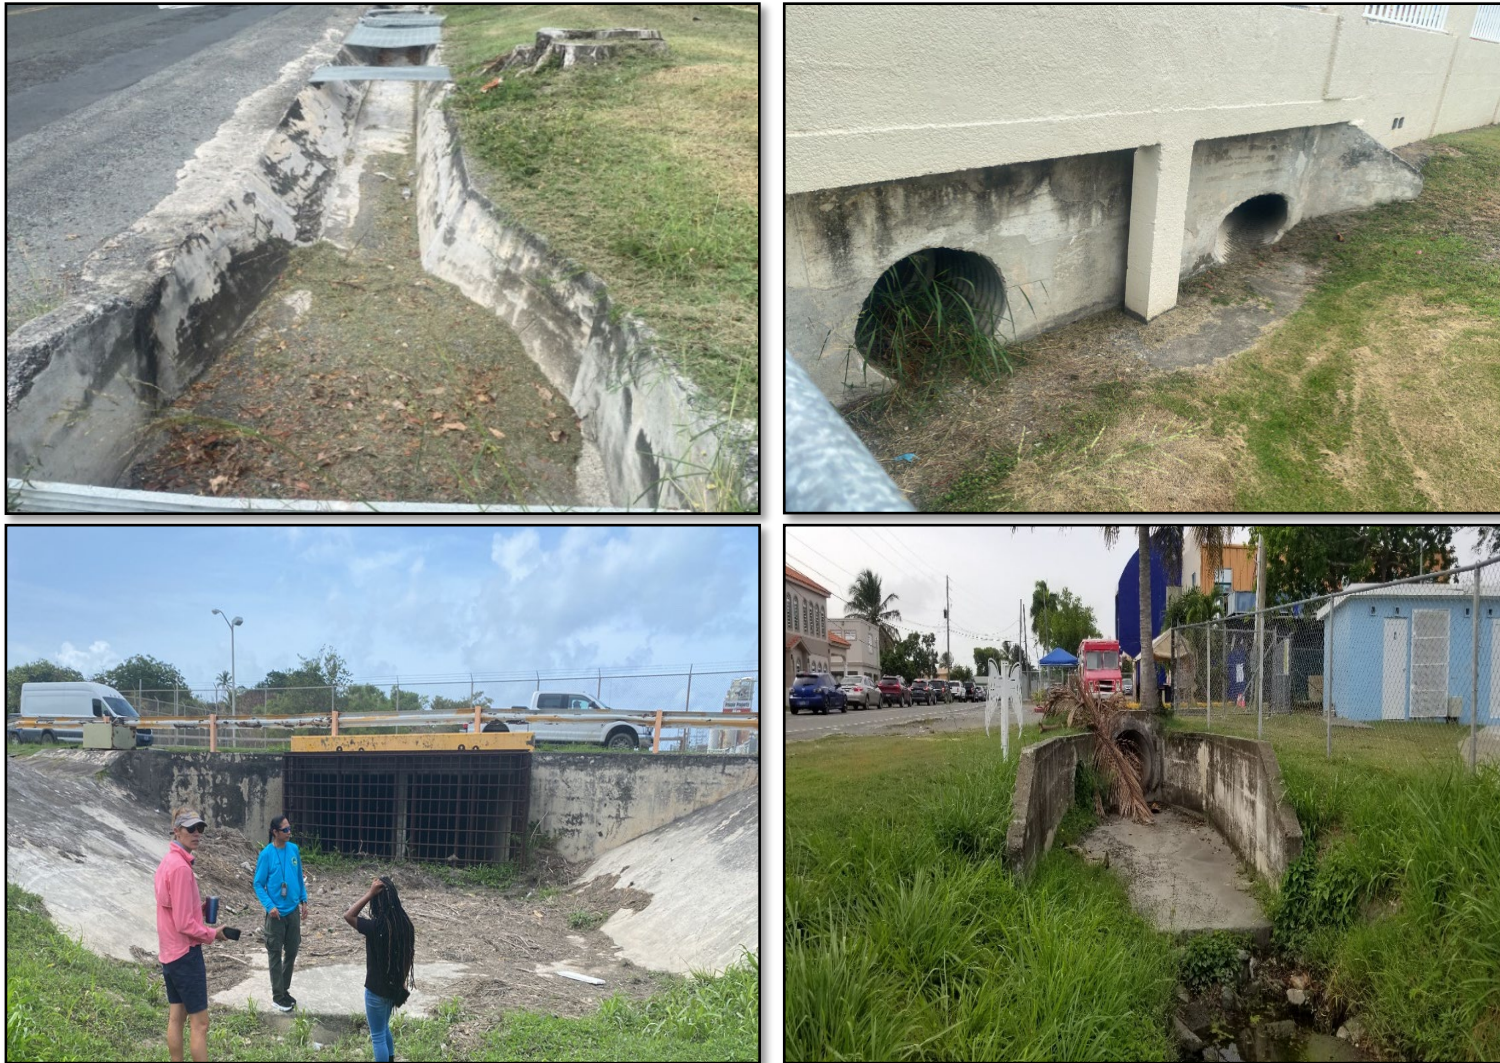
Figure 49. Examples of stormwater infrastructure.

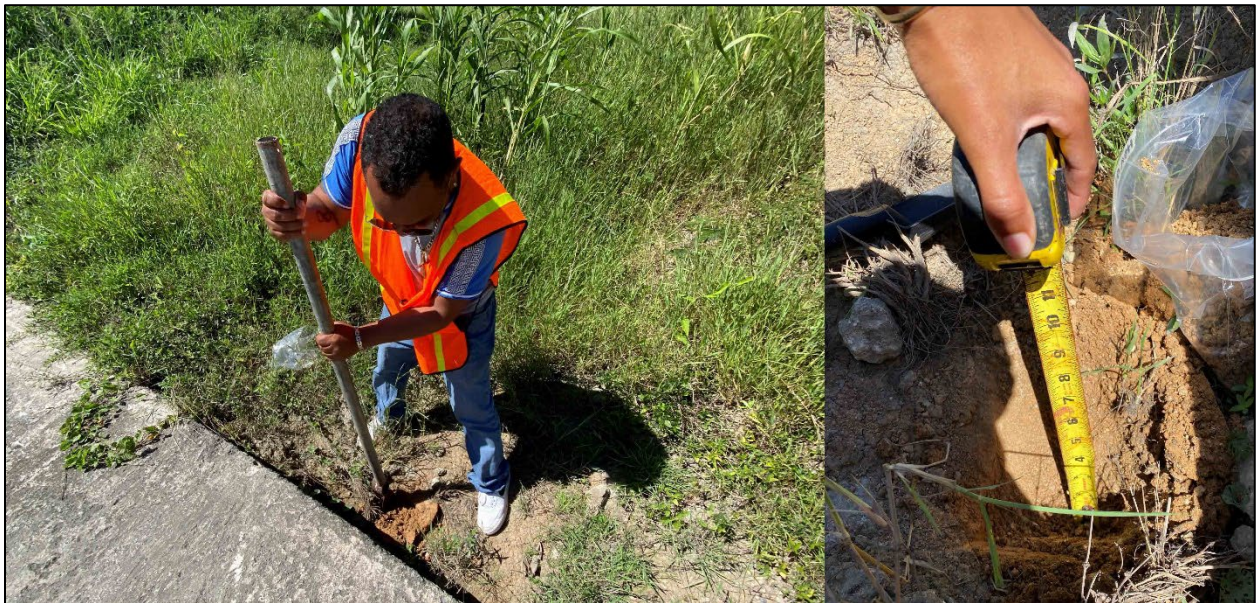
Figure 59. A sediment core being collected from the Hov02 gut channel (left). The depth of the extracted sediment core verified with a tape measure (right).

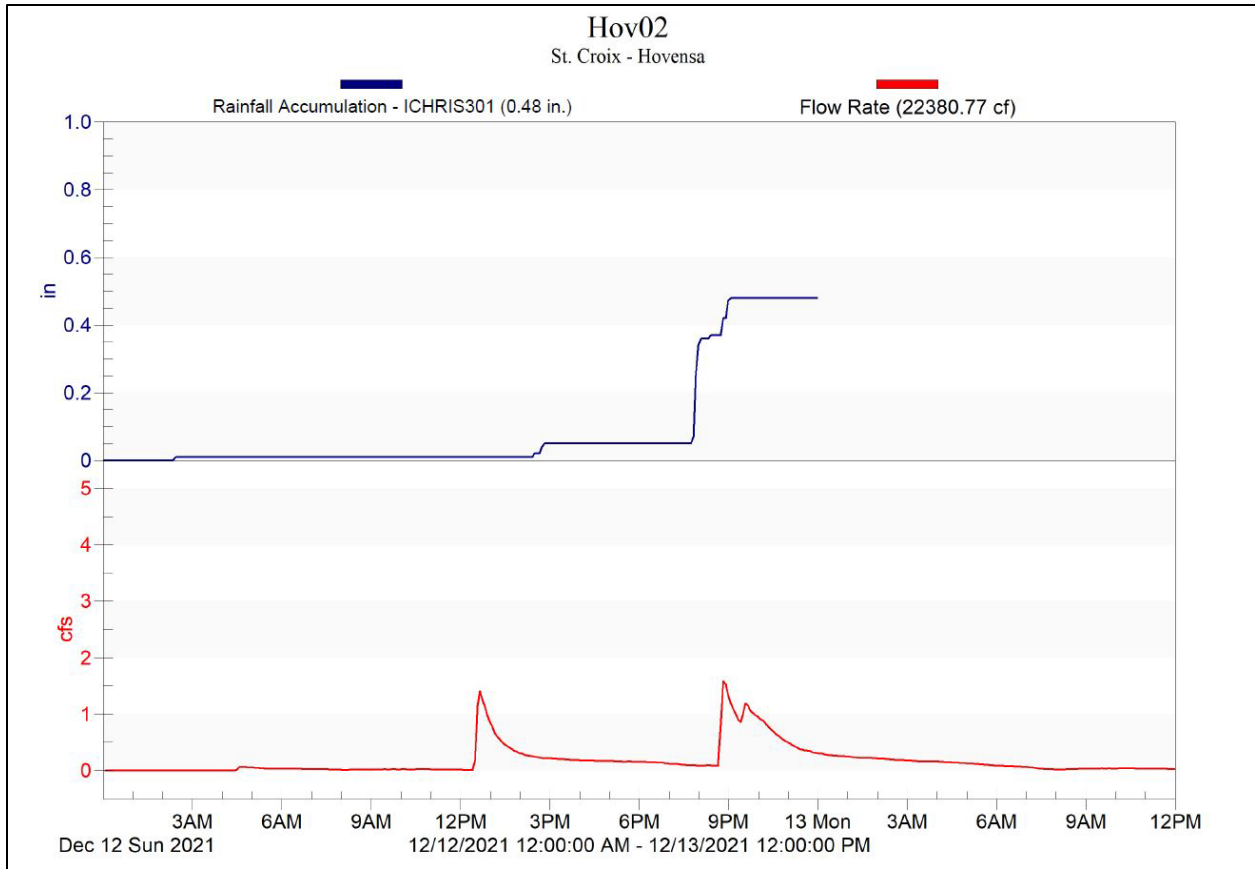
Figure 60. A hydrograph displaying flow at the Hov02 gut monitoring site (1.6 cfs) in red and the corresponding rainfall accumulation for the storm event (0.48 in.) in blue that occurred on December 12th, 2021.

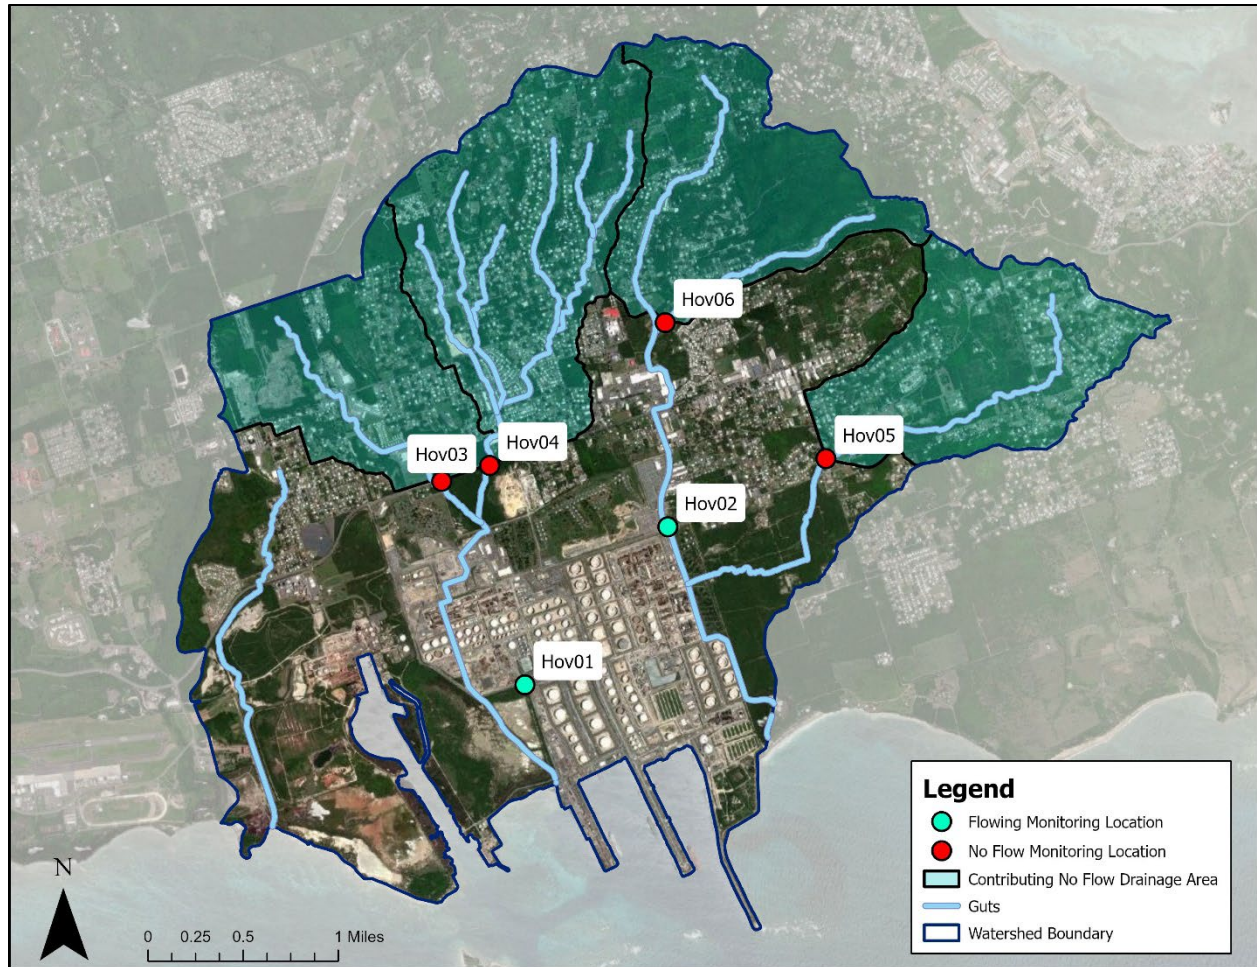
Figure 63. Four out of the six monitoring locations within the Hovensa watershed were confirmed to have no gut flow during at least two qualifying storm events in December 2021 and January 2022 (red). Each of their drainage areas are delineated in blue.

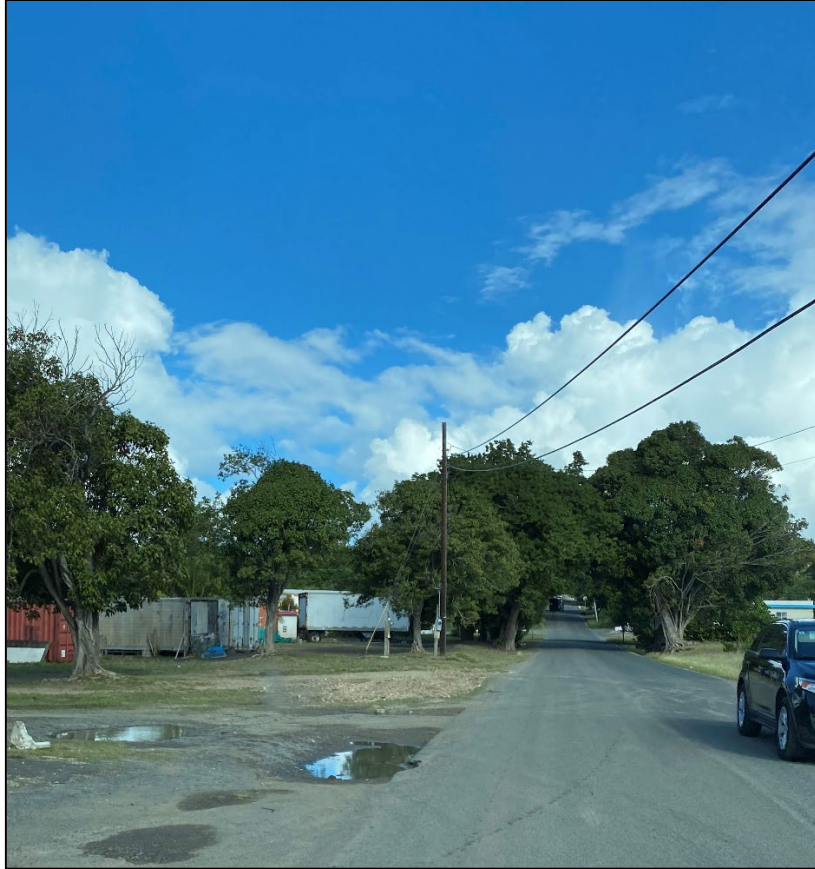
Figure 66. Ponding observed on roads adjacent to the Hov05 monitoring location directly after a storm event.

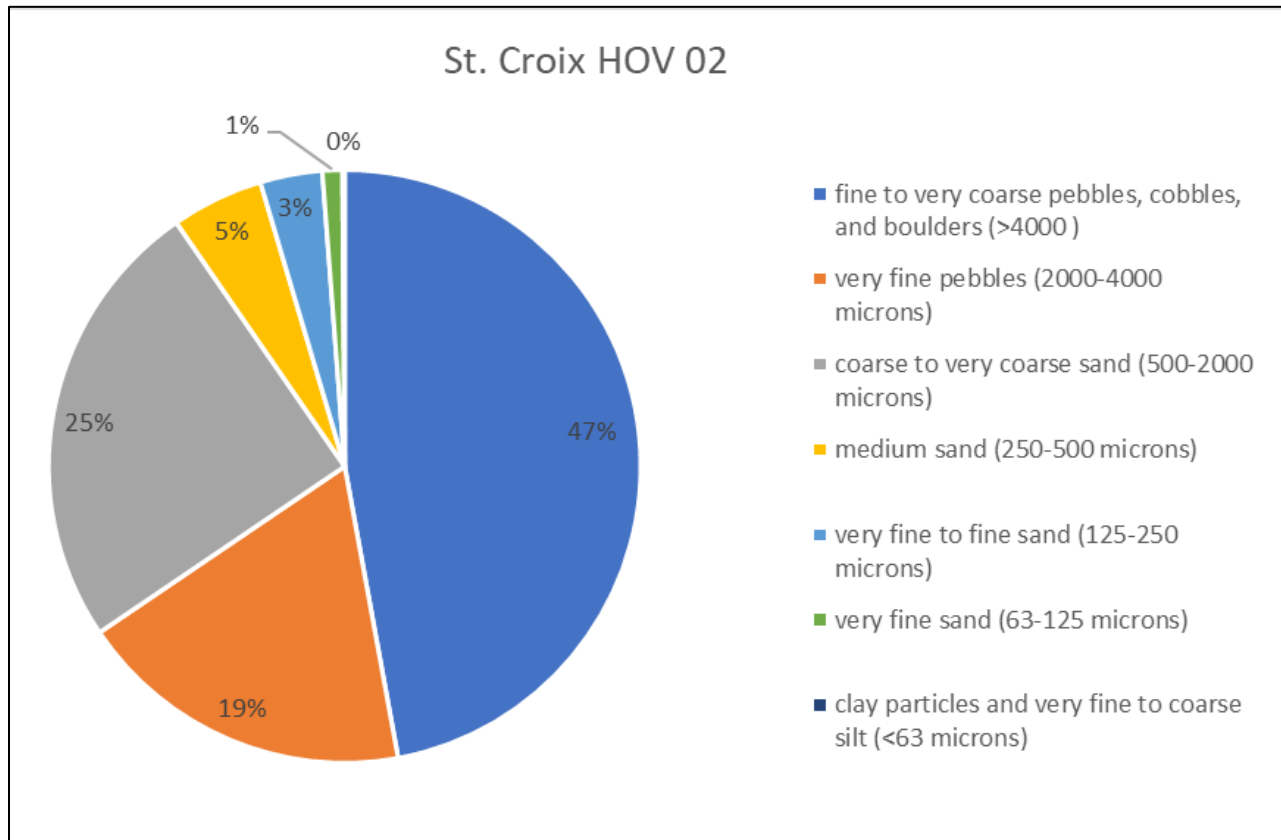
Figure 70. The percent composition of the seven grain size categories within the Hov02 sediment sample.

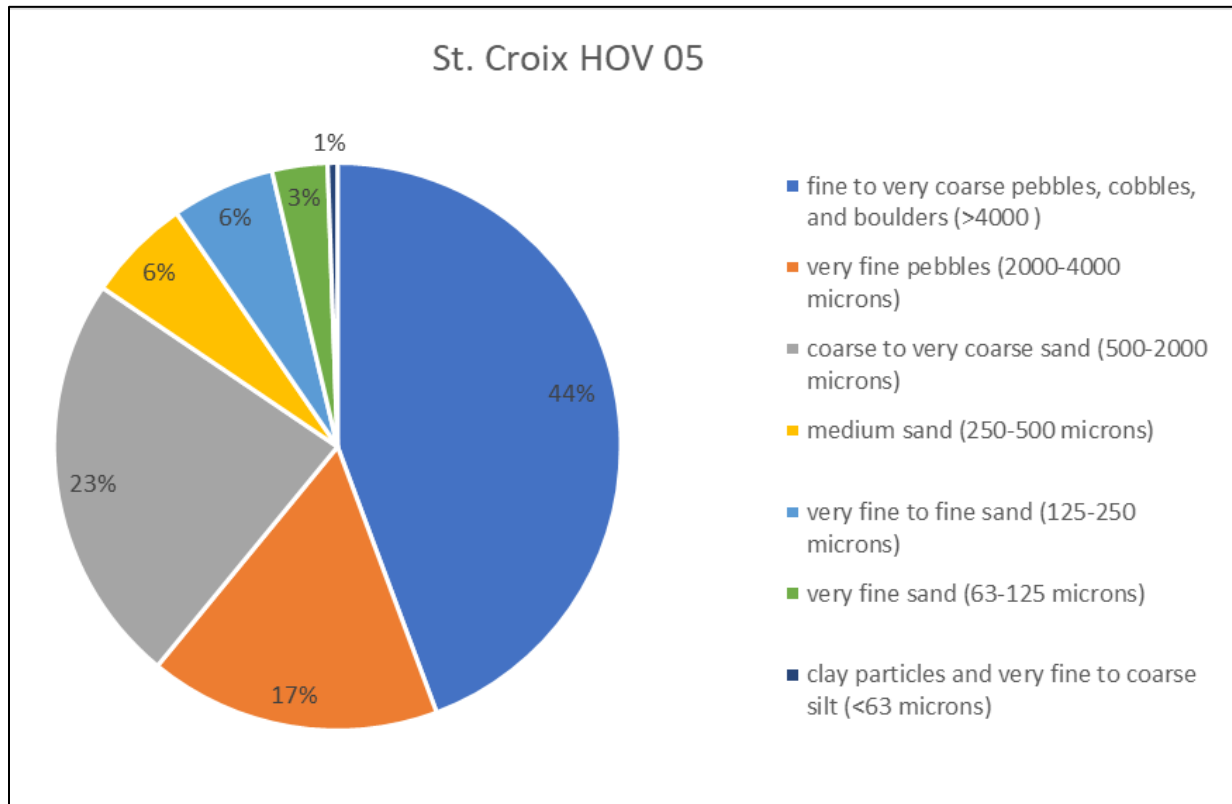
Figure 73. The percent composition of the seven grain size categories within the Hov05 sediment sample.

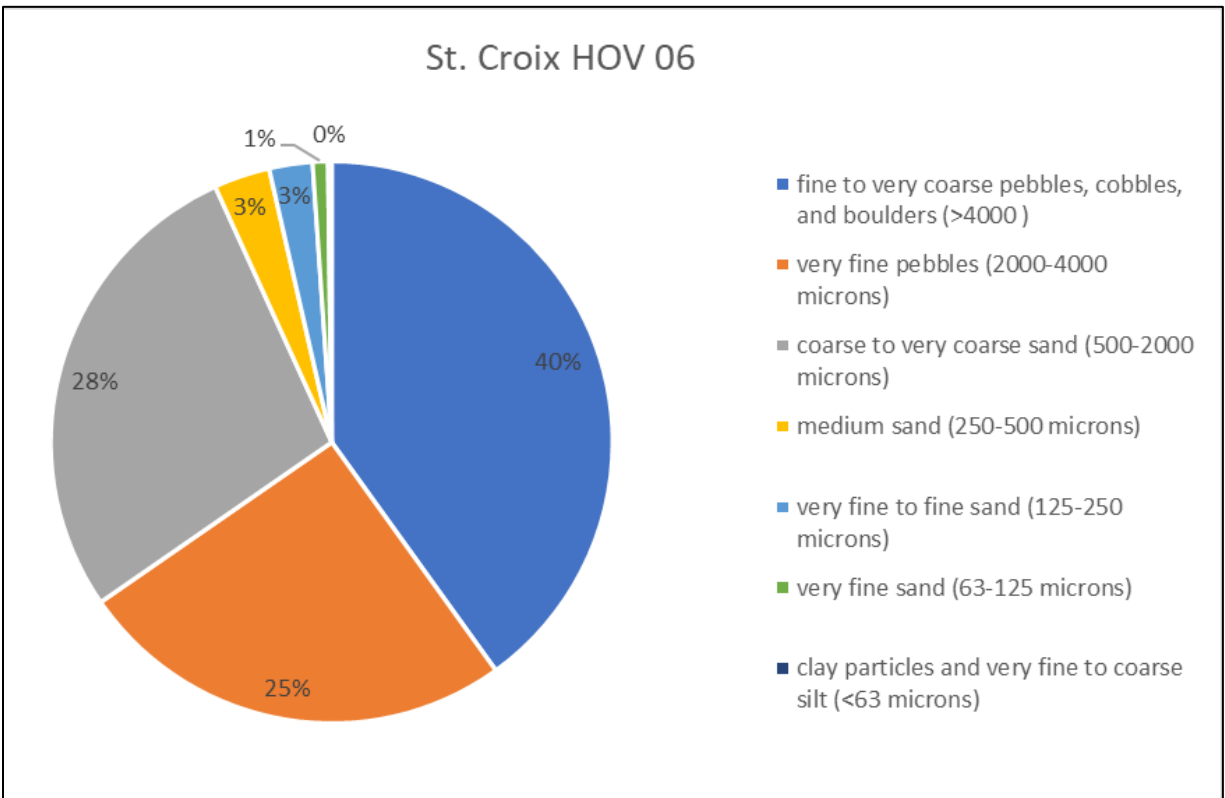
Figure 74. The percent composition of the seven grain size categories within the Hov06 sediment sample.

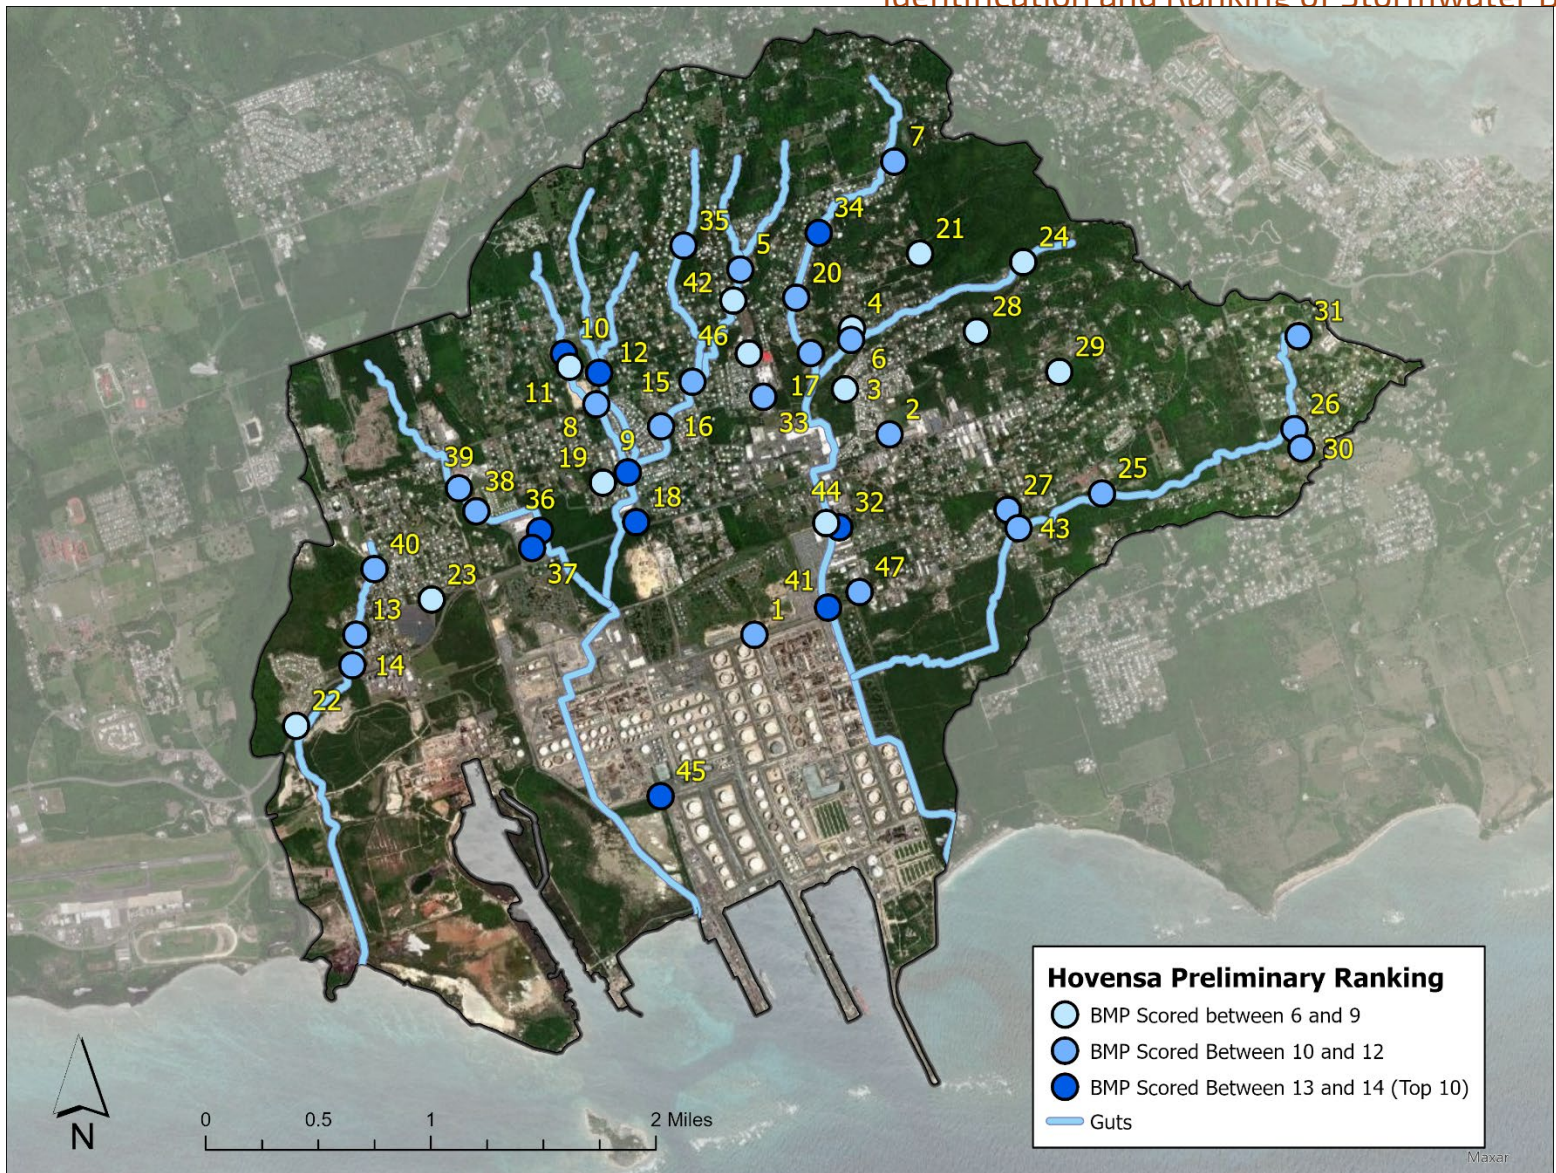
Figure 79. Map of proposed BMP points and preliminary ranking results for the Hovensa watershed. Numeric labels represent the BMP ID Number

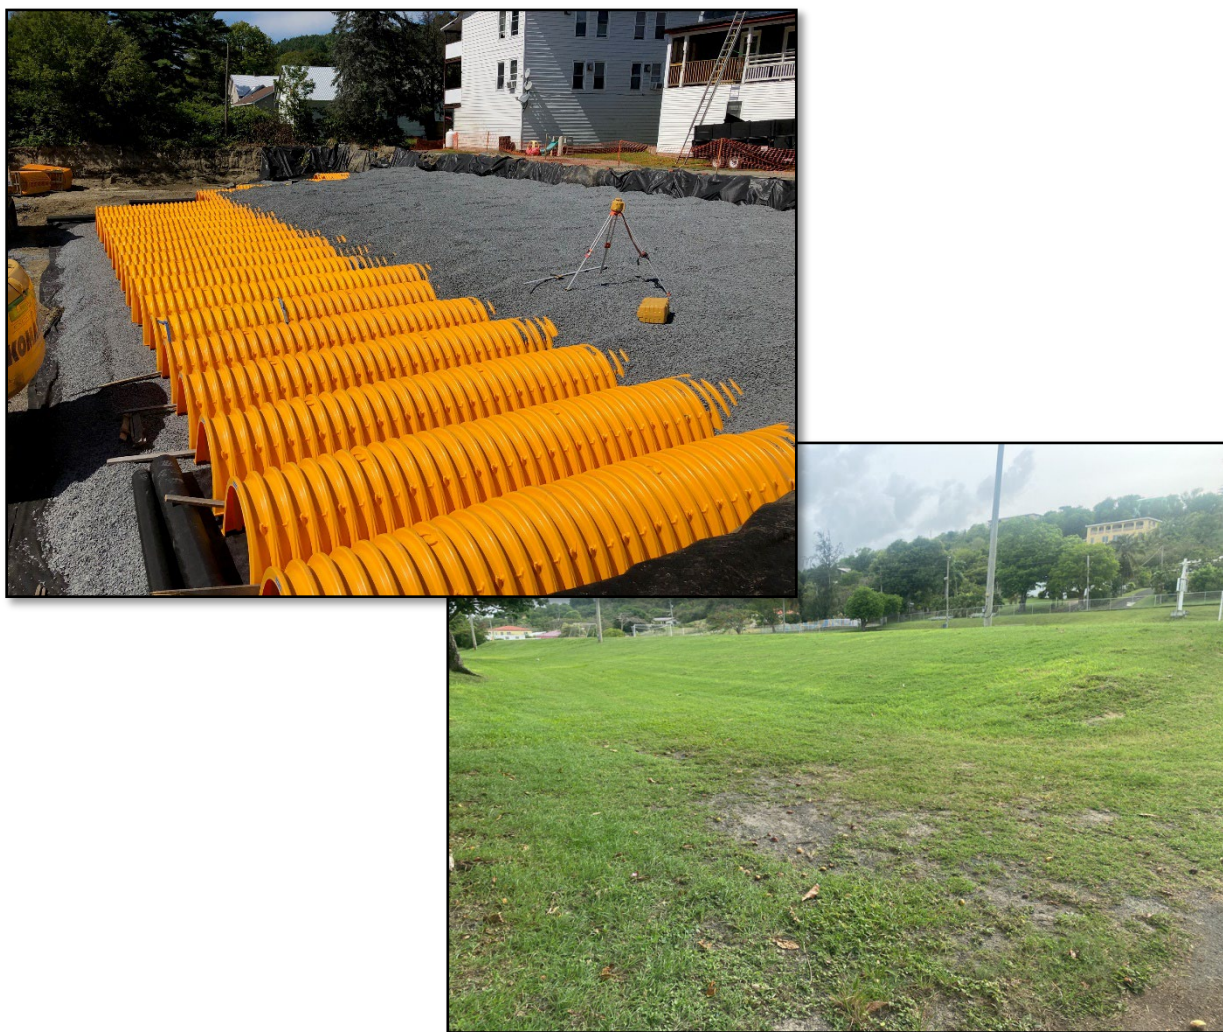
Figure 81. Example photo of subsurface infiltration chambers (above) and recreation field at Freewill Baptist Church (below).

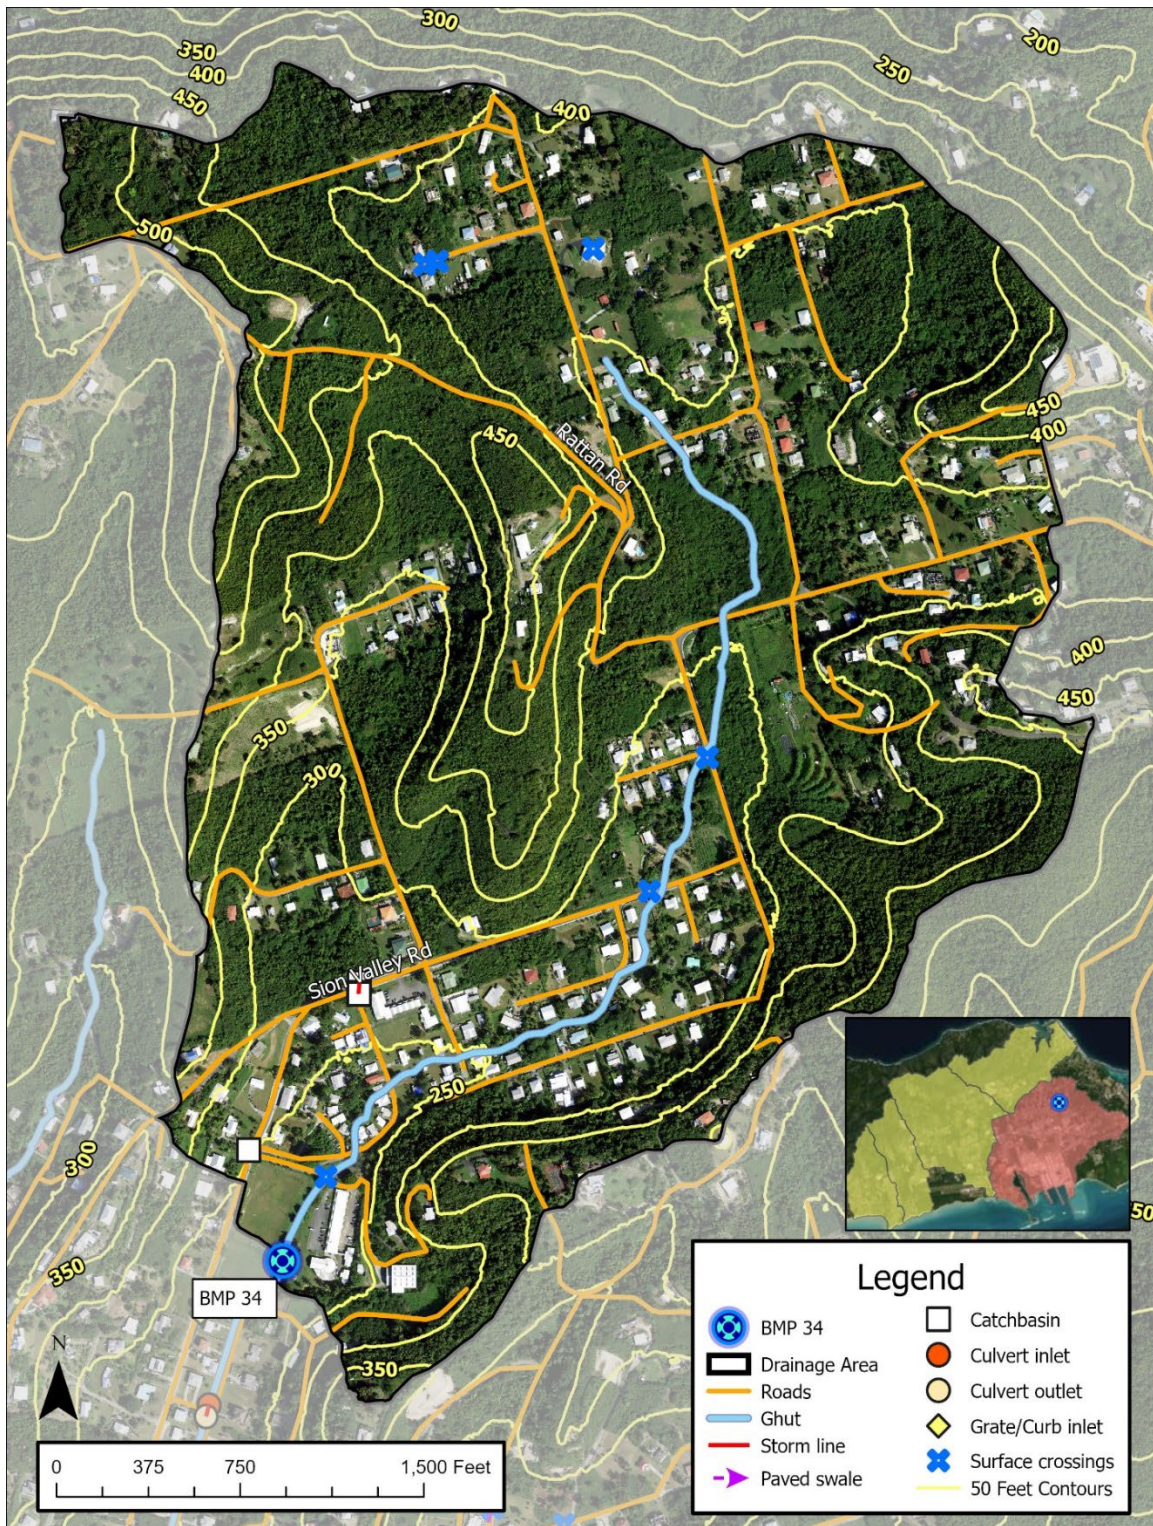
Figure 82. BMP 34's drainage area and its associated infrastructure.

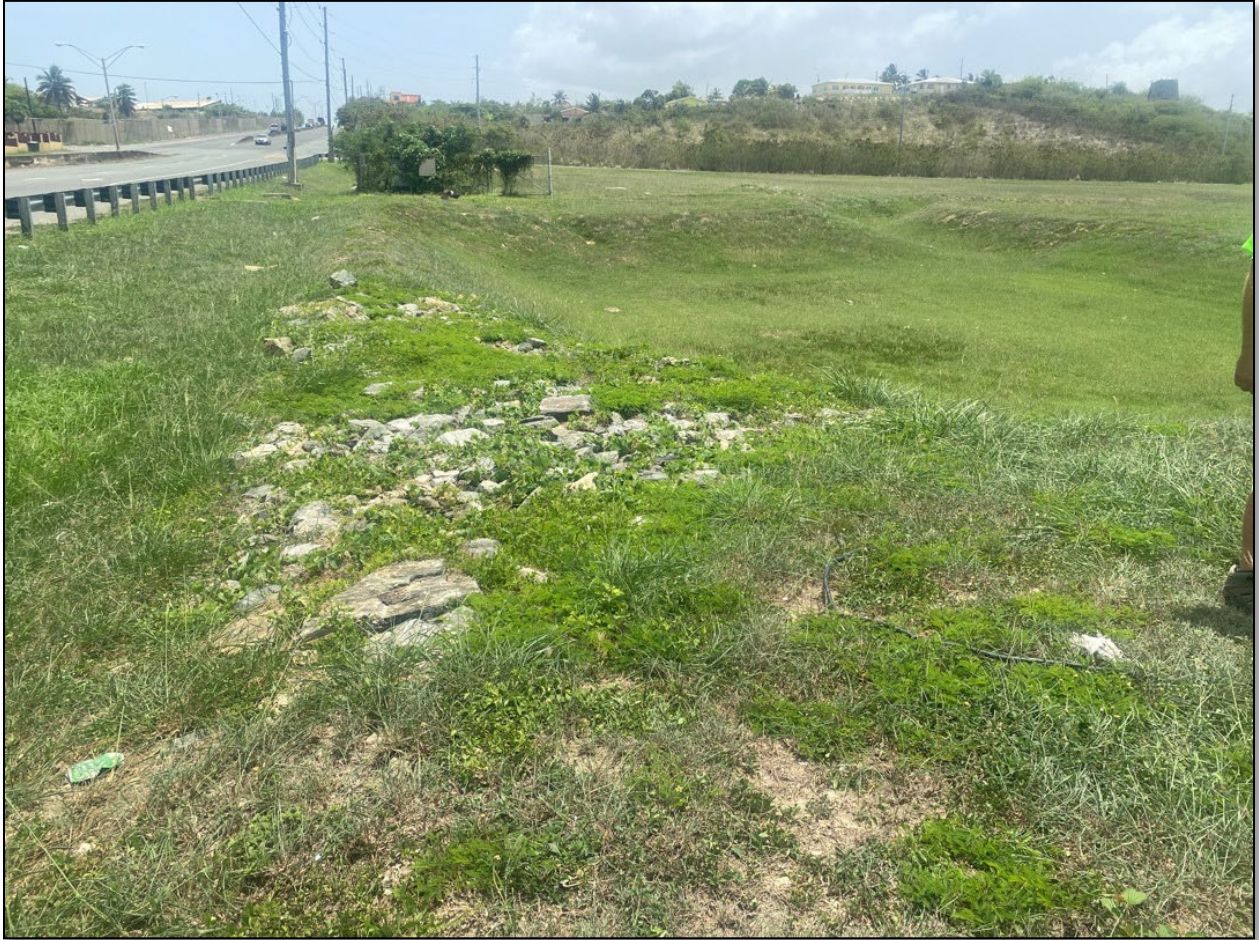
Figure 83. Existing conditions of proposed basin (BMP 41).

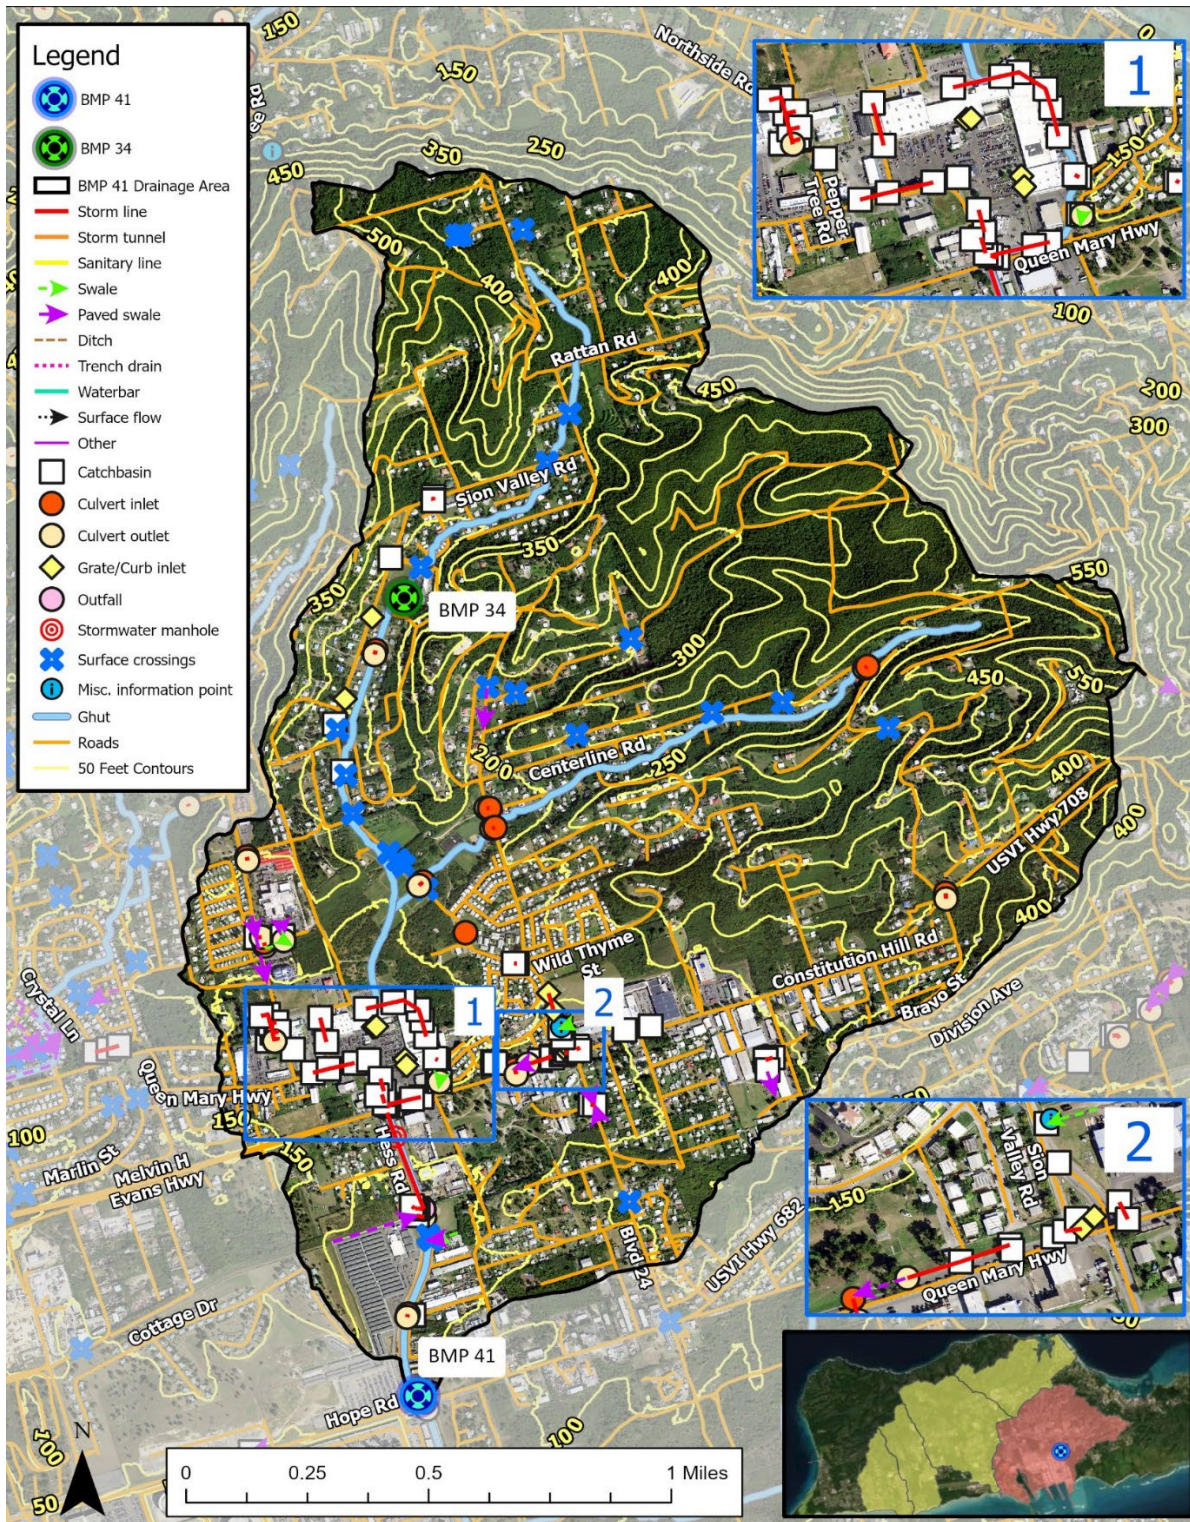
Figure 84. BMP 41's drainage area and its associated infrastructure.

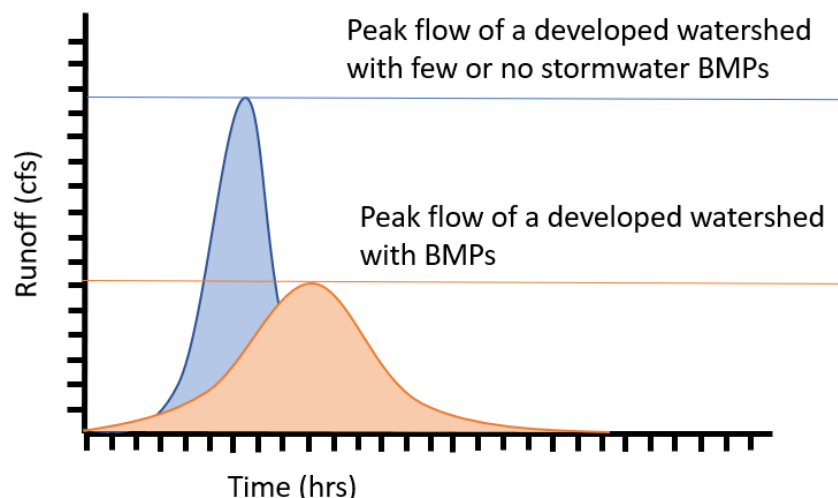
Figure 85. Illustrative hydrographs demonstrating the peak flow reduction value of implementing BMPs.

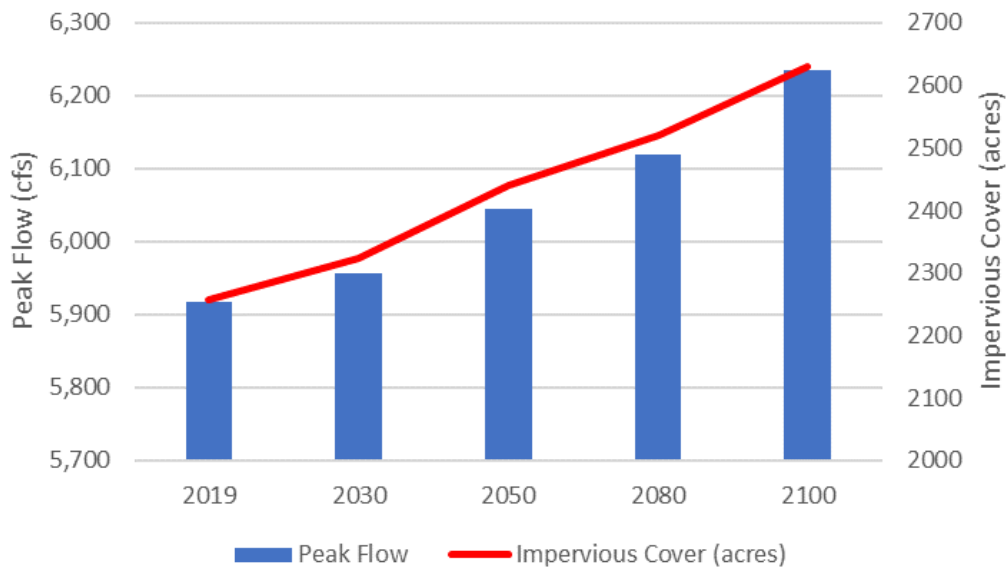
Figure 86. Relationship between watershed scale peak flow (blue) and the predicted impervious cover (red) over time.

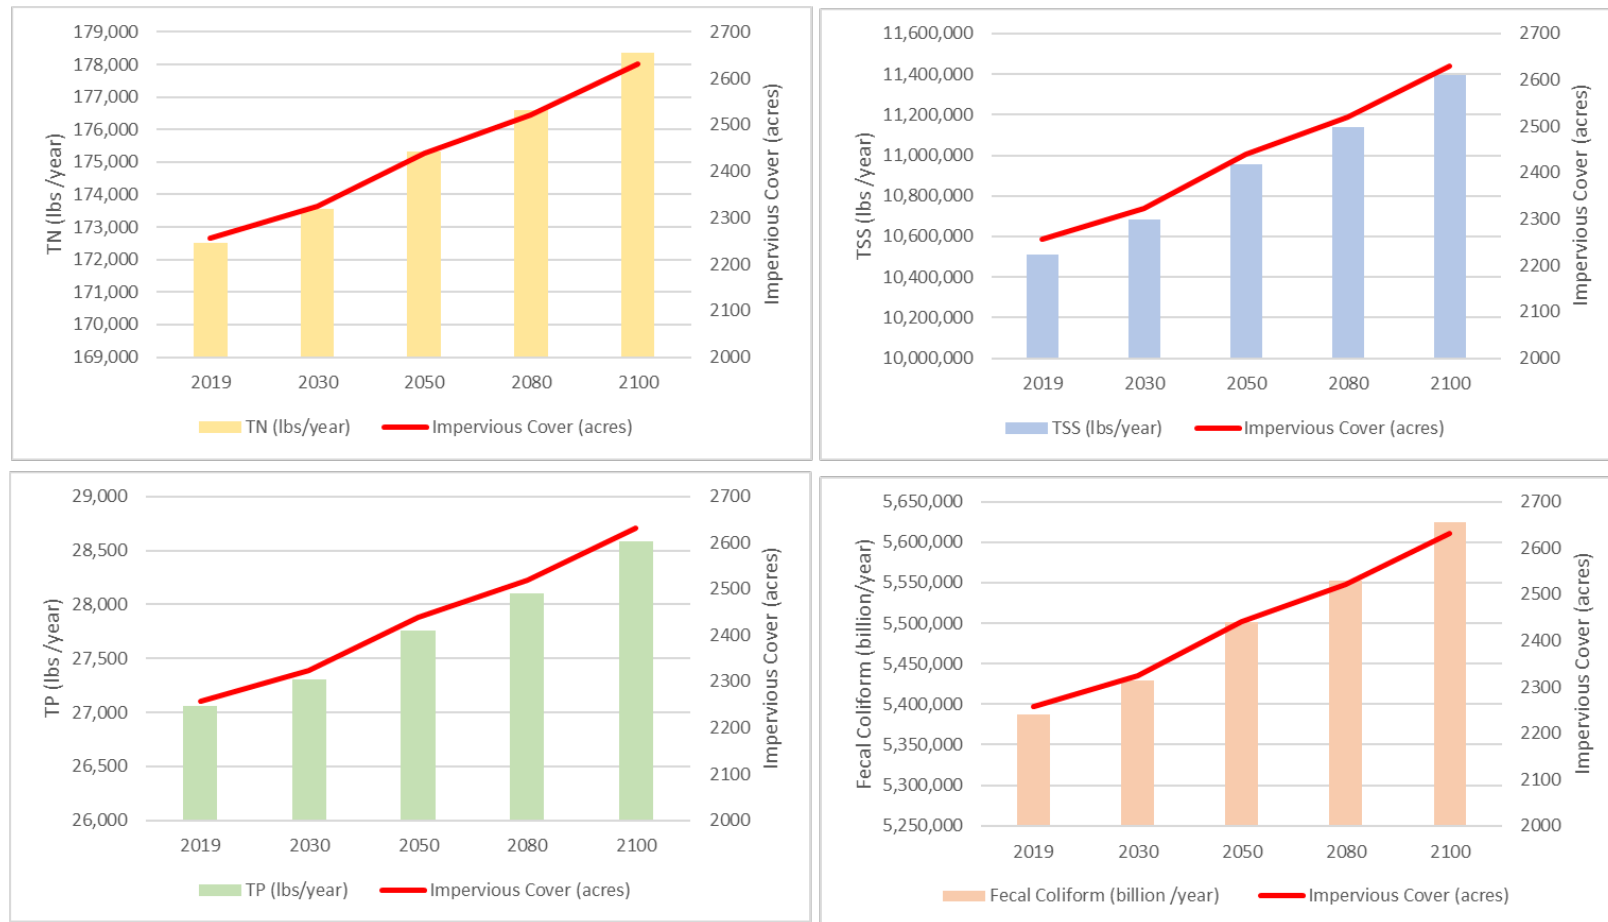
Figure 87. Relationship between watershed-scale pollutant loading for TN (yellow), TSS (blue), TP (green), and Fecal Coliform (orange) and the predicted impervious cover increase (red) over time
