**WATERSHED
MANAGEMENT PLAN
FOR THE HOVENSA
WATERSHED
ST. CROIX, USVI
JUNE 2022**

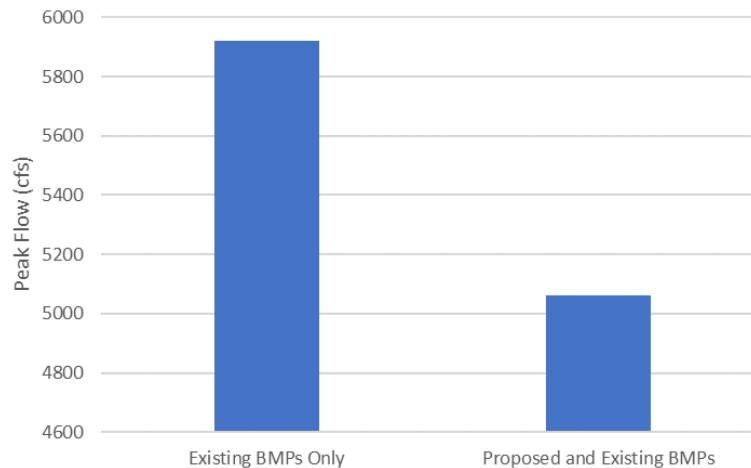
Figure 89. Peak flow was reduced at the watershed outlet from 2,436 cfs with existing BMPs to 1,409 cfs with addition of the Top 10 proposed BMPs.

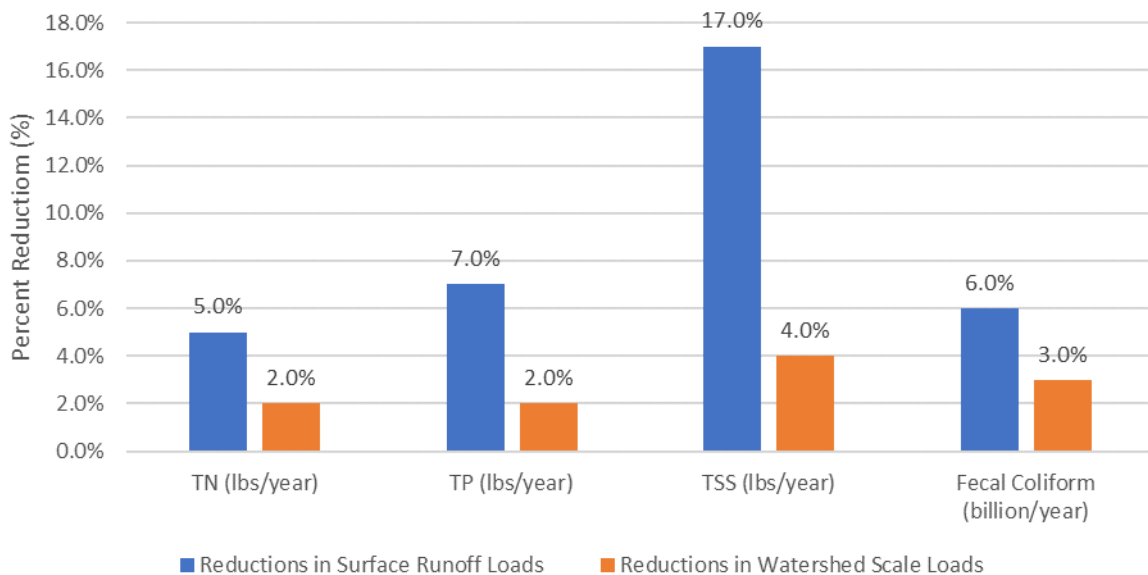
Figure 90. Pollutant load reductions attributable to the Top 10 BMPs for the Surface Runoff category (blue) and for all modeled watershed sources (orange).

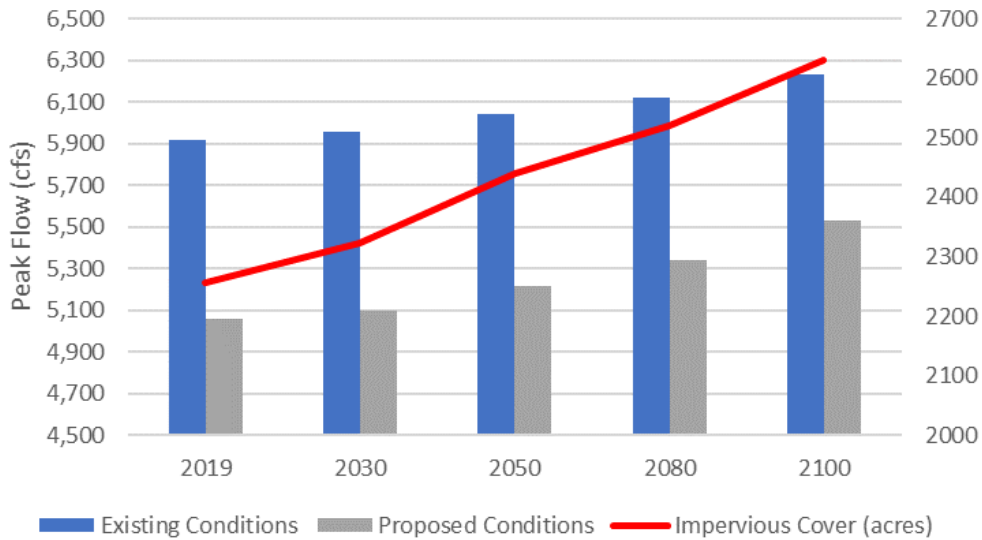
Figure 91. Relationship between watershed peak flow for the existing conditions (blue) and proposed conditions (gray), which includes the implementation of the Top 10 BMPs over time. The predicted impervious cover increase (red) over time is also shown.

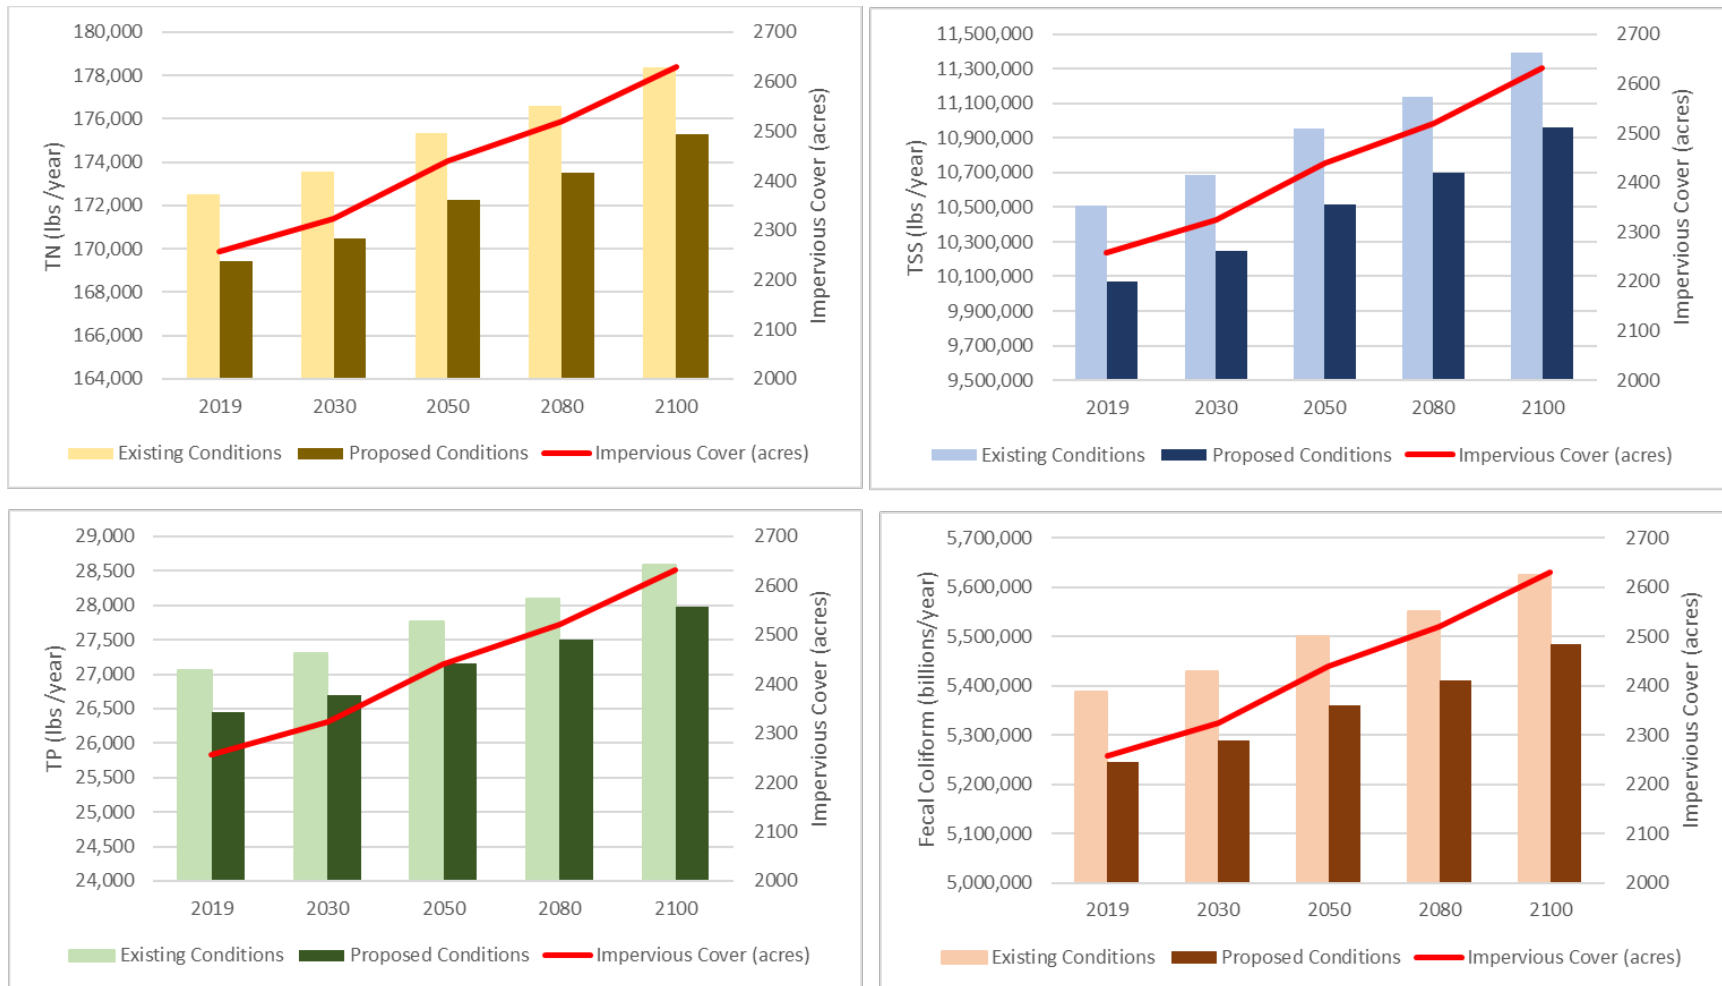
Figure 92. Relationship over time between watershed scale pollutant loading for the existing conditions (lighter colors) and proposed conditions (darker colors), which includes the implementation of the Top 10 BMPs. Loading is shown for TN (yellow), TSS (blue), TP (green), and Fecal Coliform (orange). The predicted impervious cover increase (red line) over time is also shown.
