**WATERSHED
MANAGEMENT
PLAN FOR THE
LONG POINT BAY
WATERSHED
ST. CROIX, USVI**

JUNE 2022

This watershed management plan (WMP) summarizes watershed-specific assessments and provides recommendations and design details to reduce flooding and improve water quality and resiliency. The five watersheds assessed on St. Croix include Bethlehem, Diamond, Hovensa, Long Point Bay, and Salt River Bay (Figure 1). The concurrent study on St. Thomas includes the watersheds of Bolongo Bay, Cyril E. King Airport, and St. Thomas Harbor.

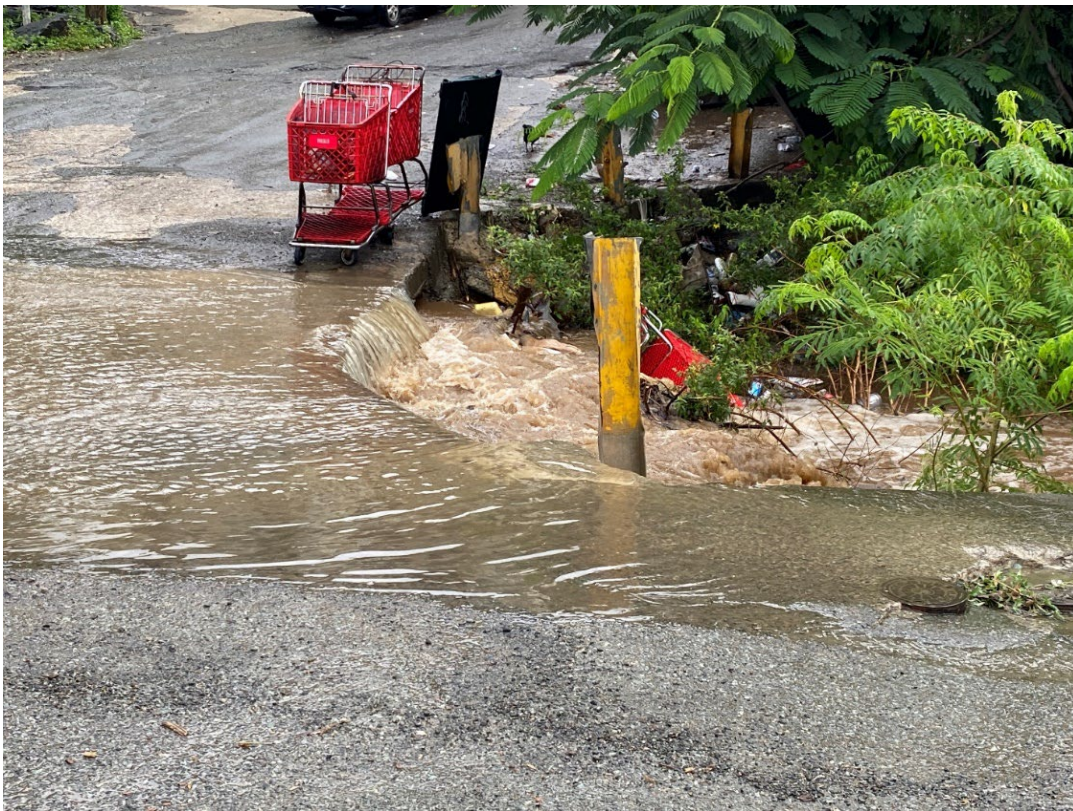
Figure 5. Runoff from impervious surfaces such as a road contributes to flooding and water quality problems.

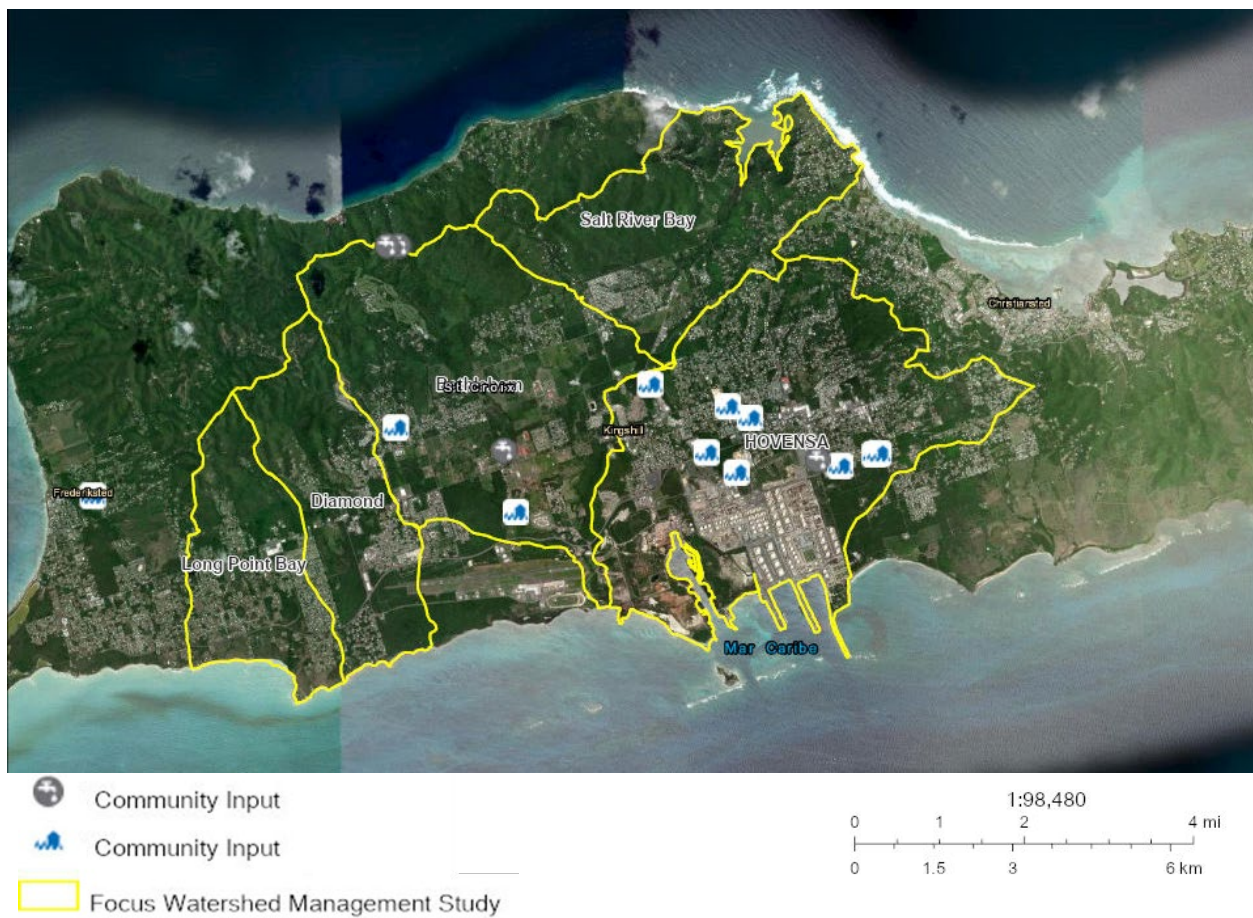
Figure 12. Flooding and water quality problem areas identified by community members.

Property damage and limited access to roadways caused by flooding and erosion were the most prevalent concerns brought up by community members. Locations identified as concerns by community members on the project website interactive map can be found in Figure 12. In response to many of those who contacted the project team or our partners about site specific issues, representatives from our team conducted site visits to assess damage or issues, meet with community members in-person, and develop proposed solutions.

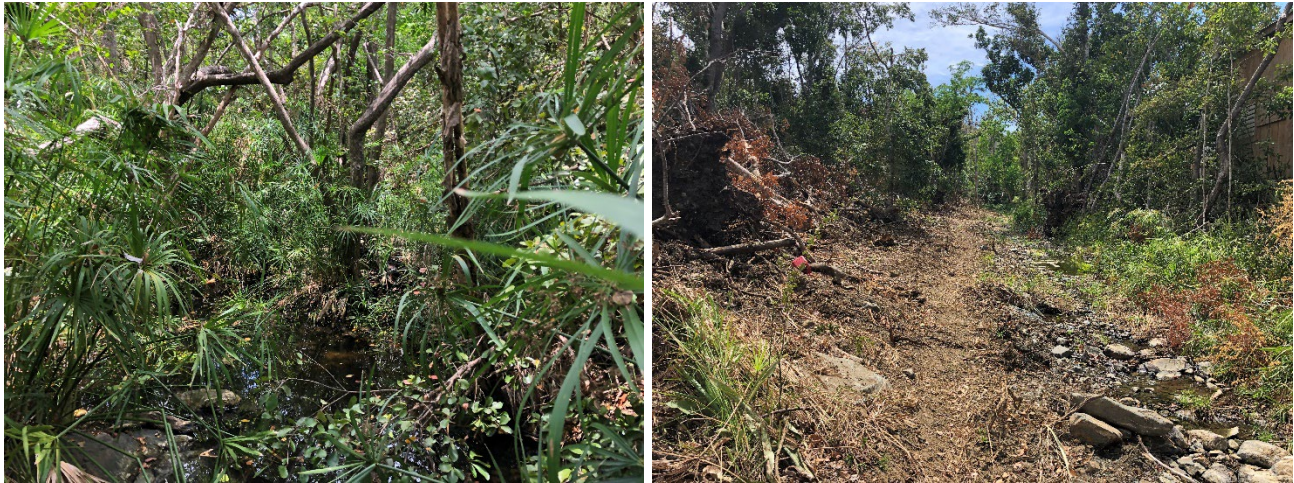
Figure 13. Photos of a gut taken by a resident before (left) and after (right) excavation.

In one specific incident, a community member detailed the excavation of old growth trees within an existing gut and along its banks (Figure 13). The community member noted how the trees used to provide shade and shelter to many species of mammals, birds, and reptiles. The area was once a place he would take his family to recreate. He stated that the excavation of the gut and its riparian buffer destroyed this ecosystem, and there has been no follow up to amend the environmental consequences of the destruction.

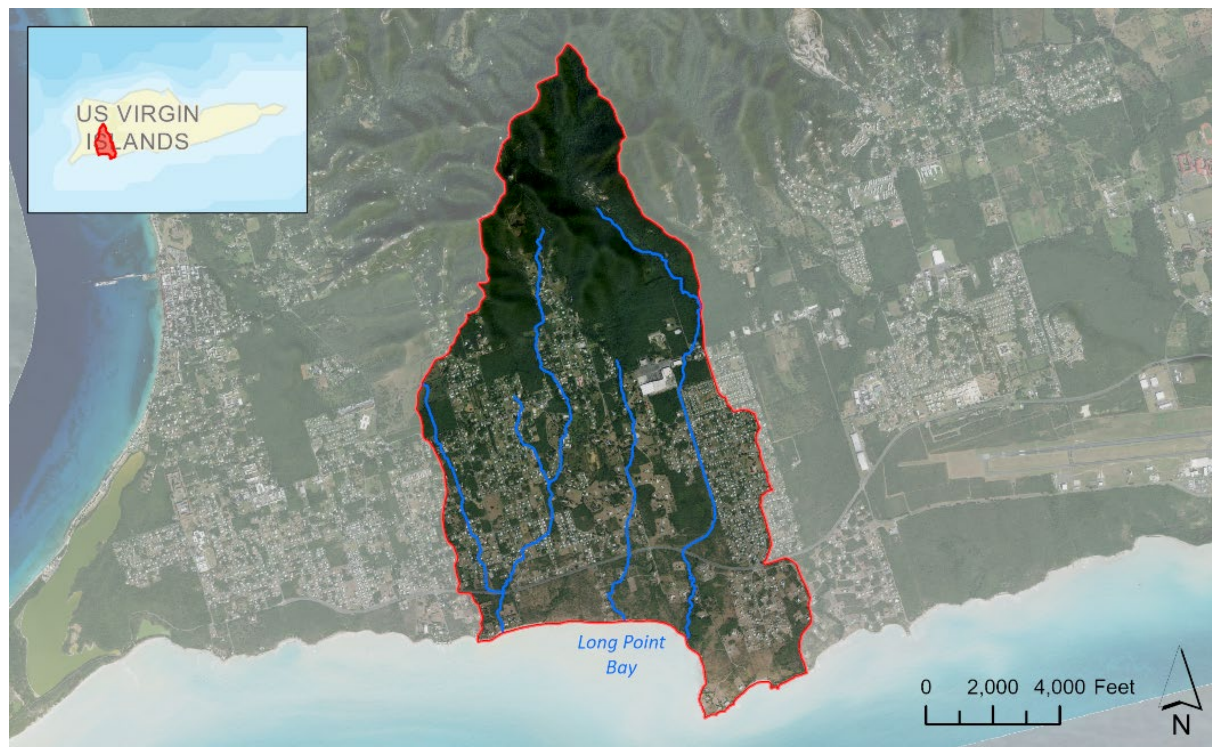
Figure 16. Overview map of the Long Point Bay watershed.

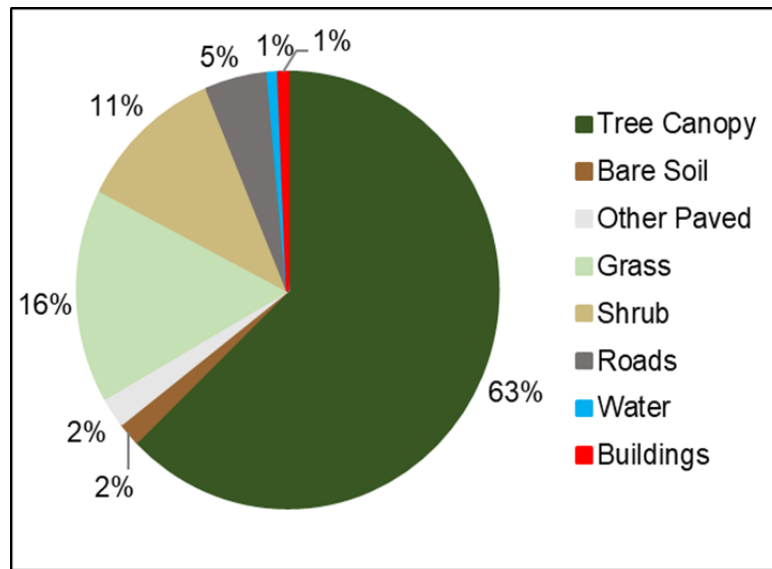
Figure 20. Existing land cover within a 25-foot buffer of guts in the Long Point Bay watershed.

In the Long Point Bay watershed, nearly 63% of the existing land-cover within the riparian buffer zone is composed of tree canopy. The other portion is predominantly grass, and shrub, with the remaining areas consisting of roads, water, buildings, other paved surfaces, and bare soil (Figure 20).

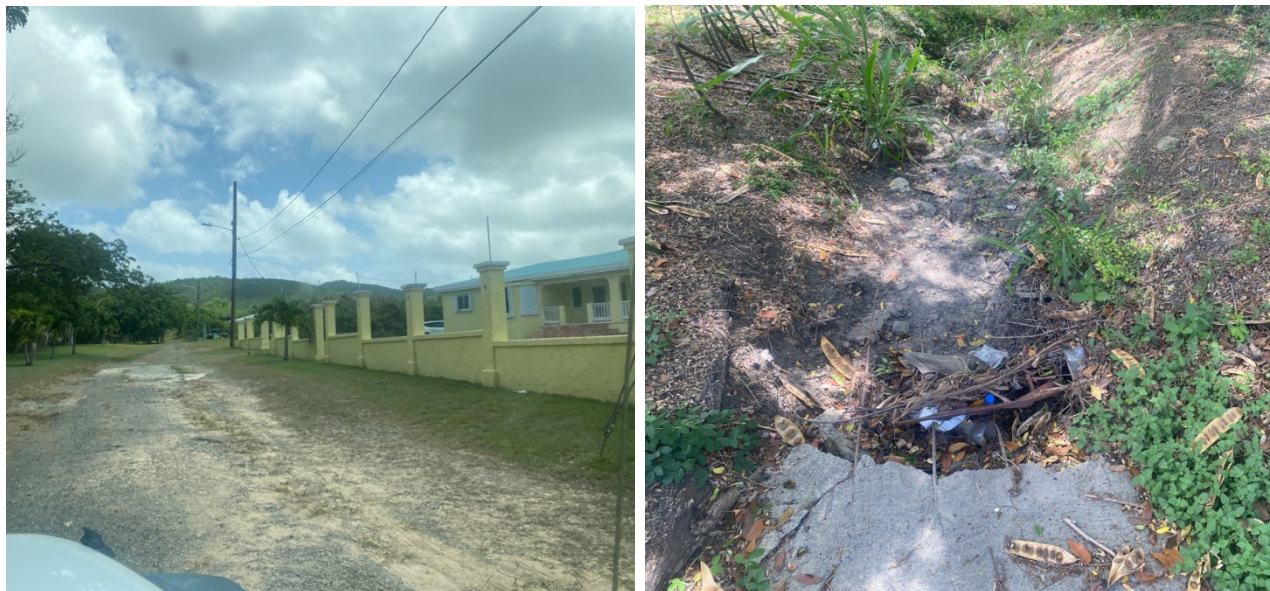
Figure 37. Road erosion (right) and clogged stormwater infrastructure (left).

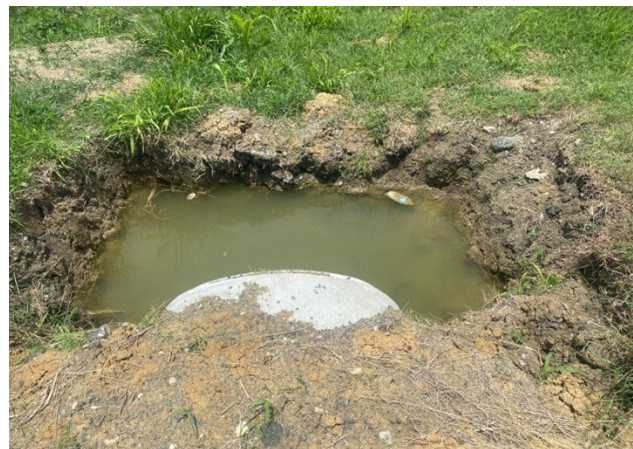
Figure 39. Suspected illicit discharge at an outfall observed during field investigations

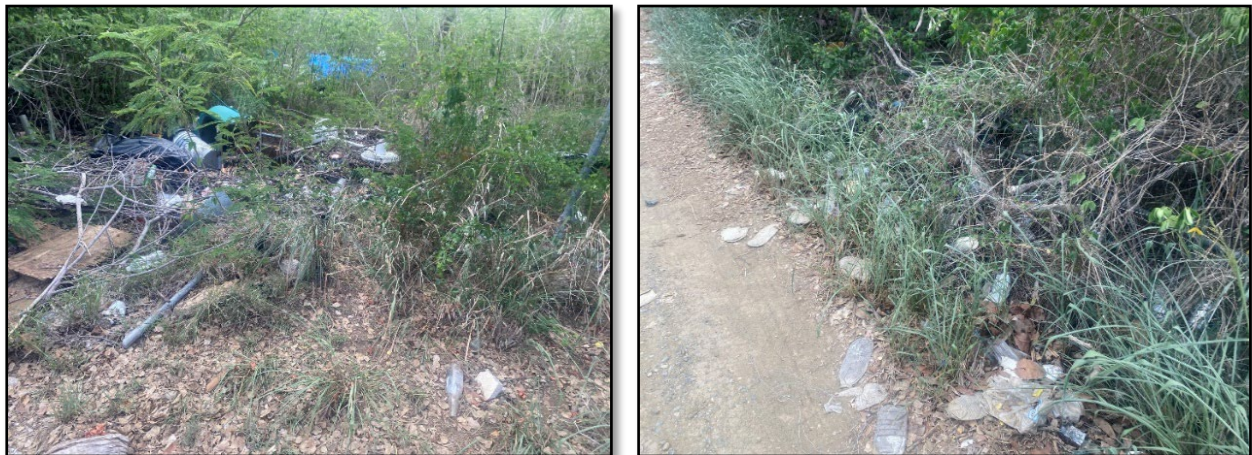
Figure 41. Examples of illegal dumping in forested areas (top left), along roadways (top right) and within stormwater infrastructure (bottom)

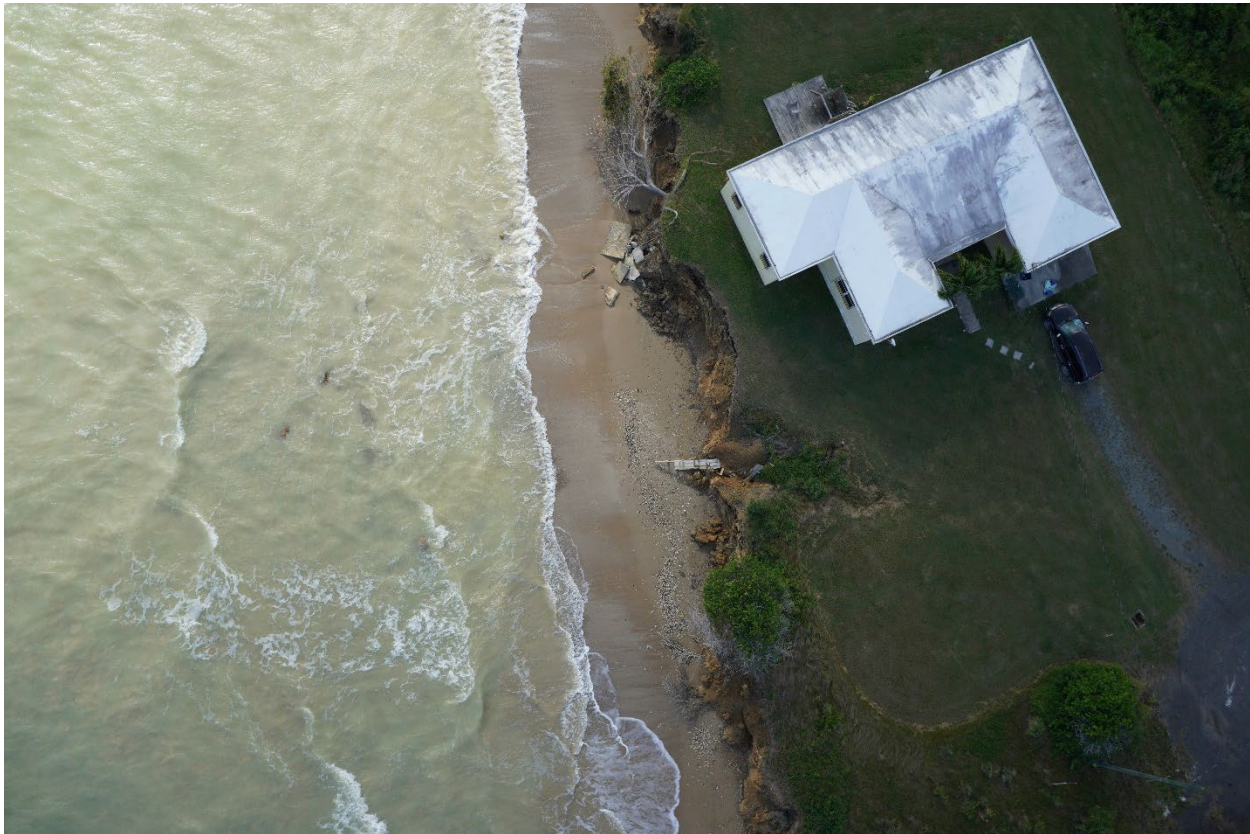
Figure 44. Coastal erosion due to sea level rise threatens stability of homes near the coast.

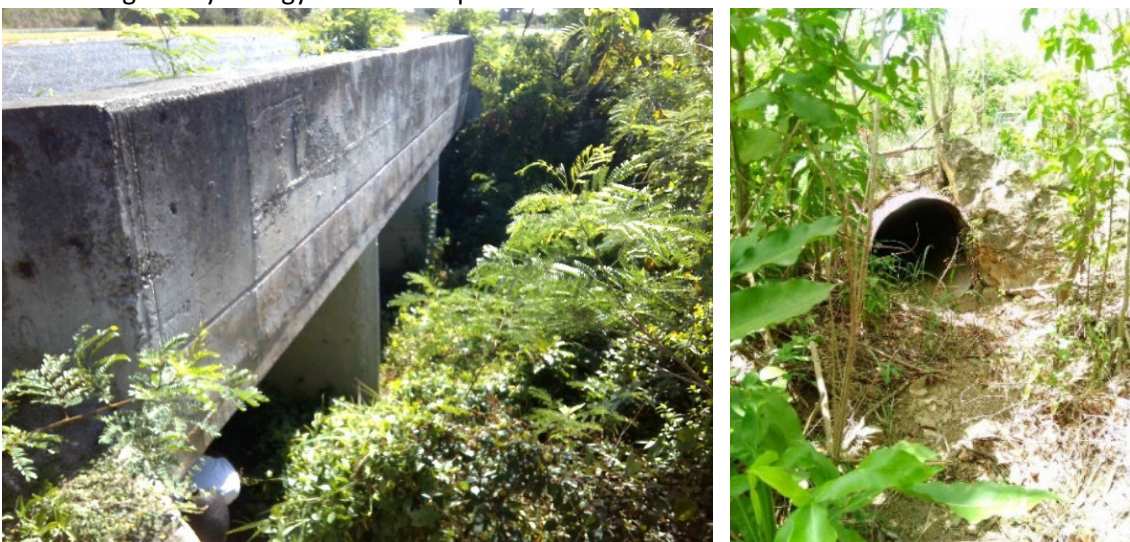
Figure 47. Examples of stormwater infrastructure in the Long Point Bay watershed.

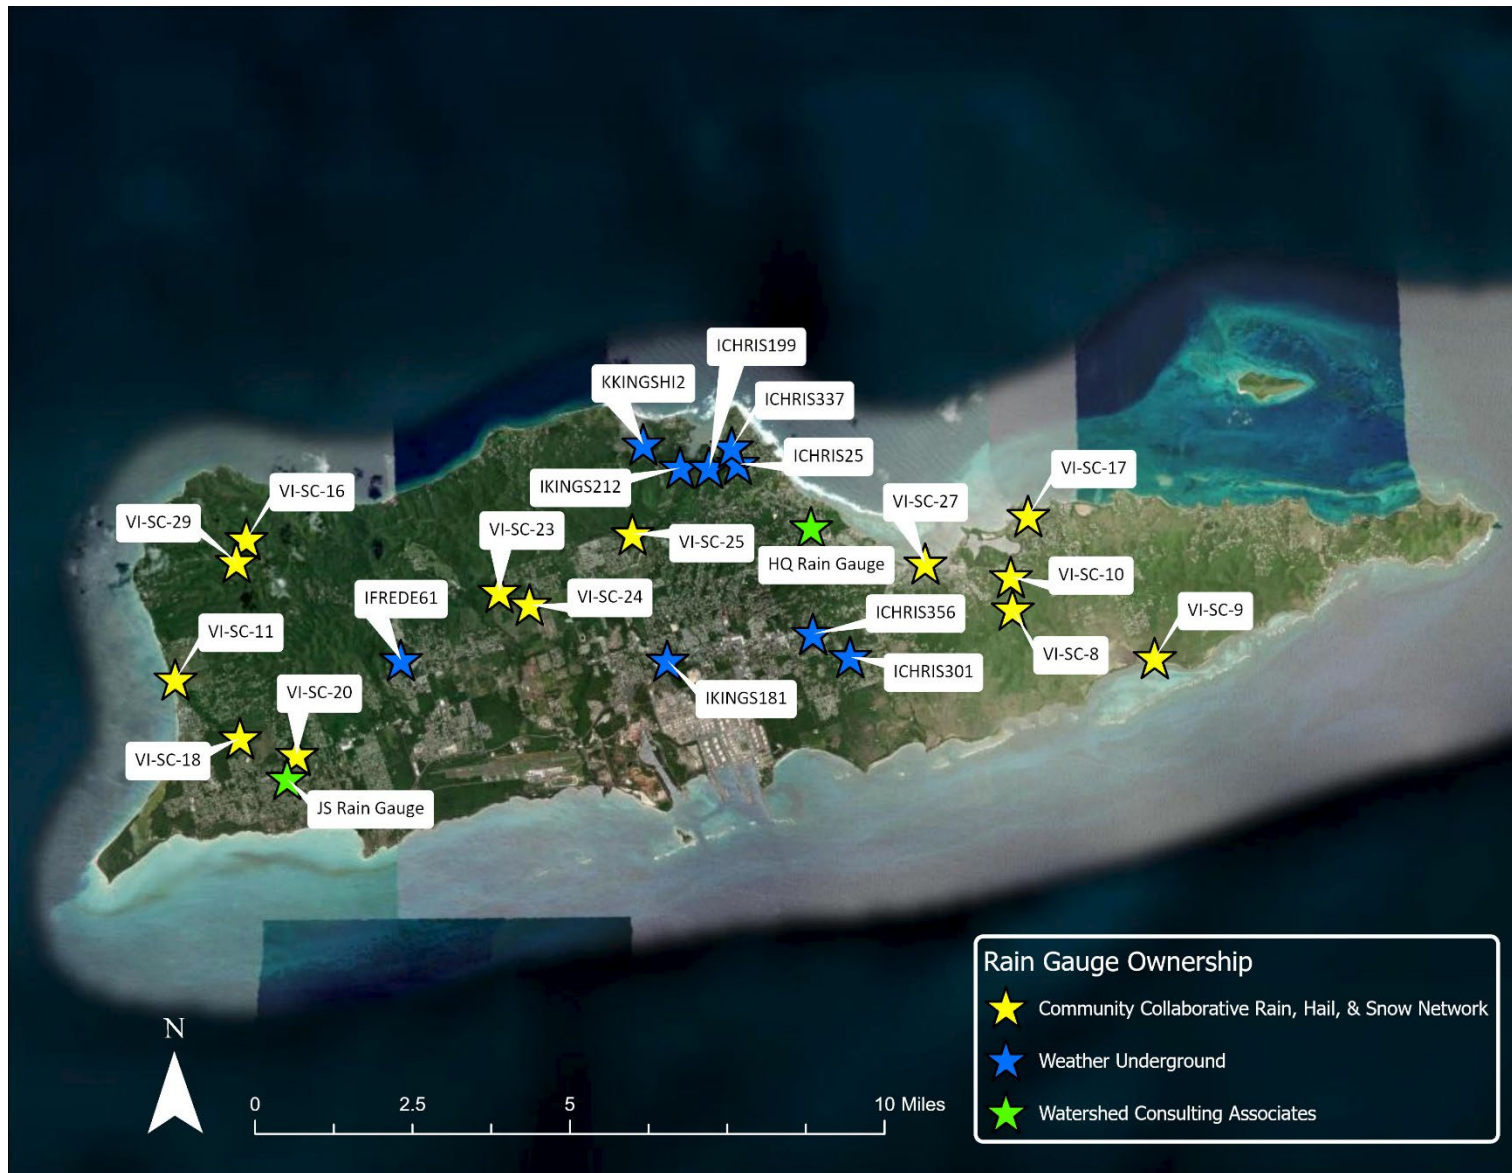
Figure 52. Rain gauge locations on St. Croix.

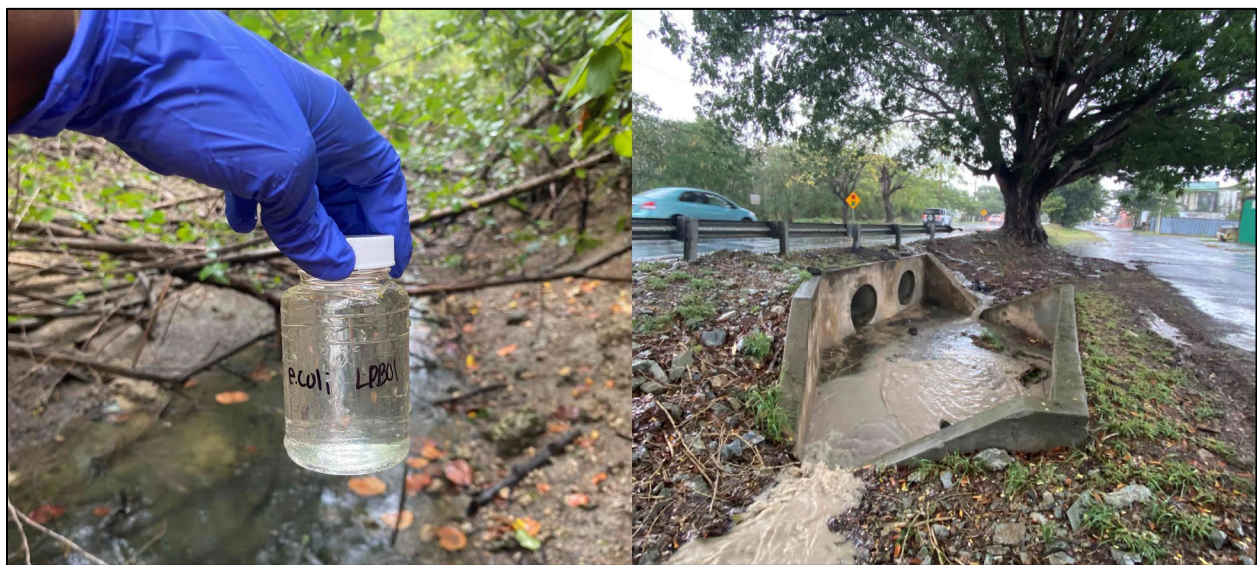
Figure 53. Grab sample collection from sampling sites LPB01 (left) & LPB05 (right).

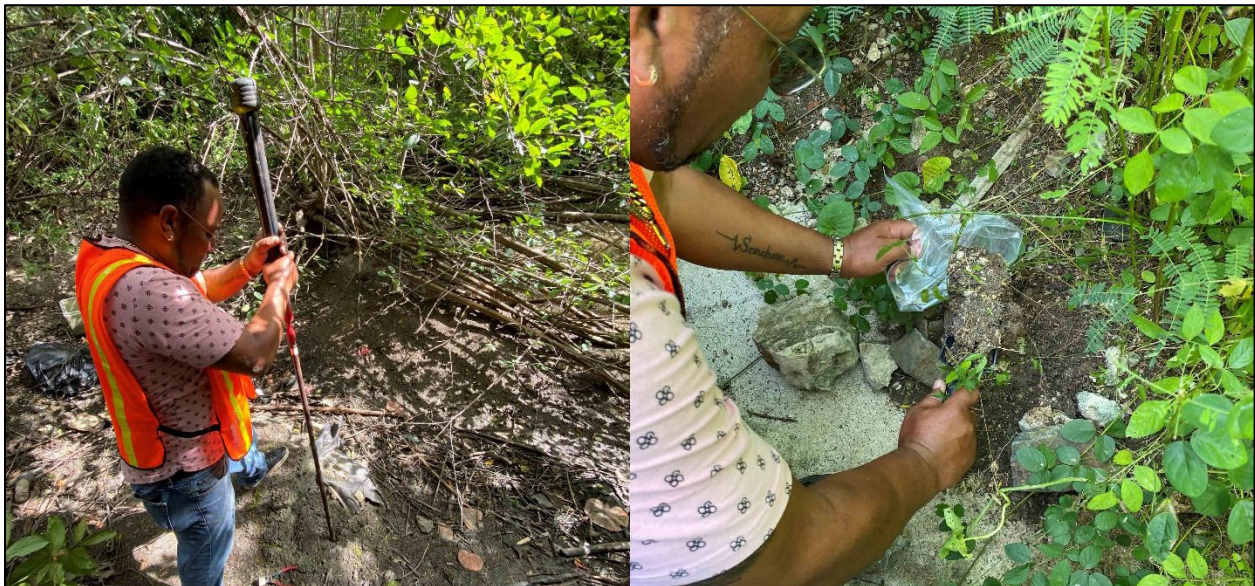
Figure 55. A sediment core being collected from the LPB01 gut channel (left) and a subsample of sediment being collected from the LPB03 gut channel (right).

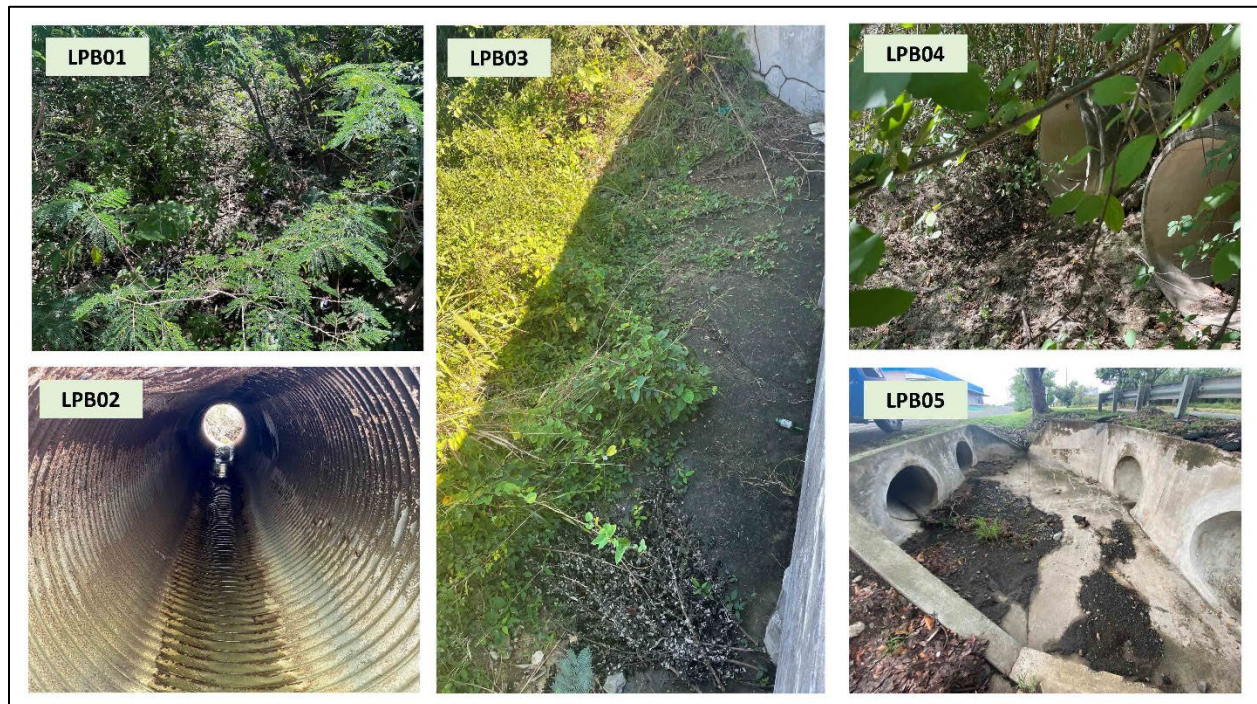
Figure 60. No storm flow was observed at all five gut monitoring locations in Long Point Bay.

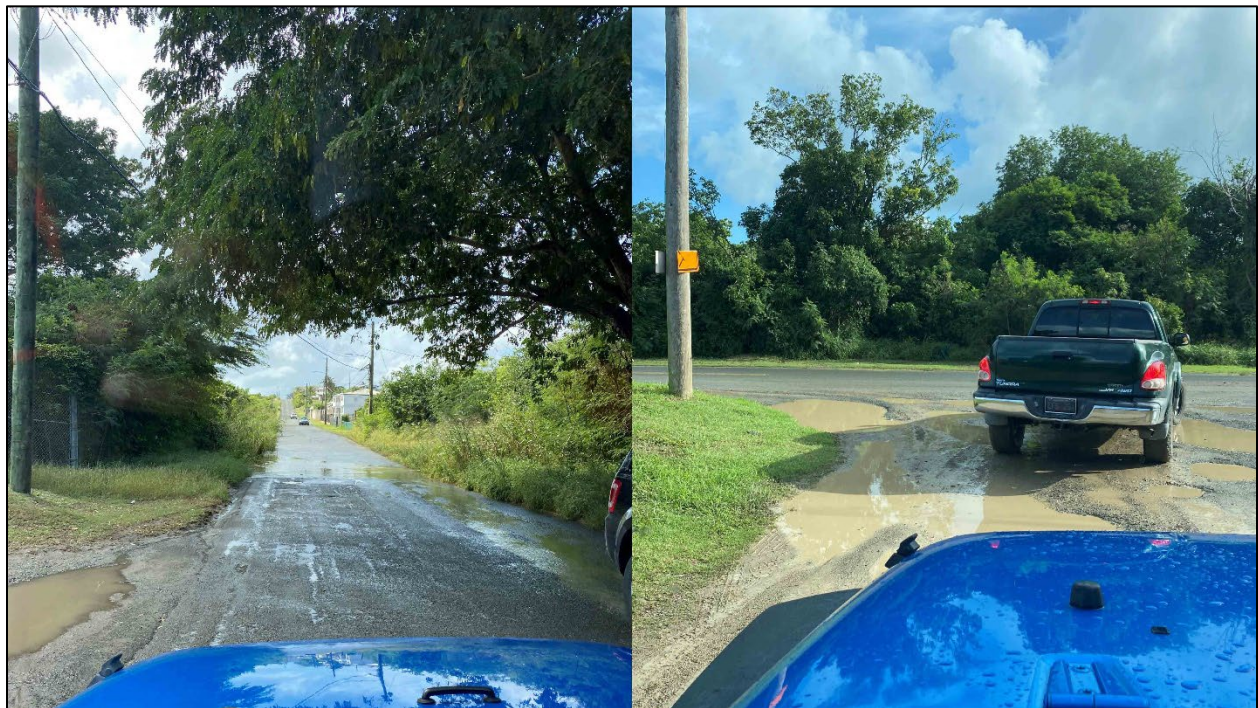
Figure 64. Ponding observed on roads adjacent to the LPB02 and LPB05 monitoring locations after a storm event.

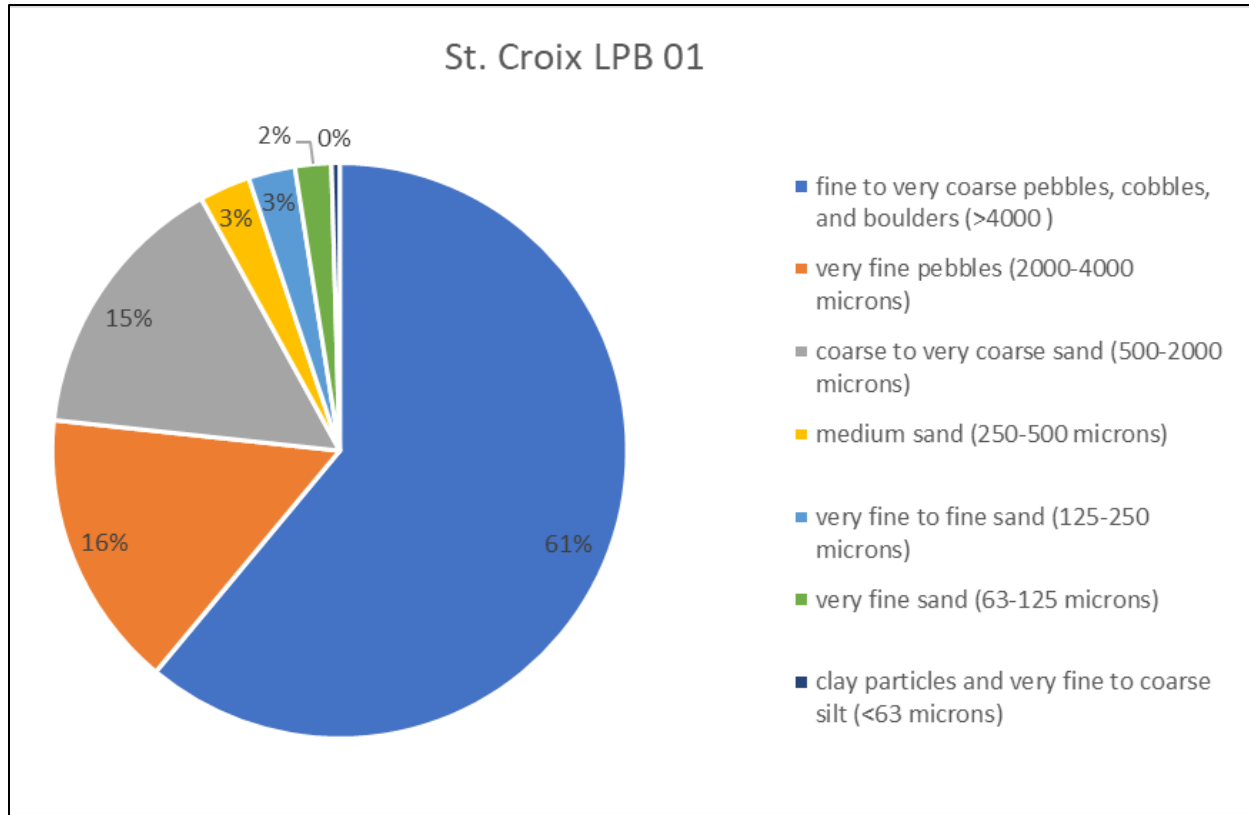
Figure 66. The percent composition of the seven grain size categories within the LPB01 sediment sample.

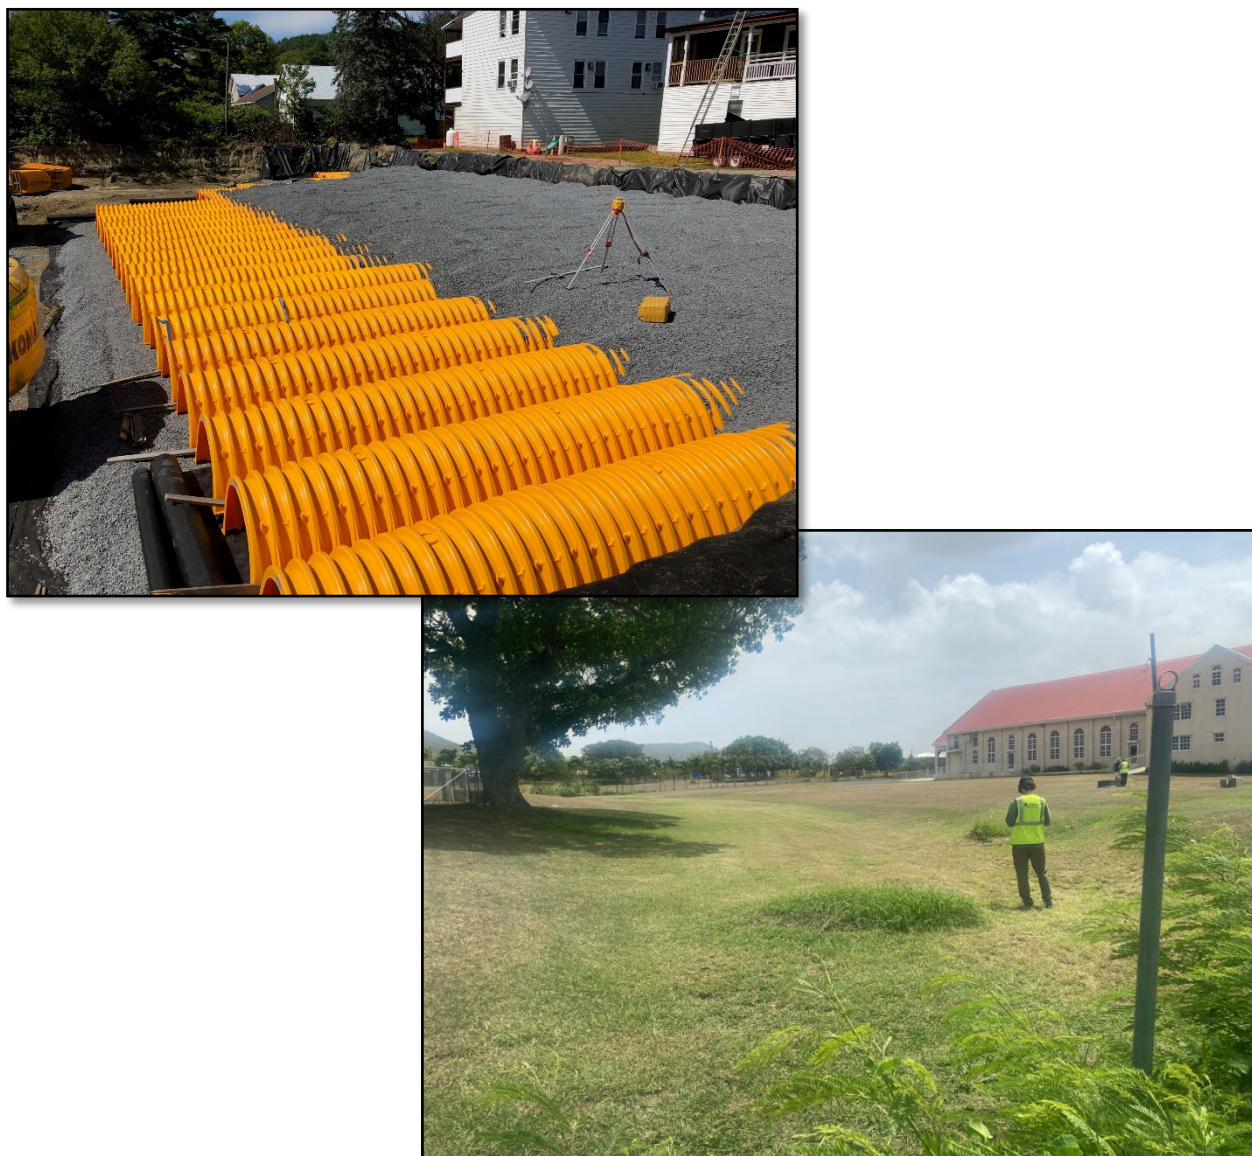
Figure 77. Example photo of subsurface infiltration chambers (above) and major gut channel near the Bethel 7th day Adventist Church (below).

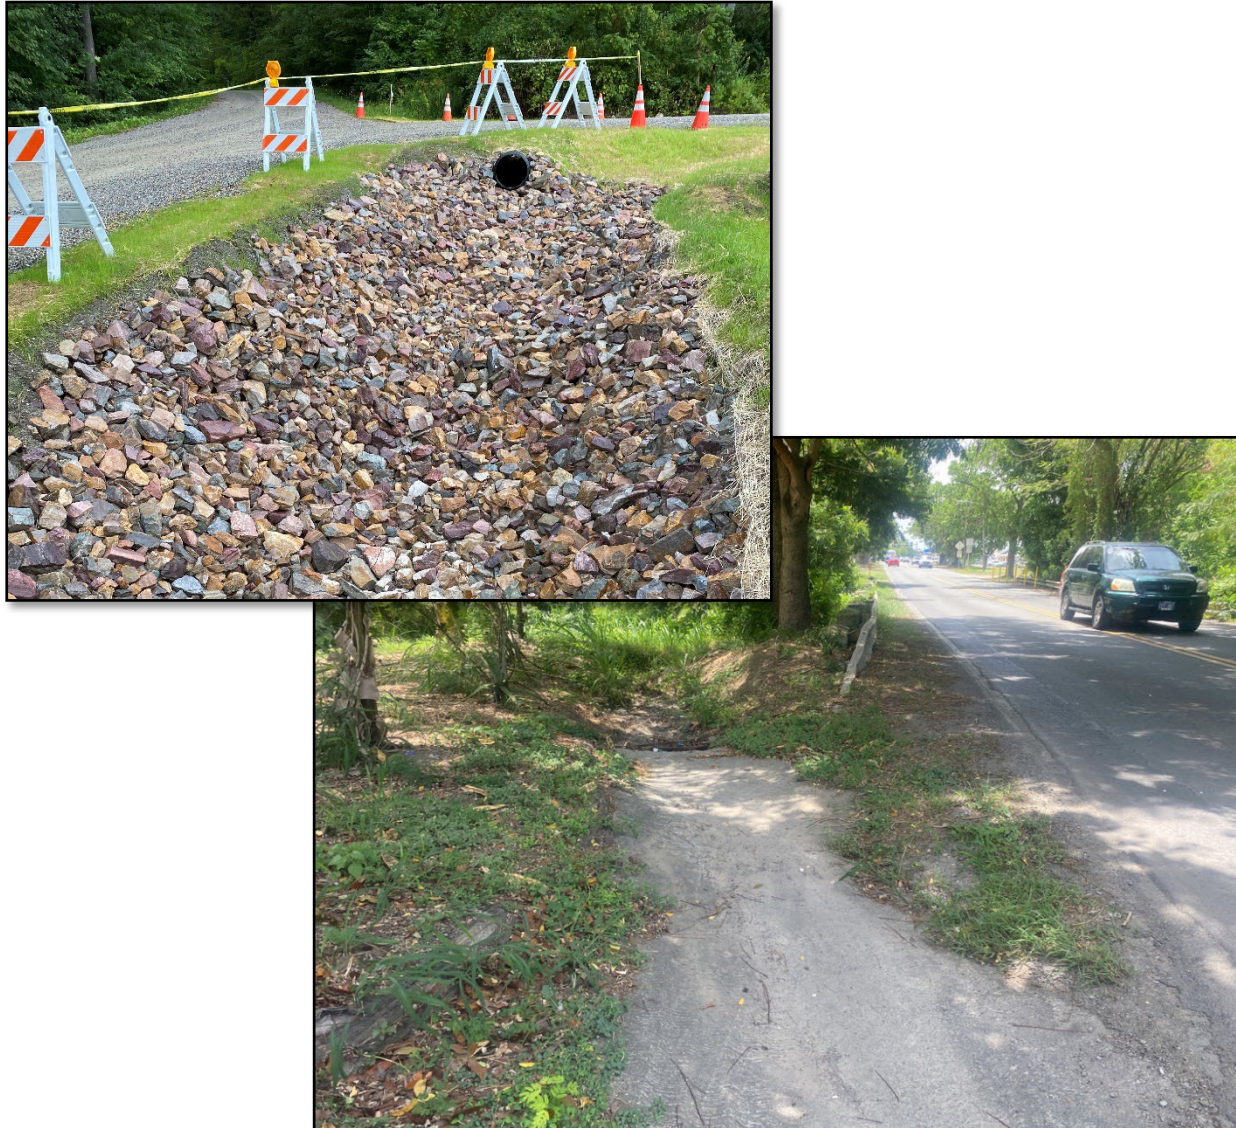
Figure 79. Example photo of stabilized channel with stone (above) and existing site conditions on Centerline Road. (below).

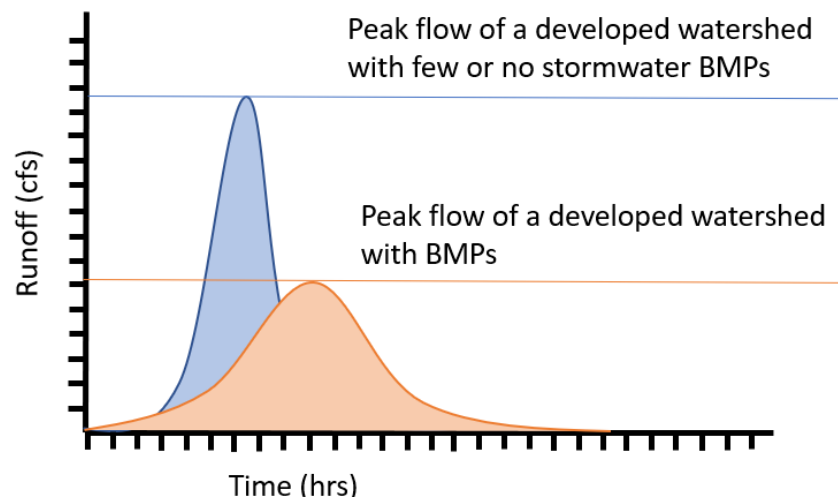
Figure 81. Illustrative hydrographs demonstrating the peak flow reduction value of implementing BMPs.

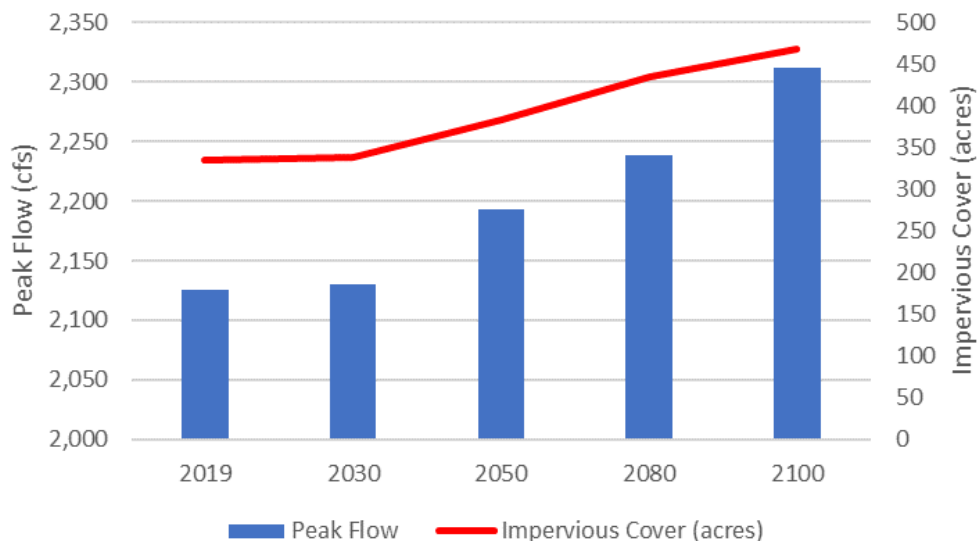
Figure 82. Relationship between watershed scale peak flow (blue) and the predicted impervious cover (red) over time.

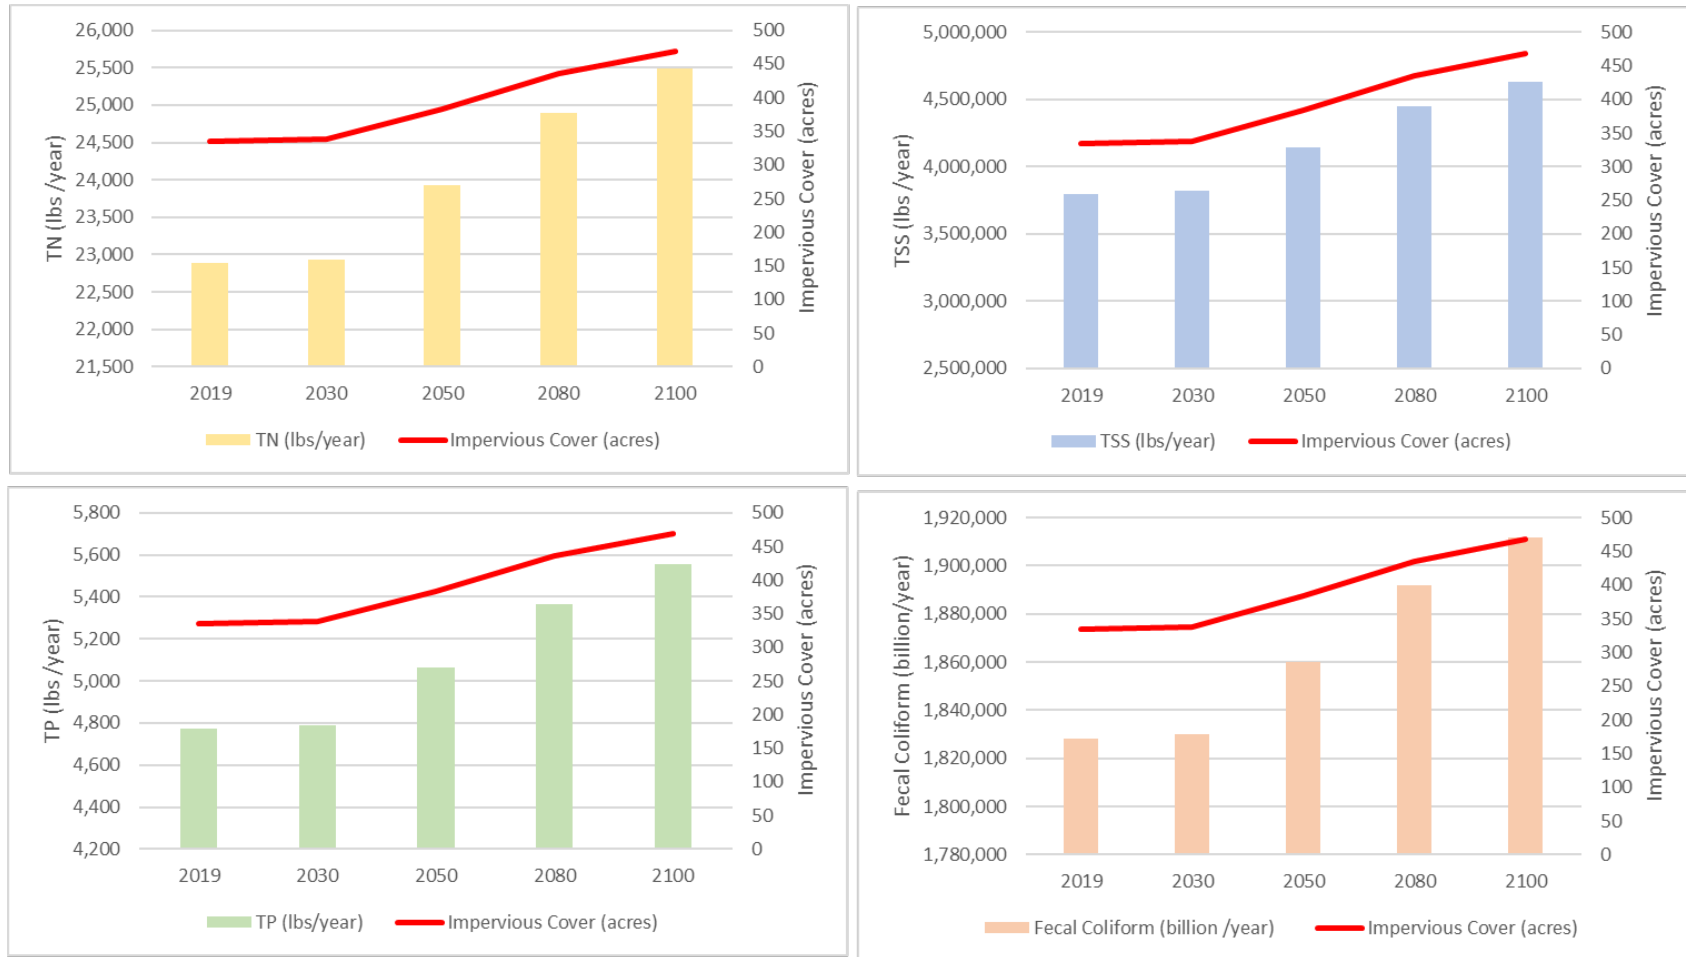
Figure 83. Relationship between watershed-scale pollutant loading for TN (yellow), TSS (blue), TP (green), and Fecal Coliform (orange) and the predicted impervious cover increase (red) over time.

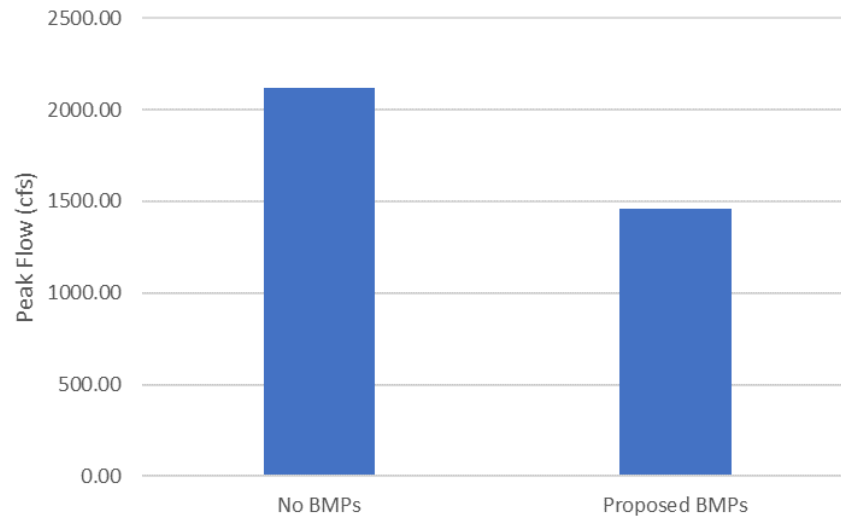
Figure 85. Peak flow reduction at the watershed outlet with proposed BMPs.

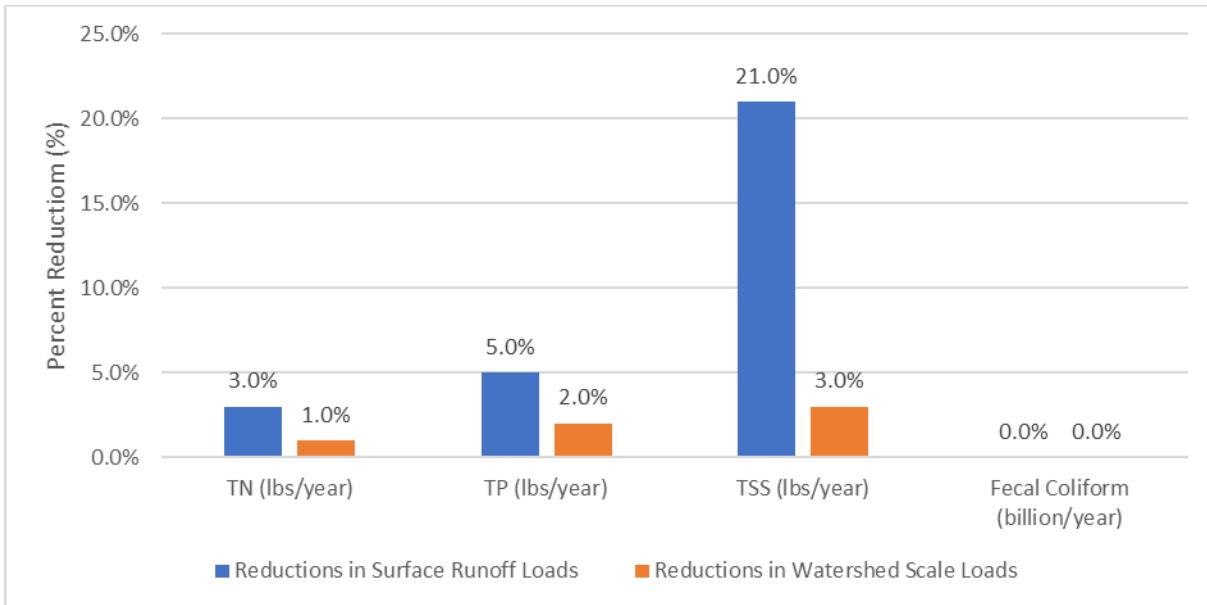
Figure 86. Pollutant load reductions attributable to the Top 10 BMPs for the Surface Runoff category (blue) and for all modeled watershed sources (orange).

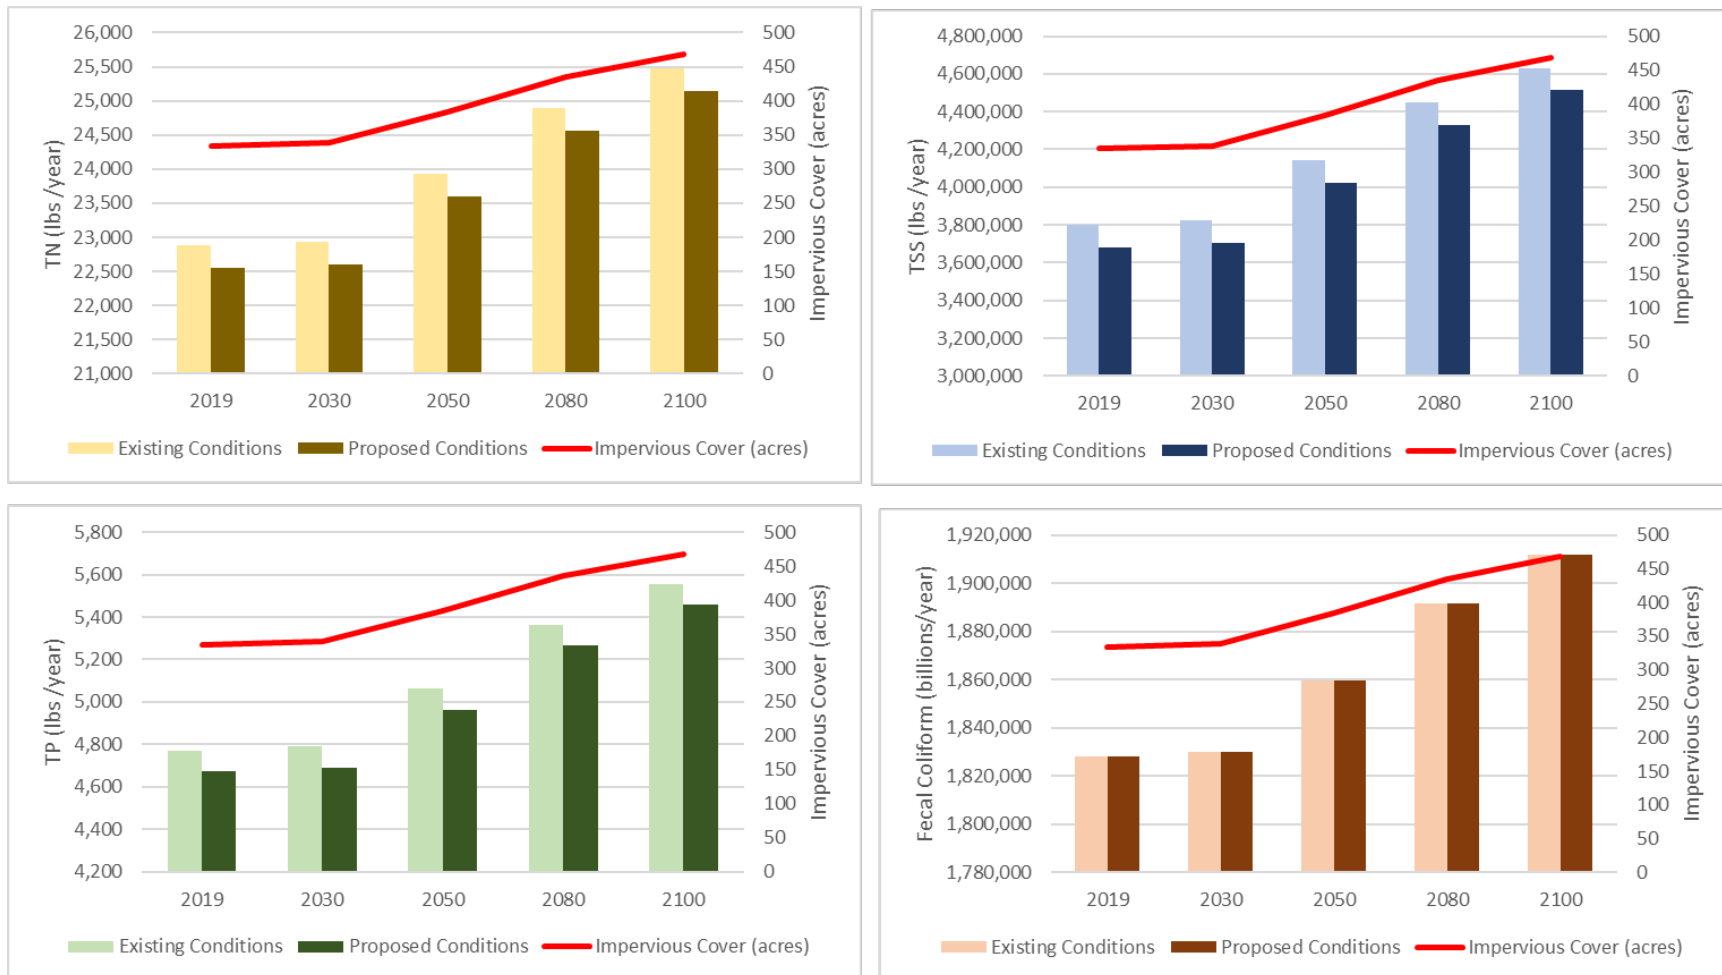
Figure 88. Relationship over time between watershed scale pollutant loading for the existing conditions (lighter colors) and proposed conditions (darker colors), which includes the implementation of the Top 10 BMPs. Loading is shown for TN (yellow), TSS (blue), TP (green), and Fecal Coliform (orange). The predicted impervious cover increase (red line) over time is also shown.
