WATERSHED MANAGEMENT PLAN FOR THE SALT RIVER BAY WATERSHED

ST. CROIX, USVI

JUNE 2022

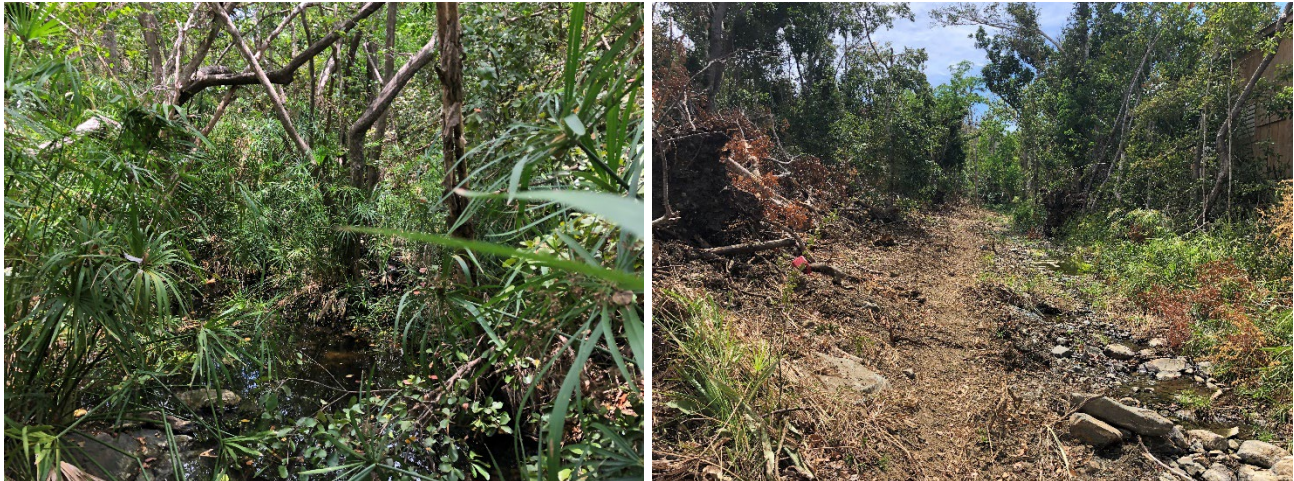
Figure 13. Photos of a gut taken by a resident before (left) and after (right) excavation.

In one specific incident, a community member detailed the excavation of old growth trees within an existing gut and along its banks (Figure 13). The community member noted how the trees used to provide shade and shelter to many species of mammals, birds, and reptiles. The area was once a place he would take his family to recreate. He stated that the excavation of the gut and its riparian buffer destroyed this ecosystem, and there has been no follow up to amend the environmental consequences of the destruction.

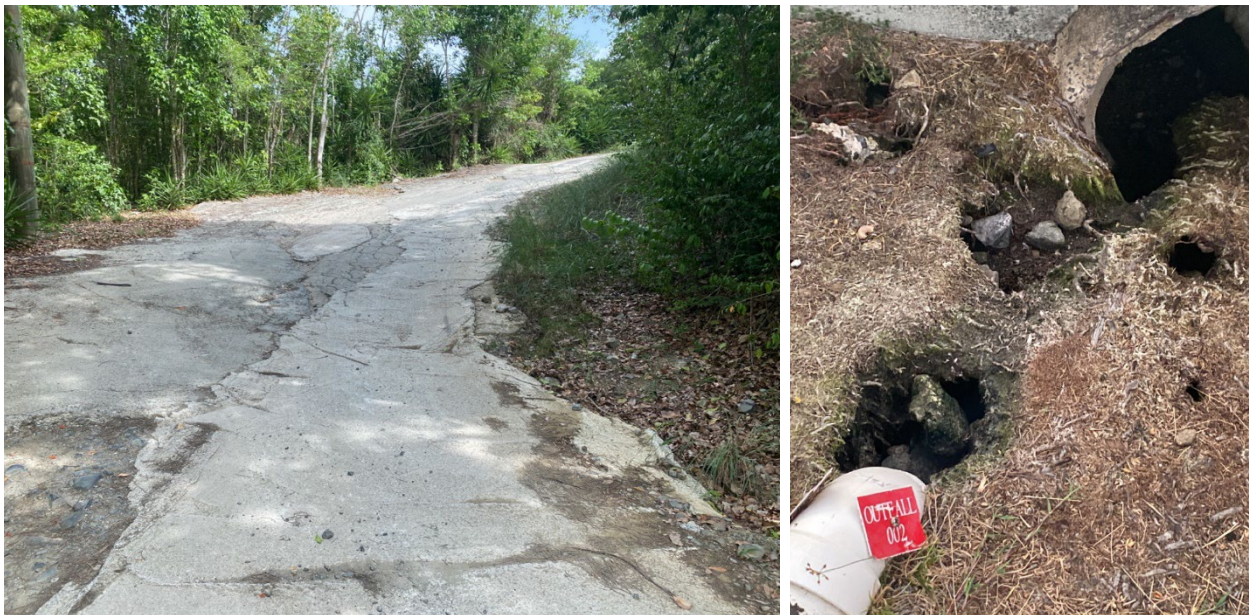
Figure 38. Road erosion (right) and clogged stormwater infrastructure (left).

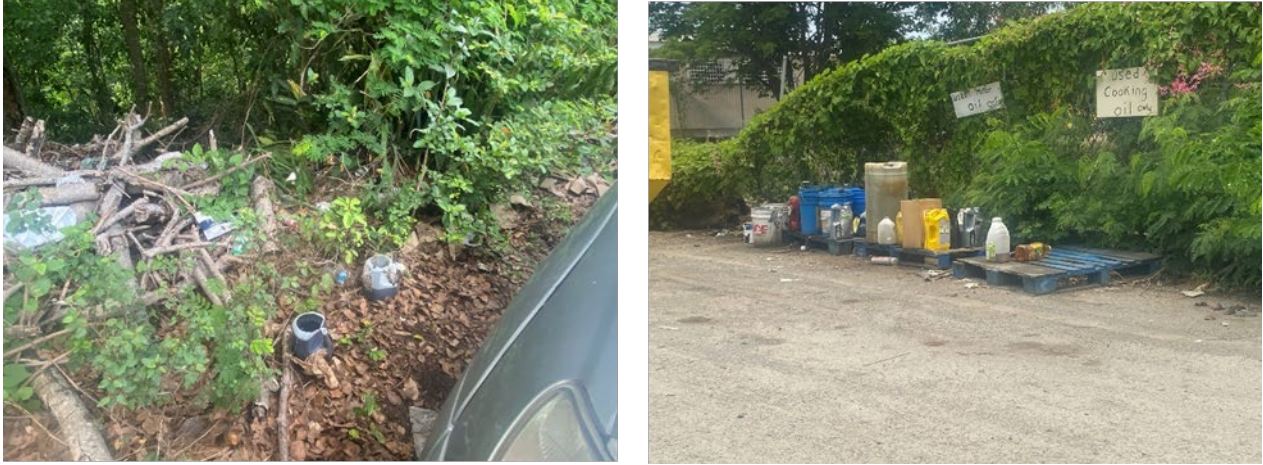
Figure 43. Open containers of used motor oil were observed placed uphill of a gut (left) and used motor and cooking oil are placed in open areas in insecure containers for collection (right).

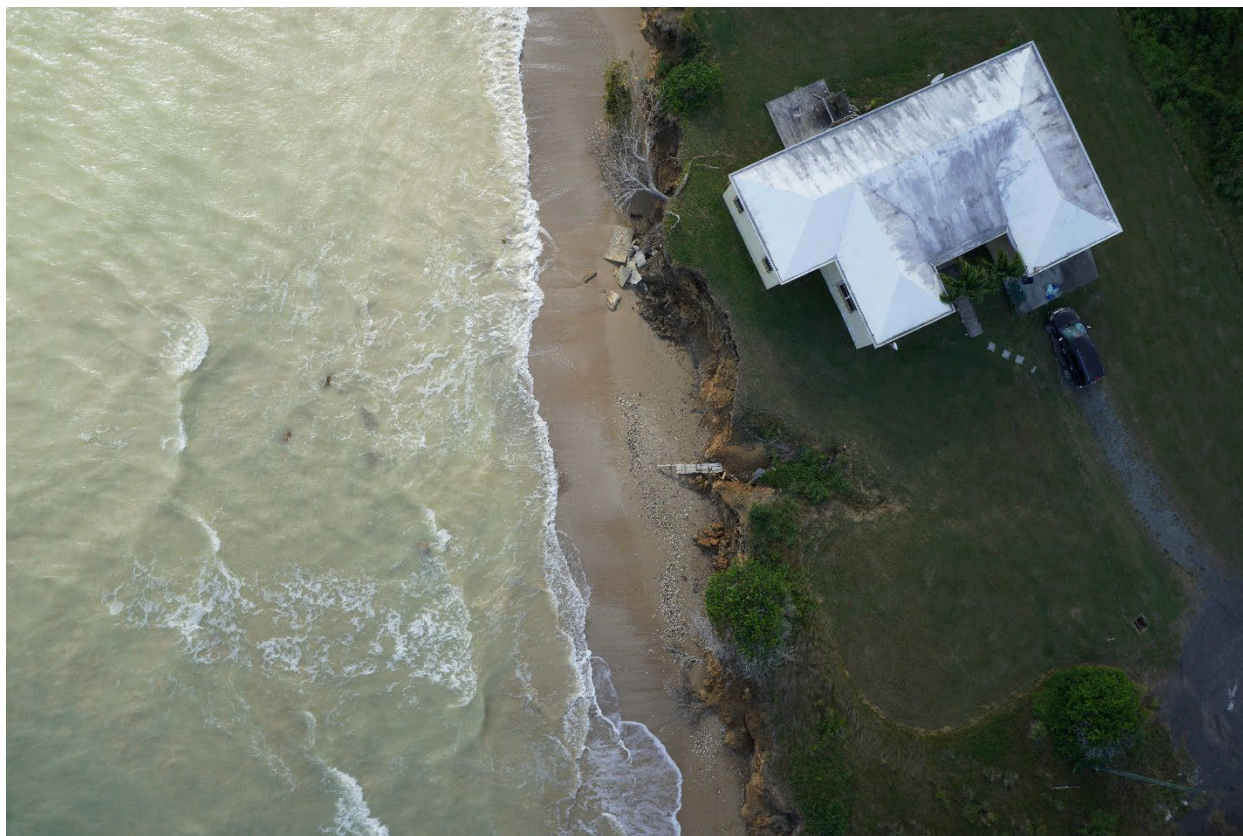
Figure 46. Coastal erosion due to sea level rise threatens stability of homes near the coast.

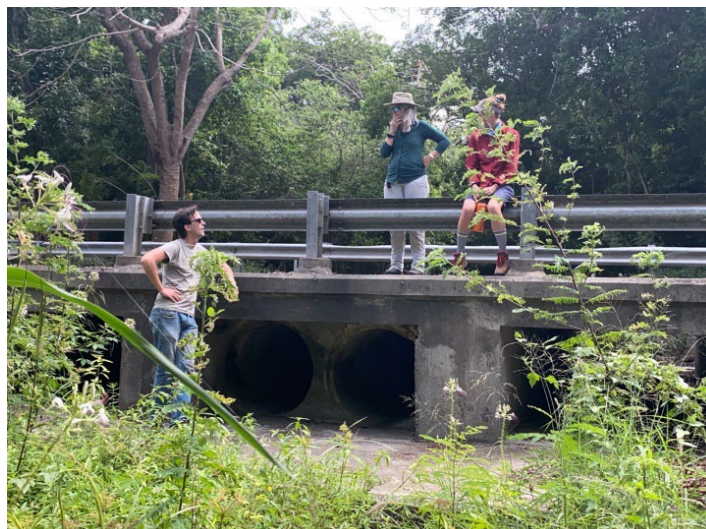
Figure 49. Culverts in the Salt River Bay watershed.

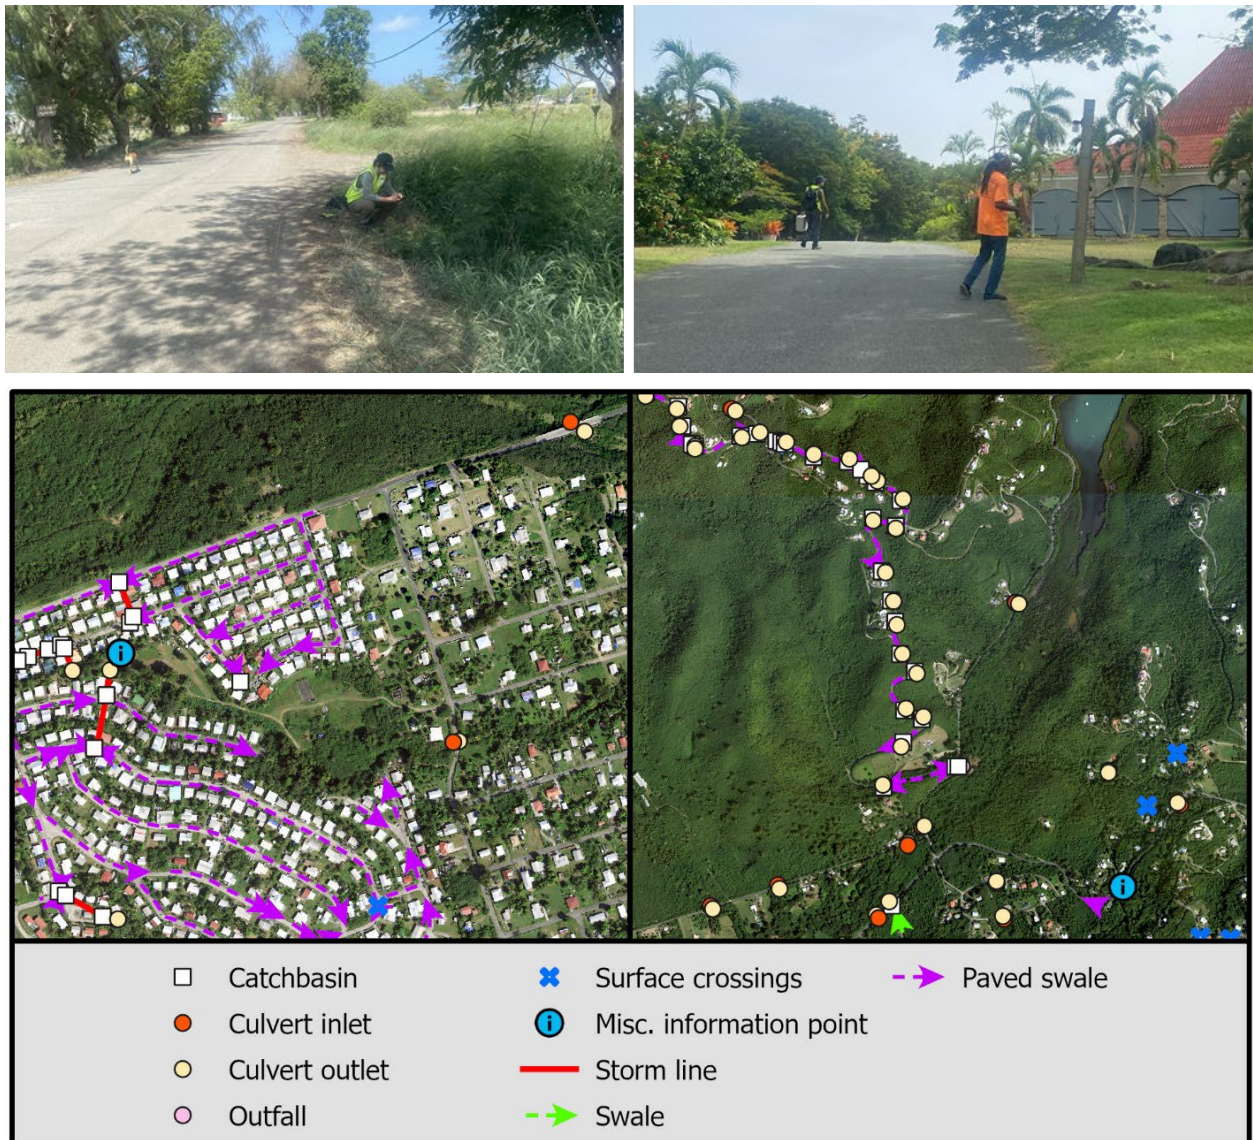
Figure 50. Inspection of existing stormwater infrastructure during field assessments (above) and an example of the maps produced (below).

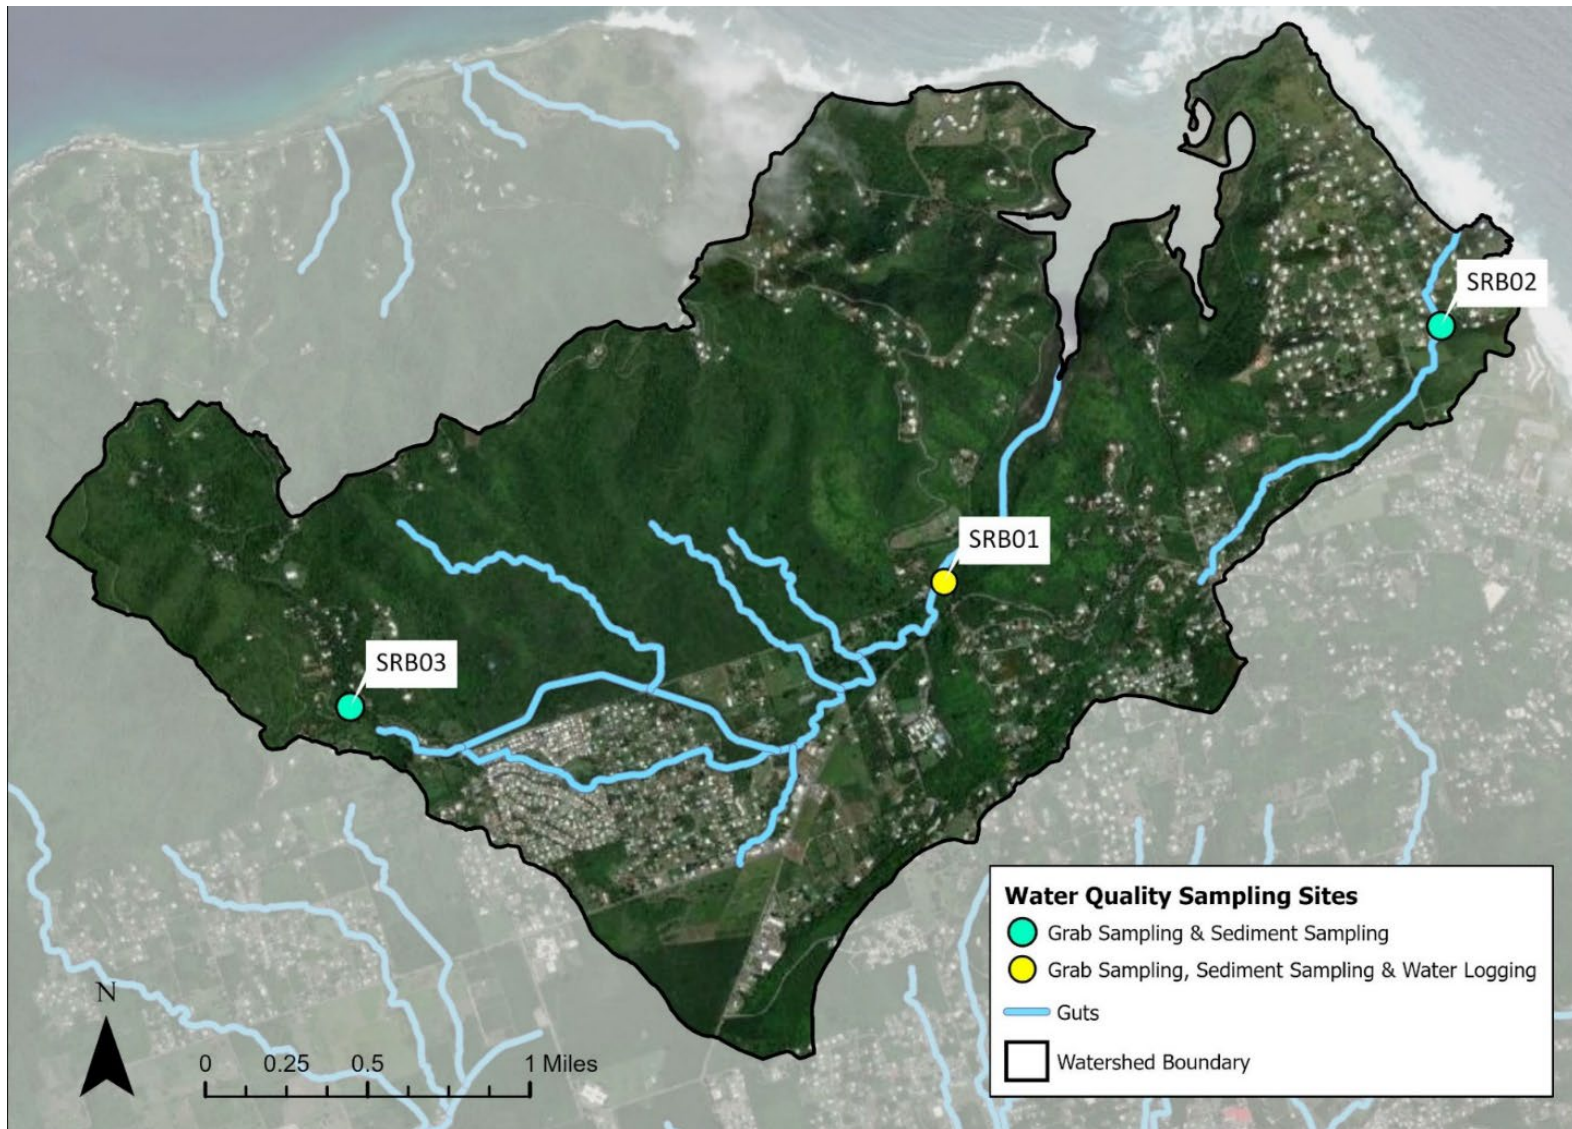
Figure 51. Grab sampling, sediment sampling, and water logging locations.

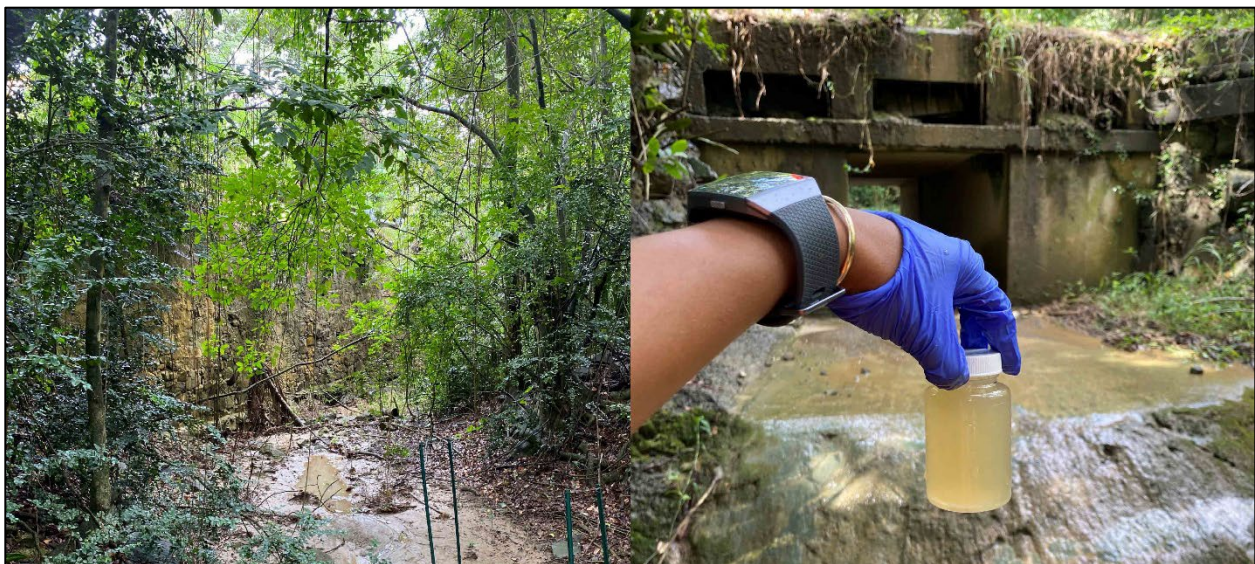
Figure 54. Grab sample collection from the SRB03 sampling site.

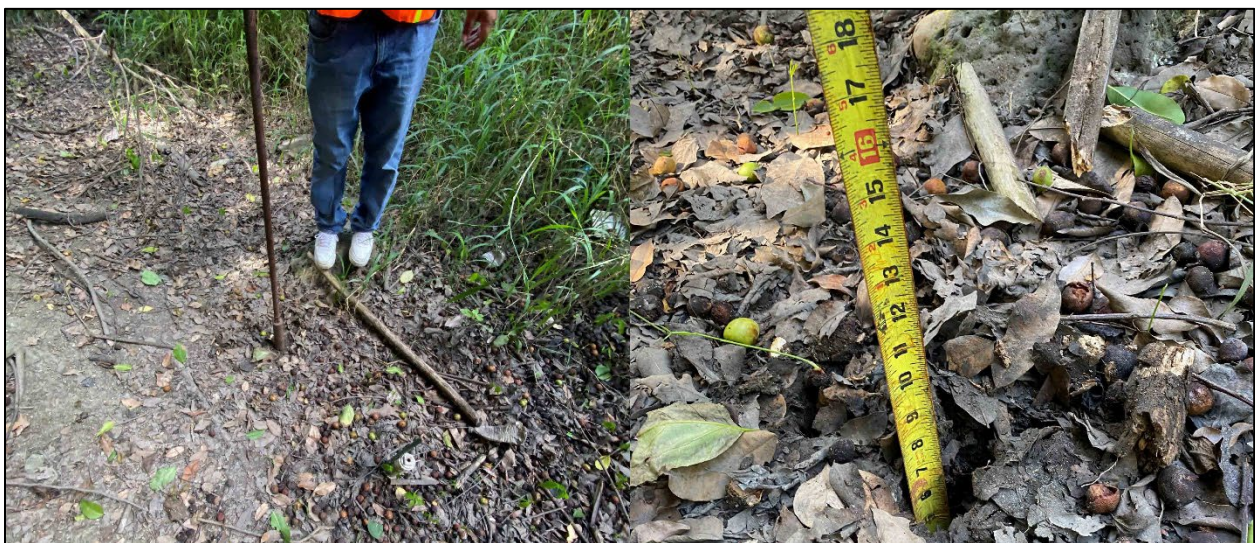
Figure 56. A sediment core being collected from the SRB01 gut channel (left). The depth of the sediment core verified with measuring tape (right).

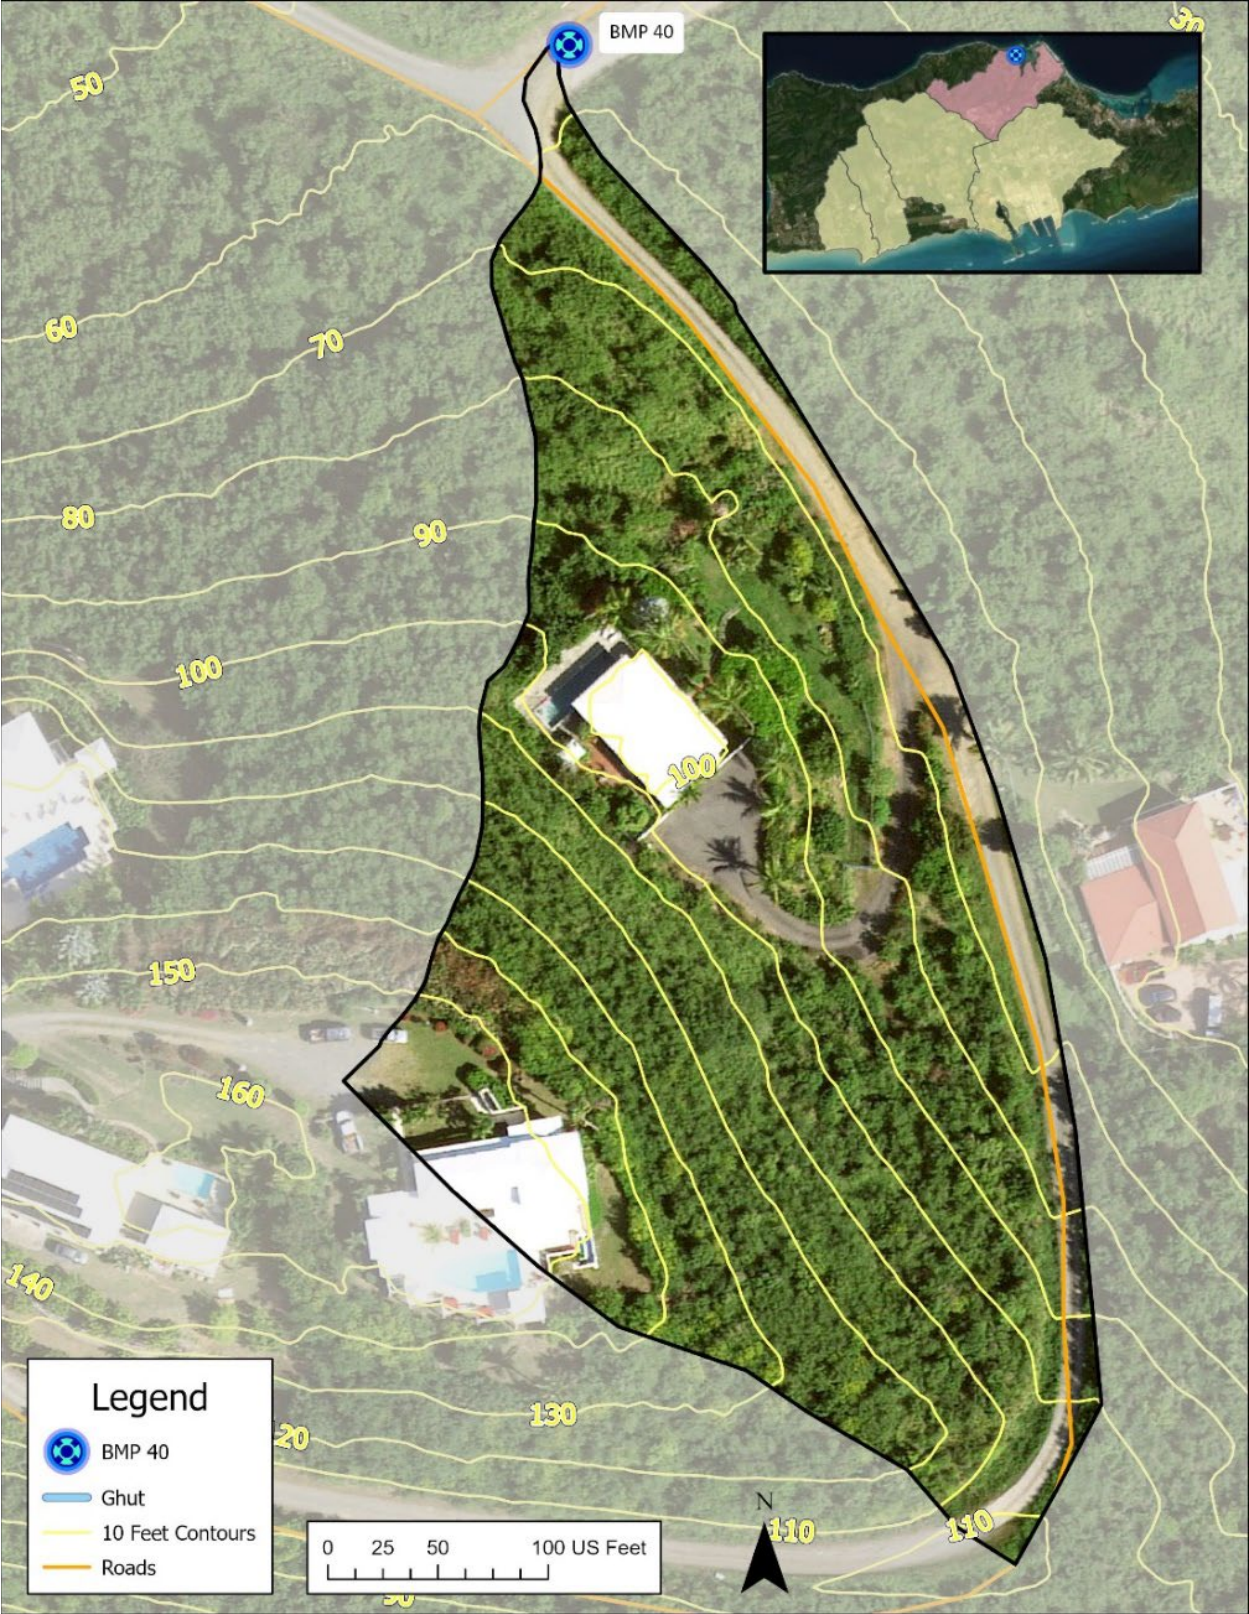
Figure 71. Map depicting the drainage area for BMP 40.

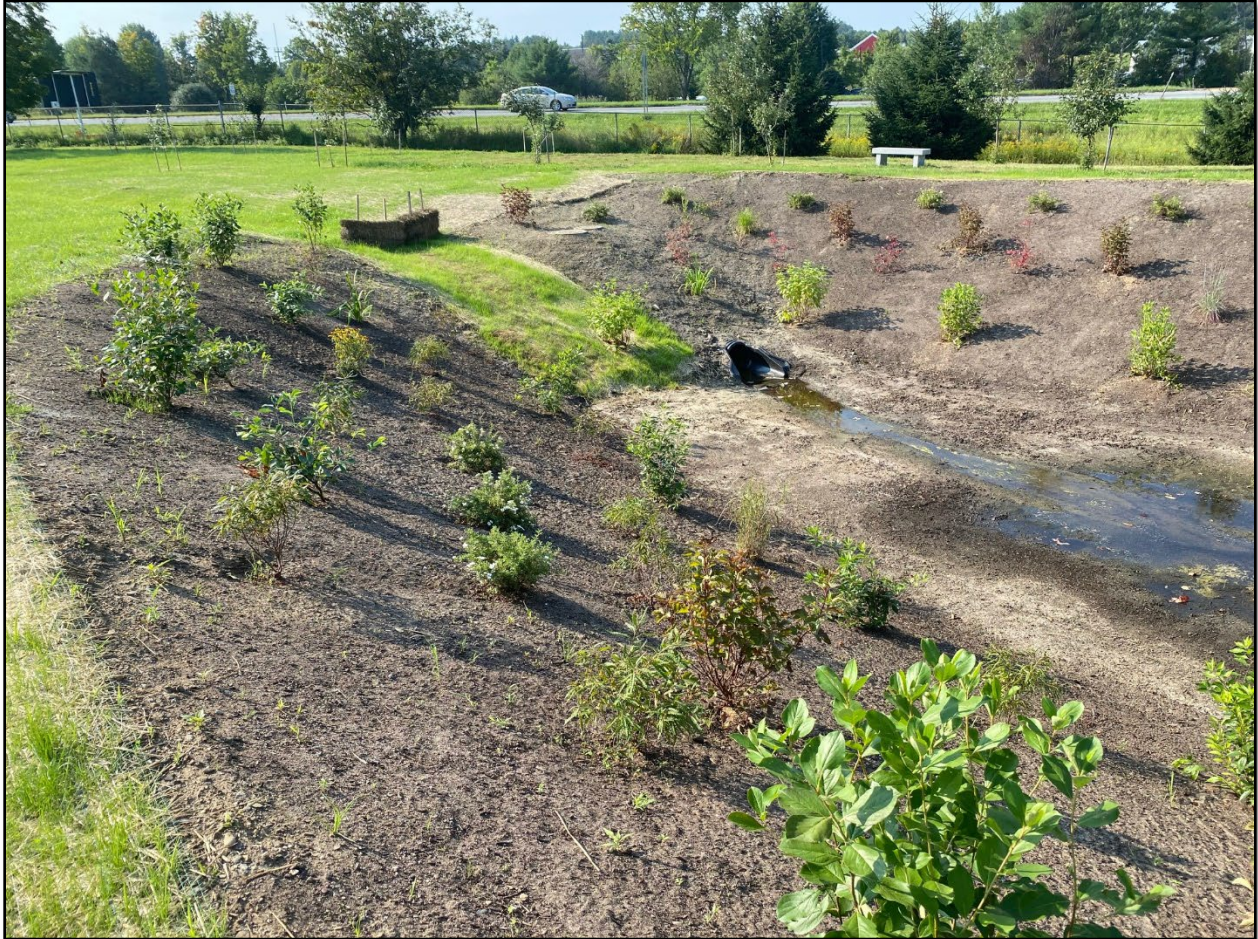
Figure 72. Example photo of a bioretention basin within a gut floodplain.

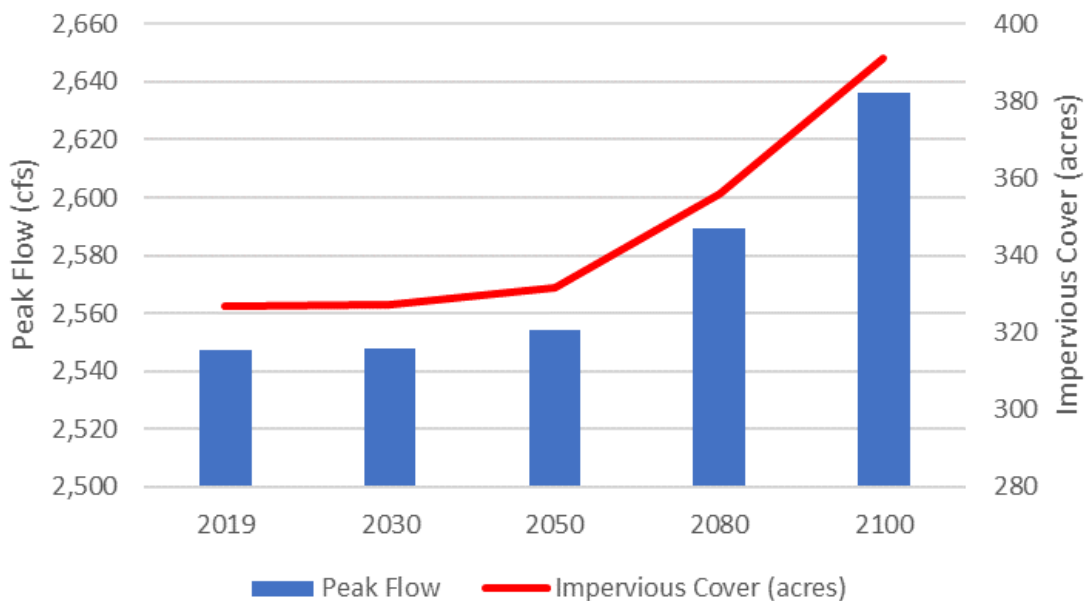
Figure 75. Relationship between watershed scale peak flow (blue) and the predicted impervious cover (red) over time.

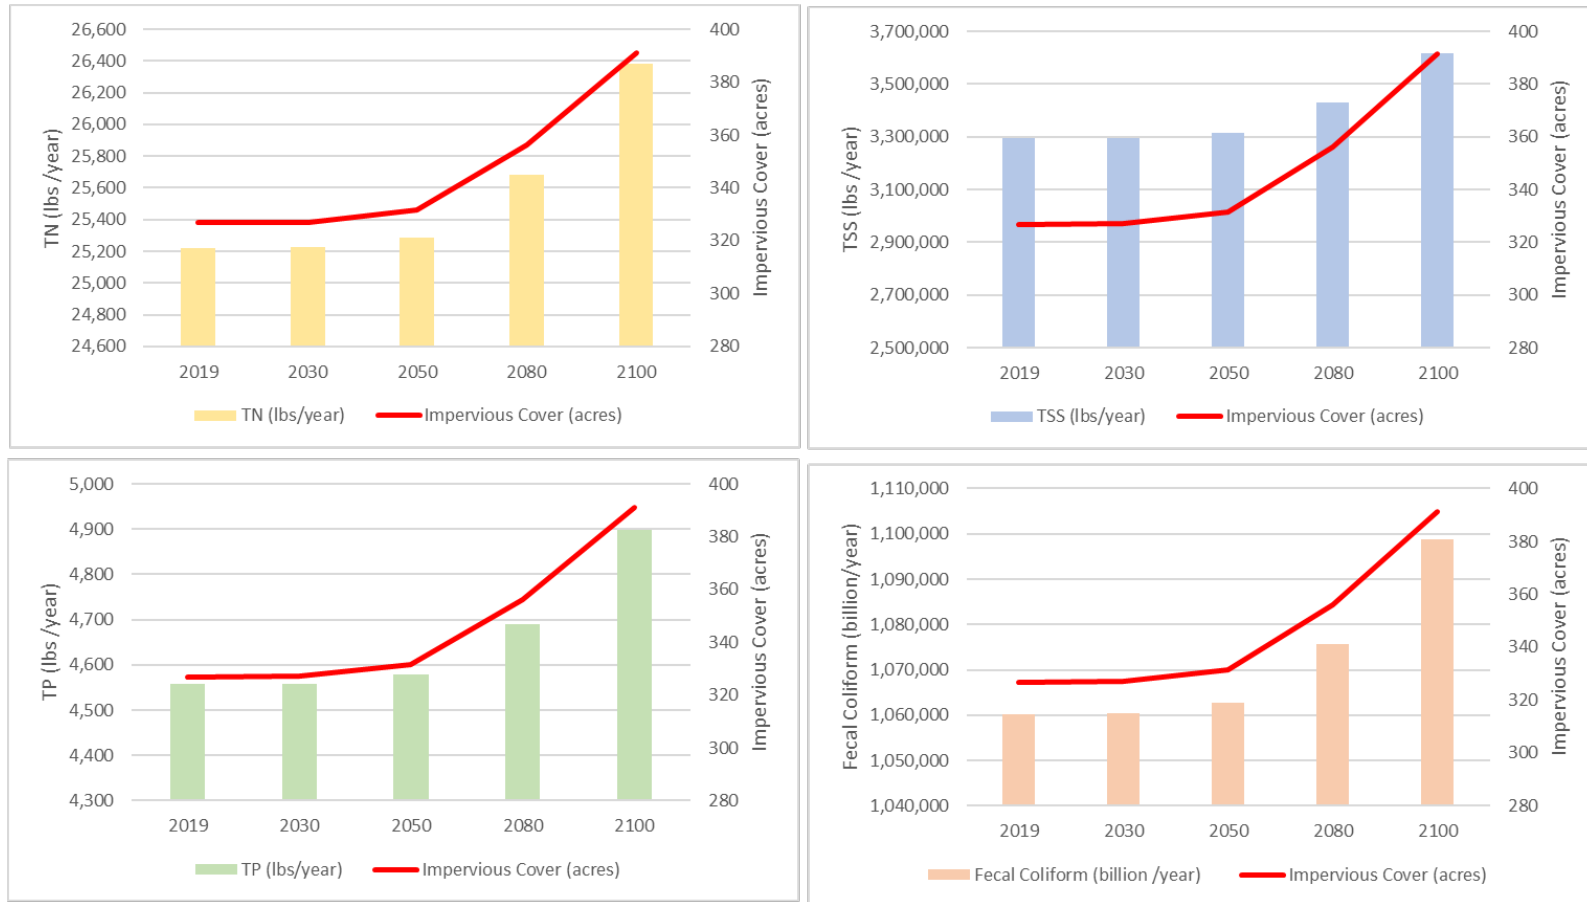
Figure 76. Relationship between watershed-scale pollutant loading for TN (yellow), TSS (blue), TP (green), and Fecal Coliform (orange) and the predicted impervious cover increase (red) over time.

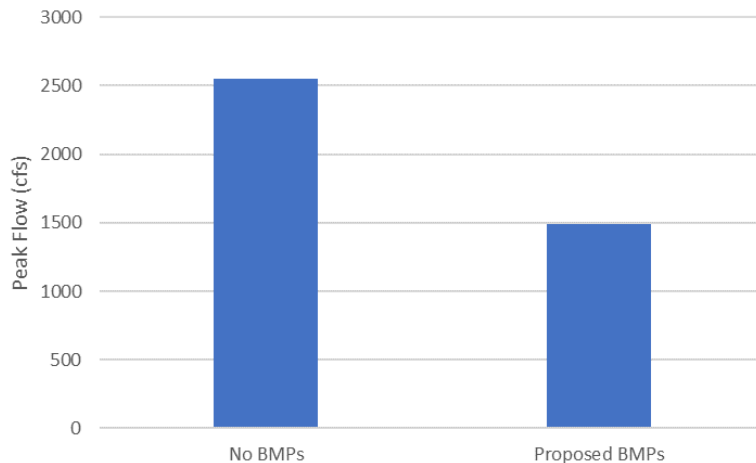
Figure 78. Peak flow reduction associated with the 10 proposed BMPs.

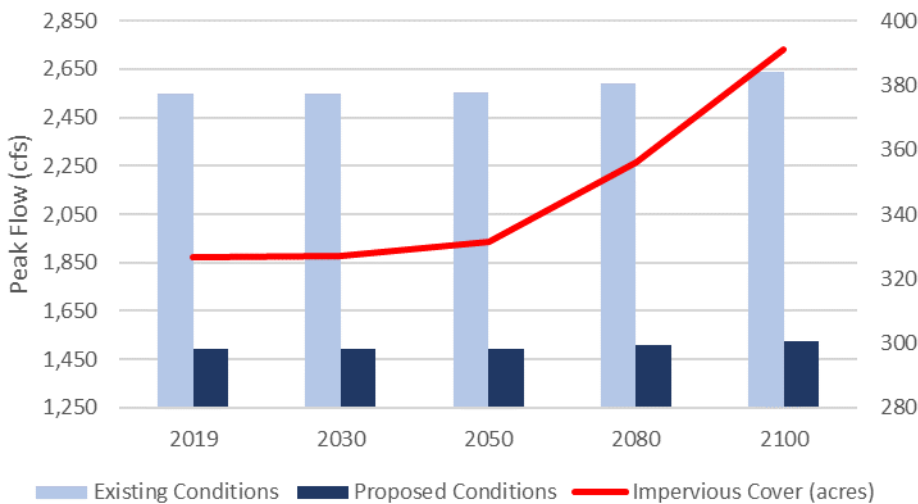
Figure 80. Relationship between watershed peak flow for the existing conditions (light blue) and proposed conditions (dark blue), which includes the implementation of the Top 10 BMPs over time. The predicted impervious cover increase (red) over time is also shown.

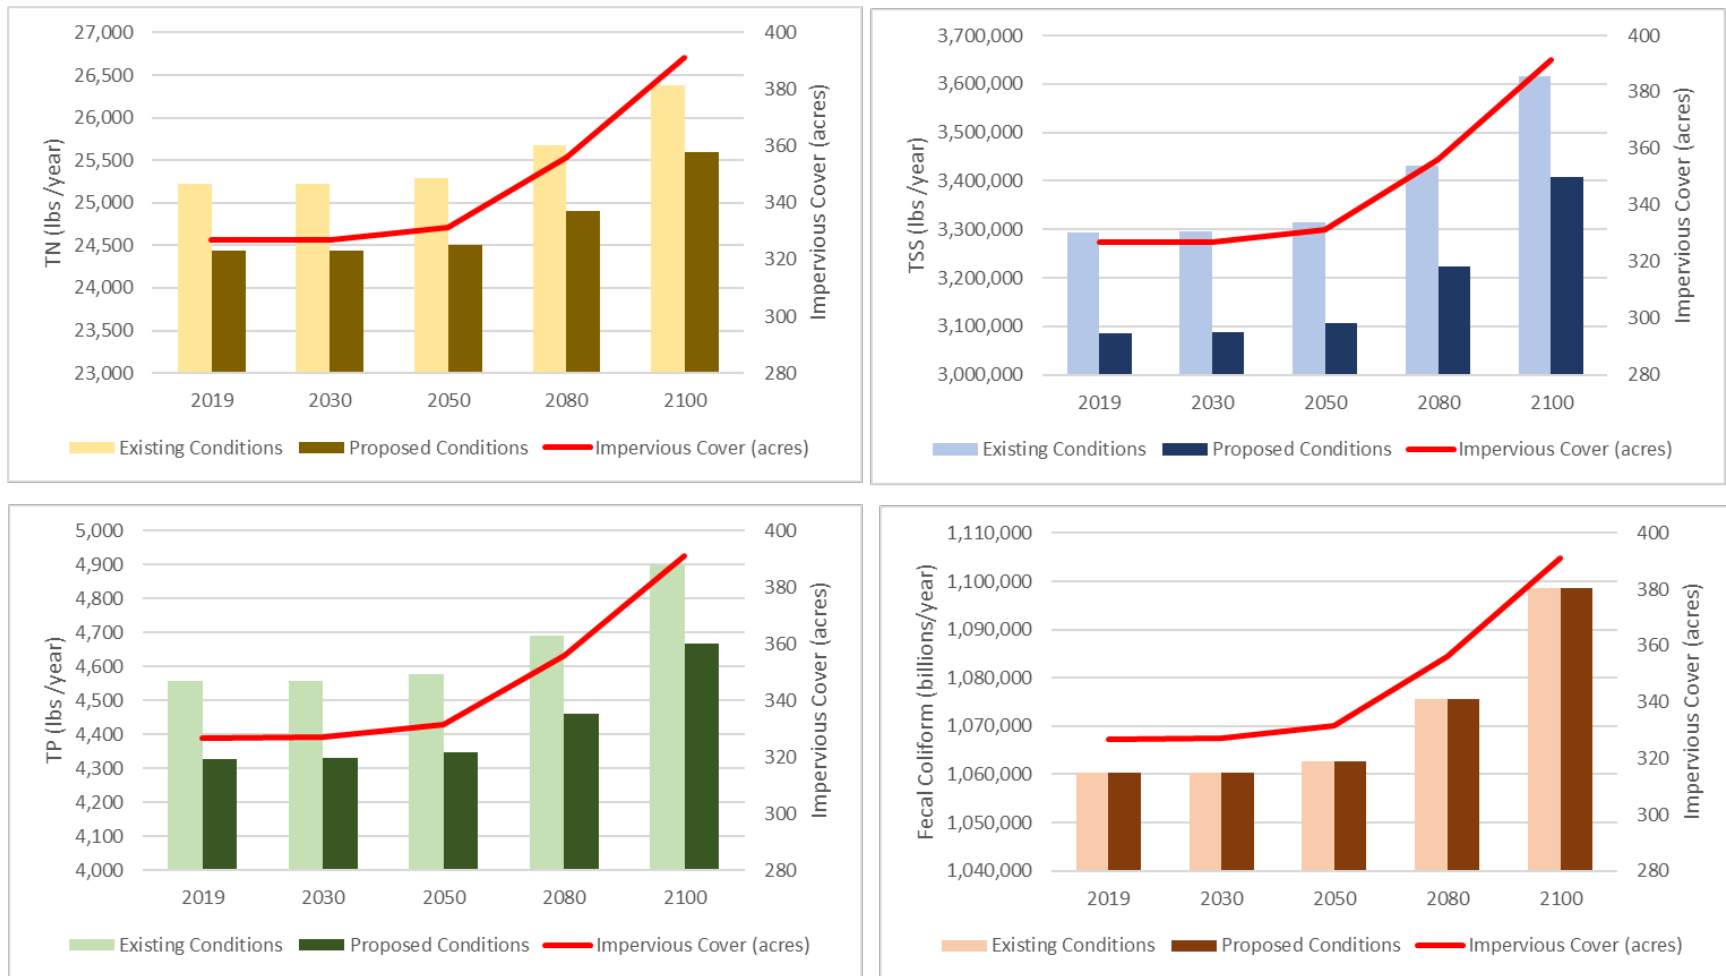
Figure 81. Relationship over time between watershed scale pollutant loading for the existing conditions (lighter colors) and proposed conditions (darker colors), which includes the implementation of the Top 10 BMPs. Loading is shown for TN (yellow), TSS (blue), TP (green), and Fecal Coliform (orange). The predicted impervious cover increase (red line) over time is also shown.
