Hydrological Classification, a Practical Tool for Mangrove Restoration

Anne F. Van Loon^{1,2*}, Bram Te Brake^{3,4}, Marjolein H. J. Van Huijgevoort^{4a}, Roel Dijkma⁴

Citation: Van Loon AF, Te Brake B, Van Huijgevoort MHJ, Dijkma R (2016) Hydrological Classification, a Practical Tool for Mangrove Restoration. PLoS ONE 11(3): e0150302. doi:10.1371/journal.pone.0150302

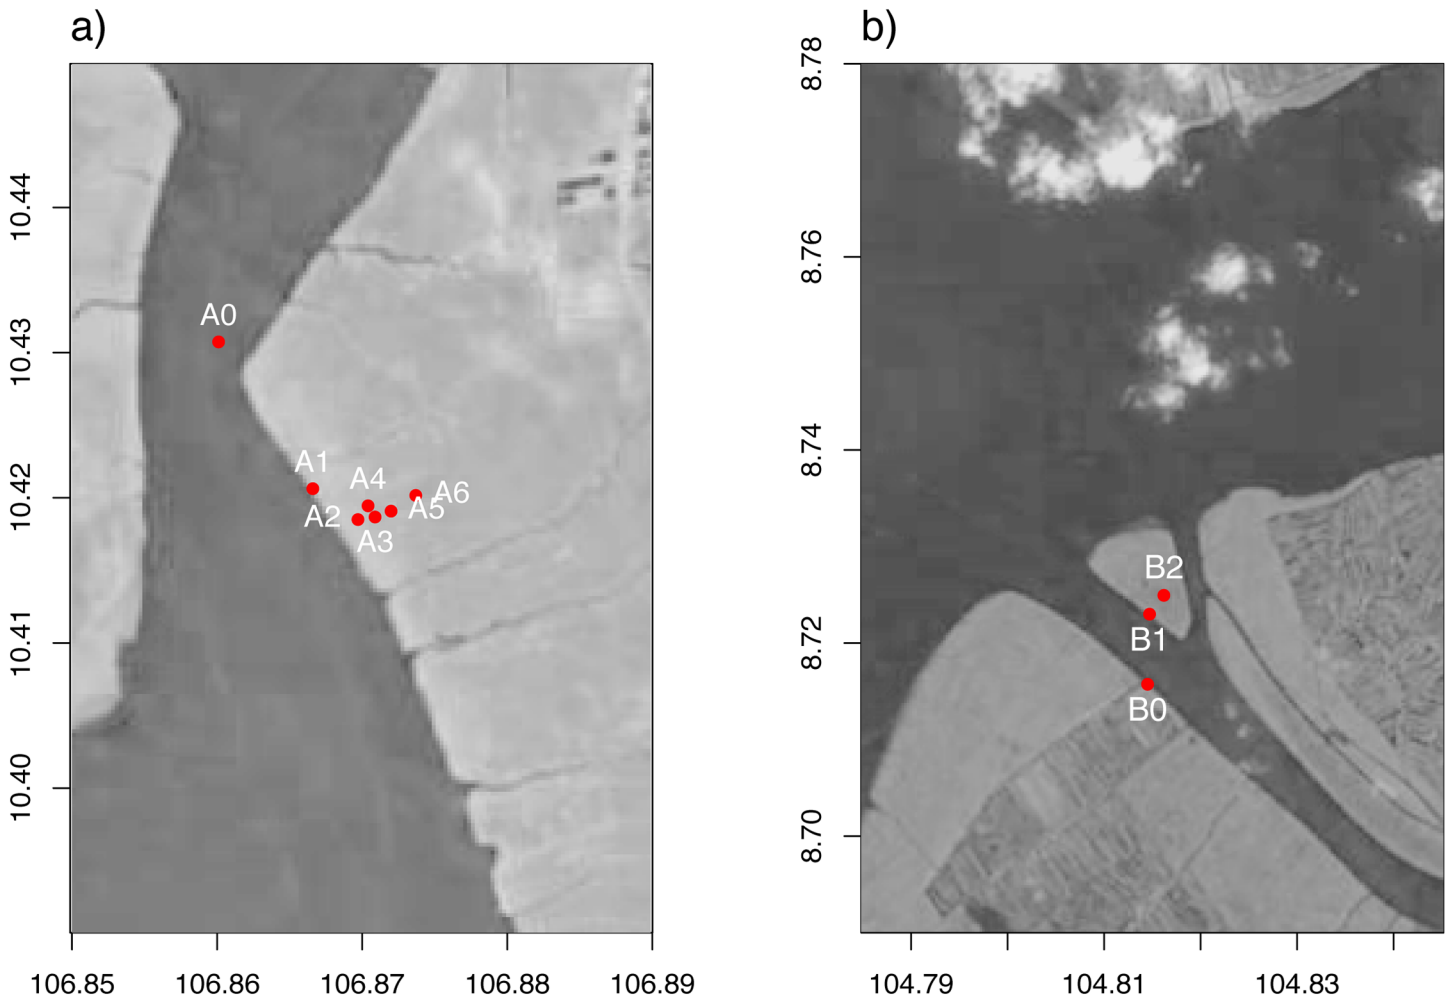
Fig 2. Location of measurement sites in Vietnam. a) Can Gio, b) Ca Mau. Measurement sites in open water (A0, B0) and in the mangrove forest (see Table 4). Landsat data available from the U.S. Geological Survey.

Measurement location A is a transect perpendicular to the Dong Tranh river, with a total length of 700 m (Fig 2a). Vegetation shows a clear distribution from *Avicennia alba* Blume close to the river to *Rhizophora apiculata* Blume further inland, with zones with higher biodiversity in between (Table 4).

Measurement location B is on the Con Ngoi island in the Cua Lon channel (Figs 1c and 2a). This island is located in the strict protection zone of the Mui Ca Mau National Park. The mangrove forest on this recently formed island is completely naturally generated (Table 3) and consists mainly of *Avicennia sp.* and *Rhizophora sp.* combined with some other species (Table 4).

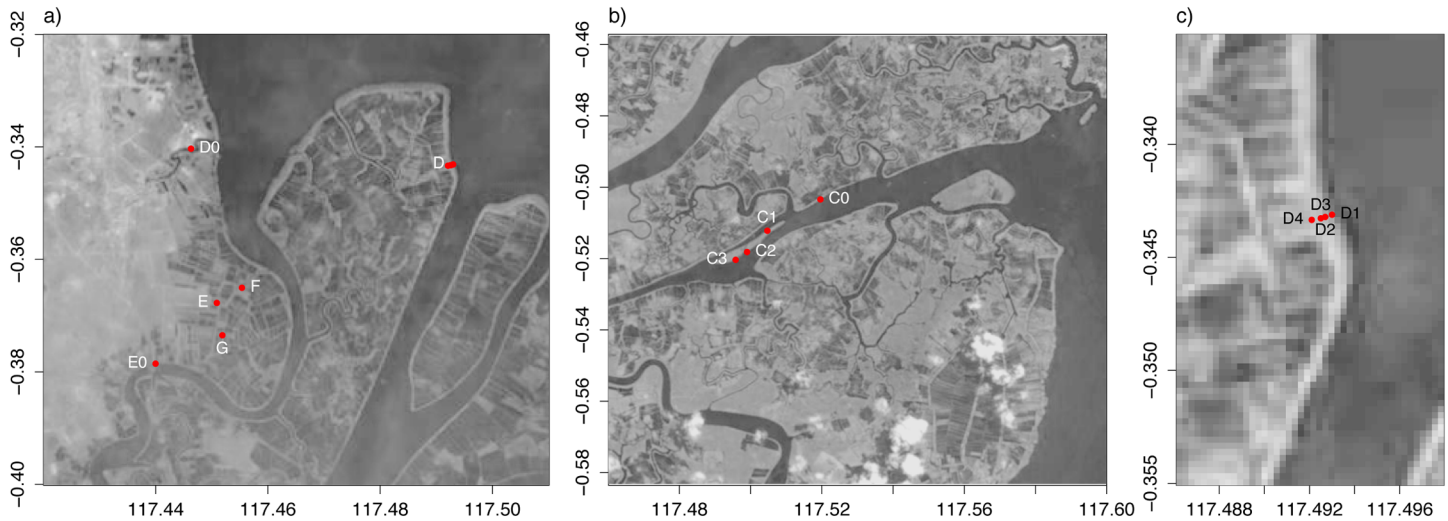
Fig 3. Location of measurement sites in Mahakam—Indonesia. a) measurement sites in open water (D0, E0) and inland (D–G), b) measurement sites of location C, c) measurement sites of location D (see Table 4). Measurement sites in location E, F, and G are too close together to indicate separately. Landsat data available from the U.S. Geological Survey.

Measurements were taken at several locations in the delta focusing on natural (C and D) and hydrologically disturbed (E, F and G) conditions (Fig 1d). Location C is on an elongated island in the river about 9 km inland from the coast (Fig 3a). The vegetation has a natural mix of different species (Table 4). Location D is in the northern part of the delta at the coast (Fig 3b). Measurements were done in a transect of 100 m perpendicular to the coast (Fig 3c). Vegetation shows a distribution from *Sonneratia alba* J.Smith at the coast to *Acrostichum Aureum* L. inland (Table 4).

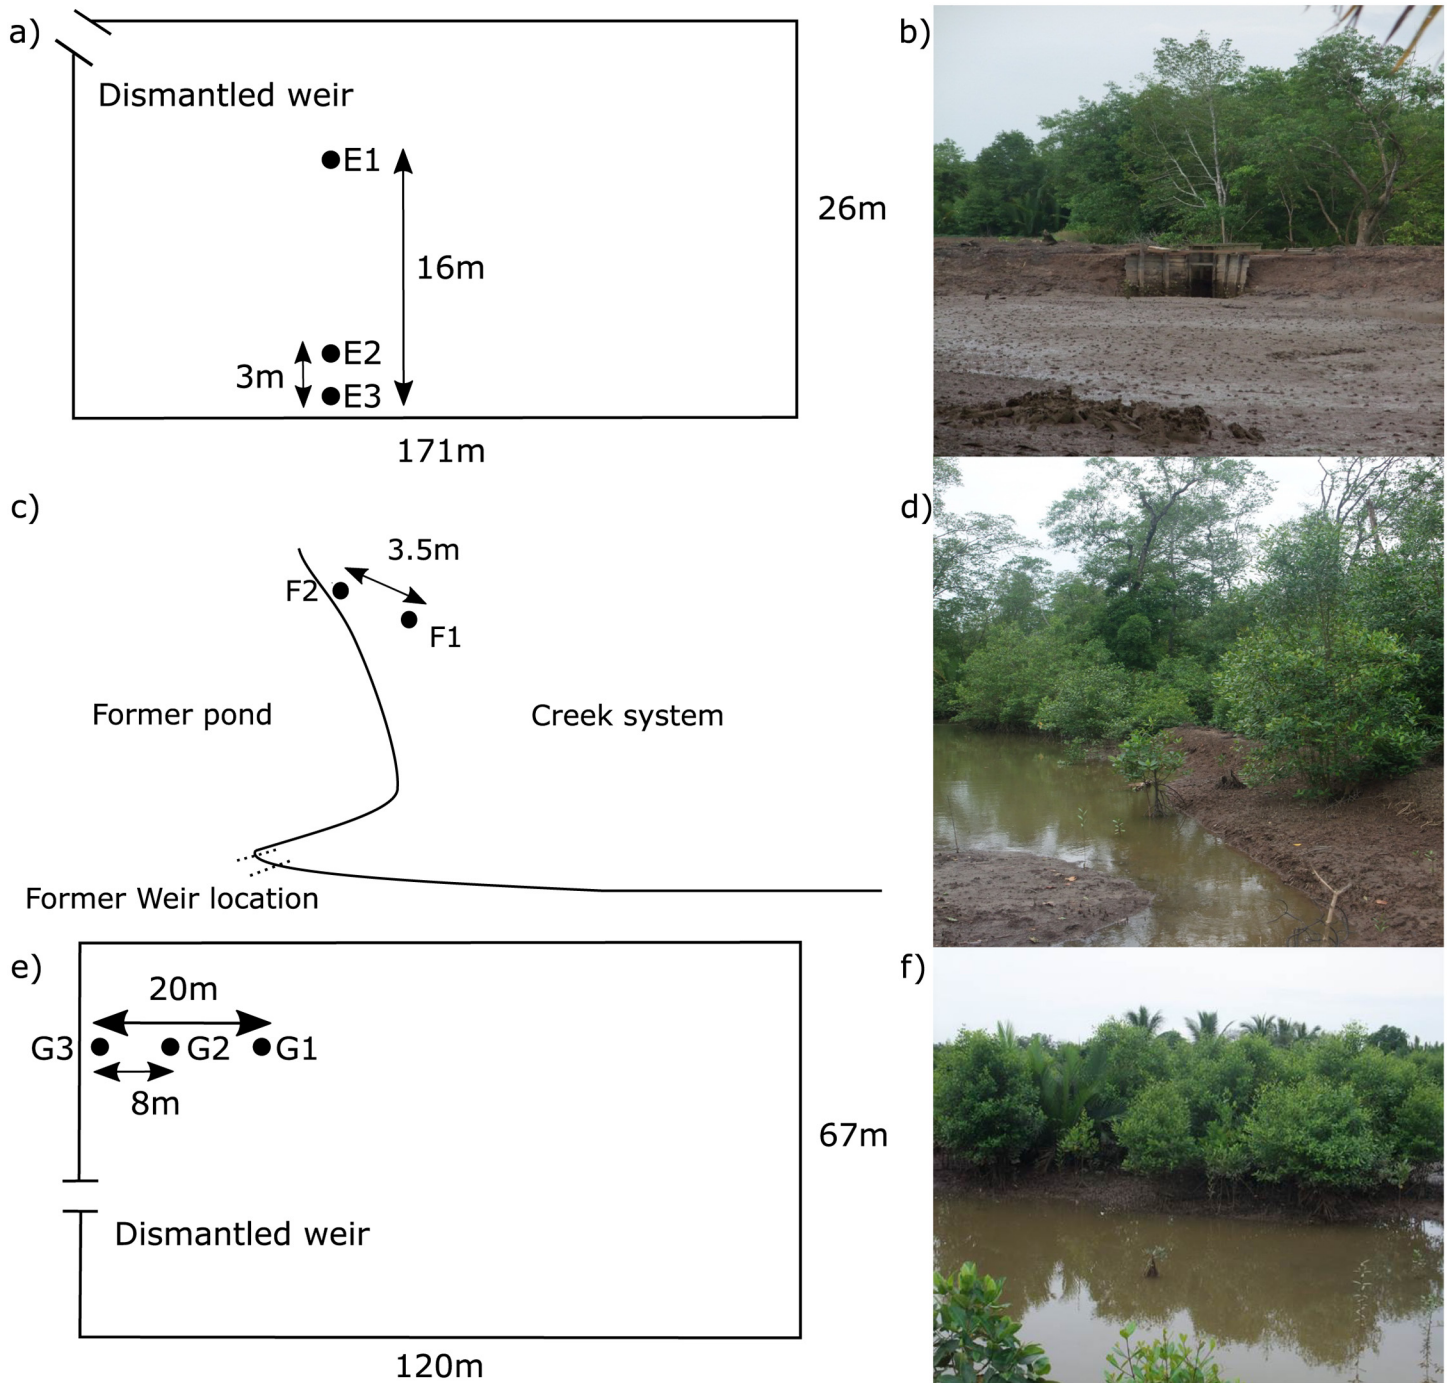
Fig 4. Measurement sites in location E–G in Mahakam—Indonesia. a) measurement setup location E, b) photo location E, c) measurement setup location F, d) photo location F, e) measurement setup location G, f) photo location G.

Locations E, F and G were chosen as examples of restoration sites with disturbed hydrological conditions (Fig 1d and Table 4). Location E is a shrimp pond abandoned since 2008 and with dikes around the pond still present (Fig 4a and 4b). There are some natural *Nypa Fruticans* Wurmb and planted coconut palms around the edges, but no vegetation inside the pond. Site F is a shrimp pond in the process of restoration with 10 years of new growth in and around

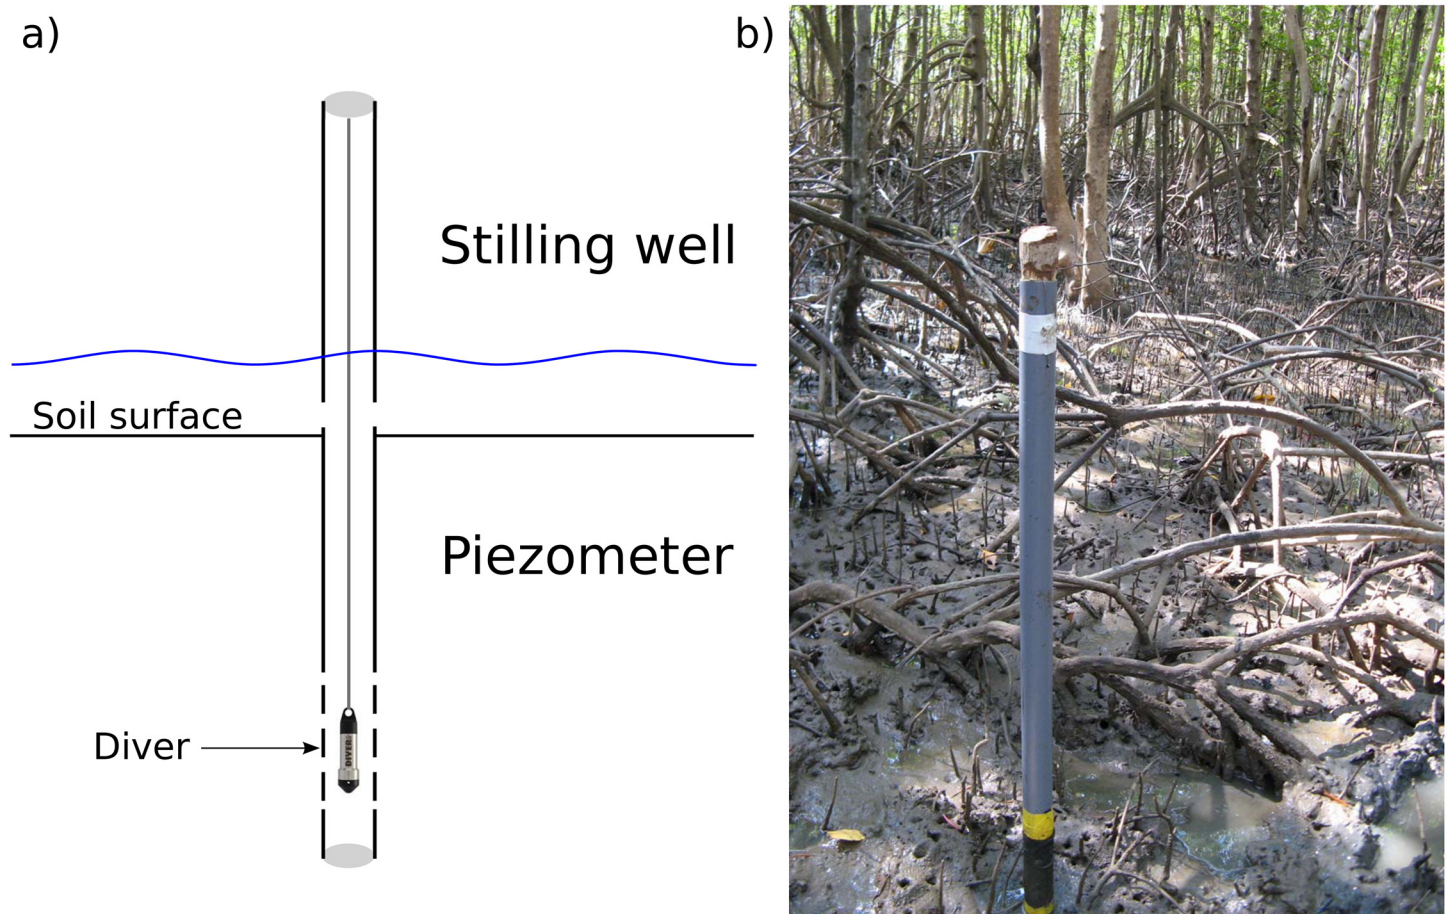
Fig 5. Water level measurement set up. a) diver installed in tube that serves as stilling well above soil surface and as piezometer below soil surface, b) installation in the field.

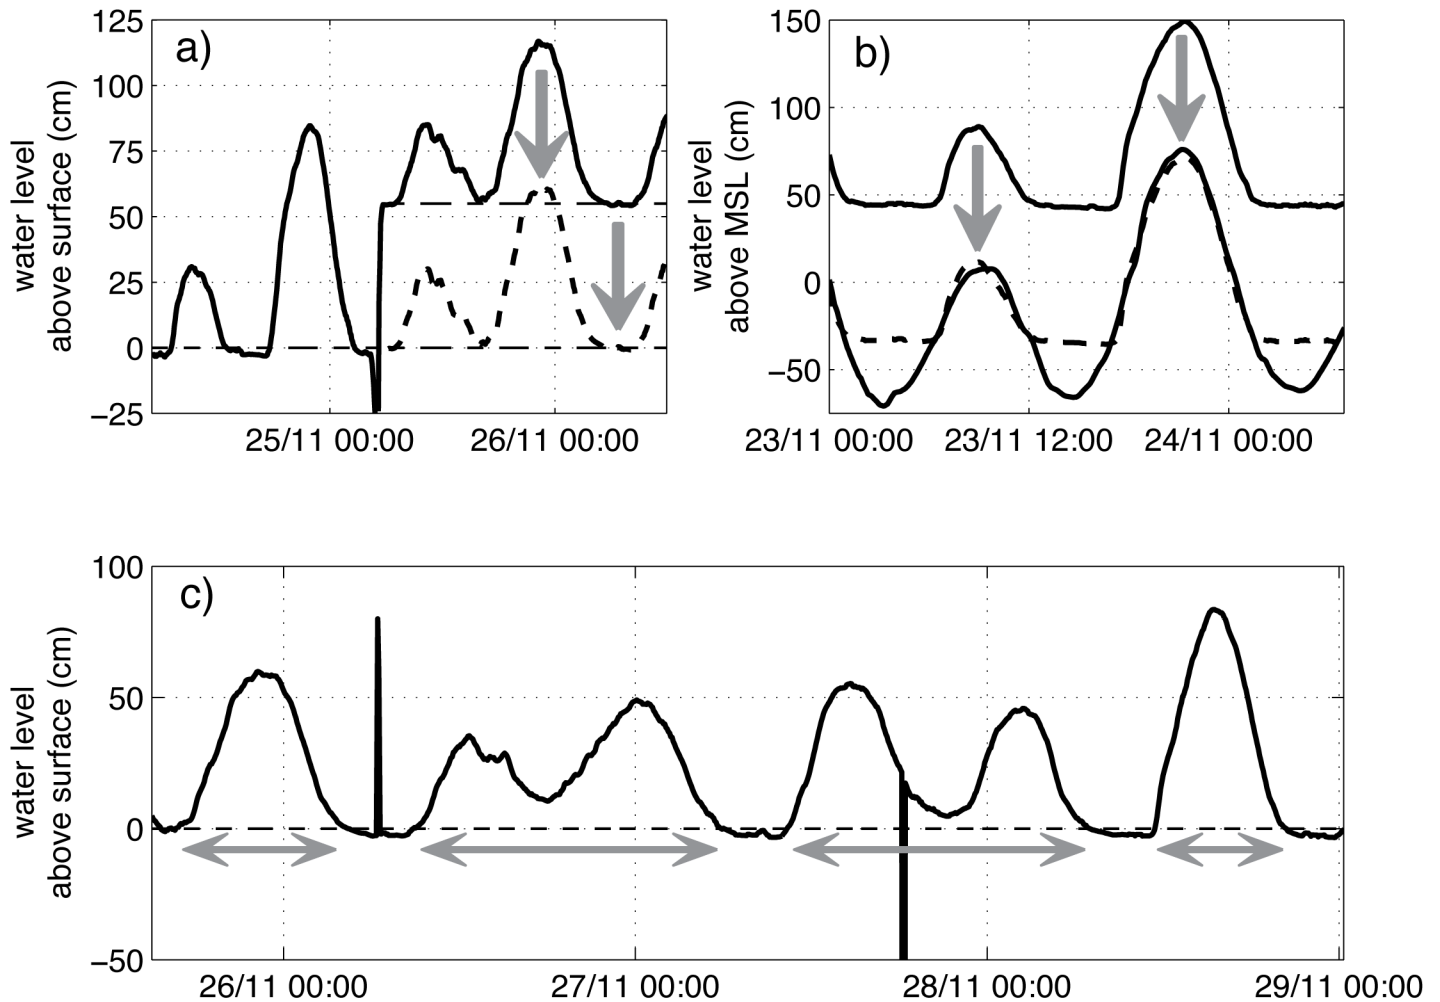
Fig 6. Example of time series of water levels to show the methodology used for time series analysis. a) estimation of surface level from nod point and correction of changes in reference level, b) estimation of elevation with respect to mean sea level, c) correction of measurement errors and calculation of duration of inundation. The horizontal dashed lines represent estimated soil surface level.

levels. The resulting nod point in the time series represents surface level and was set to 0 (Fig 6a—left side).

By counting the measurement intervals with water levels above soil surface level, inundation durations and number of inundations were obtained. The minimum duration of inundation and dry-fall was set at 15 minutes to remove measurement errors, outliers, and small fluctuations in water levels (Fig 6c). [65] and [30] found that duration of inundation is most important in determining mangrove species distribution. We applied two variables related to duration of inundation (i.e. average duration per inundation and per day) that are relevant in irregular tidal regimes [39]. Based on these two variables, sites were then classified into hydrological classes using Table 2.

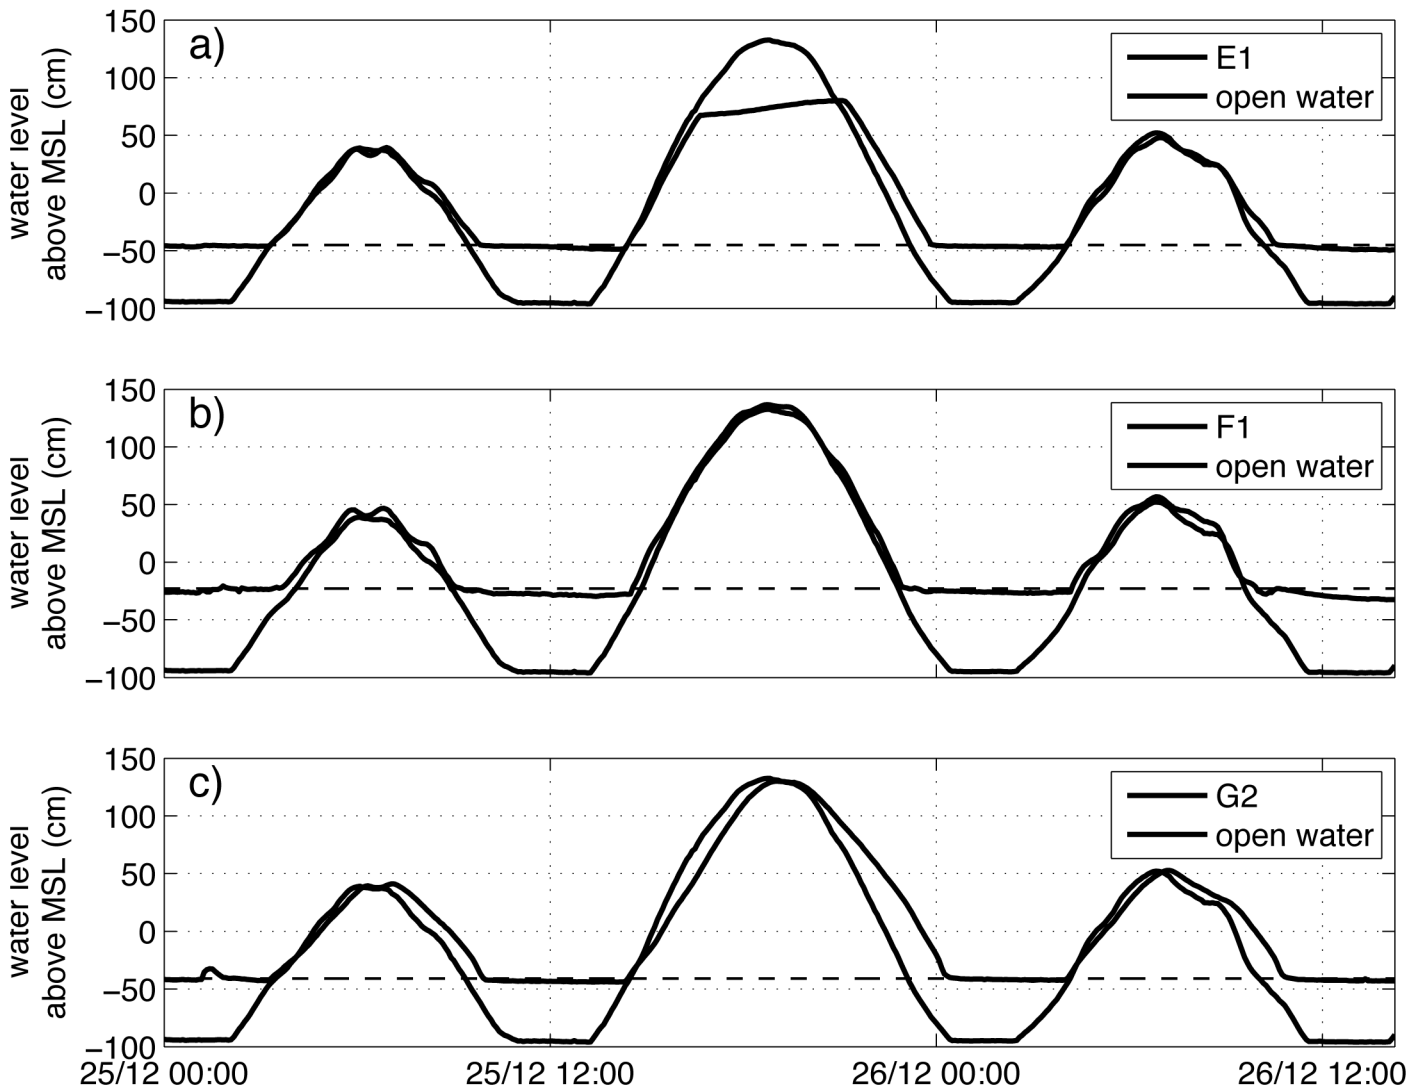
Fig 7. Time series of water levels in three hydrologically disturbed sites in Mahakam (E1, F1, G2) and their respective open water site.

To evaluate the reasons for certain hydrological and vegetation conditions and possible mismatches between them in the restoration sites, we studied water level time series of some selected sites (E1, F1 and G2) in more detail and compared them with open water levels ([Fig 7](#)).

At site E1, we see a clear capping at the higher high tides; water levels never reach above 80 cm, which is up to 50 cm lower than the tidal maximum for the measurement period. The reason for this capping is unclear, but might be related to obstruction of dikes. It does, however, not influence inundation duration. The obstruction of dikes also causes tailing (i.e. higher water levels than expected during ebb), which does result in longer inundations, on average 2.6% longer in *min per day* and 10% longer in *min per inundation* compared to a situation with free outflow ([Table 6](#)). This effect of tailing is reflected in the resulting class. Site E1 has a lower class in reality (i.e. wetter conditions) than expected from the open water levels ([Table 6](#)).

At site G2, tailing is obvious ([Fig 7](#)). During ebb, outflow is restricted, resulting in a longer duration of inundation. Inflow is also restricted at this site, but less than outflow. Without these restrictions, site G2 would have had shorter inundations, on average 23% shorter in *min per day* and 8.5% shorter in *min per inundation*, and a higher class, so drier conditions ([Table 6](#)).
