**VESSUP BAY/EAST END  
AREA OF PARTICULAR CONCERN  
(APC)**

***A COMPREHENSIVE ANALYTIC STUDY***

**V.I. DEPARTMENT OF PLANNING AND NATURAL RESOURCES  
*Coastal Zone Management Program***

September 21, 1993

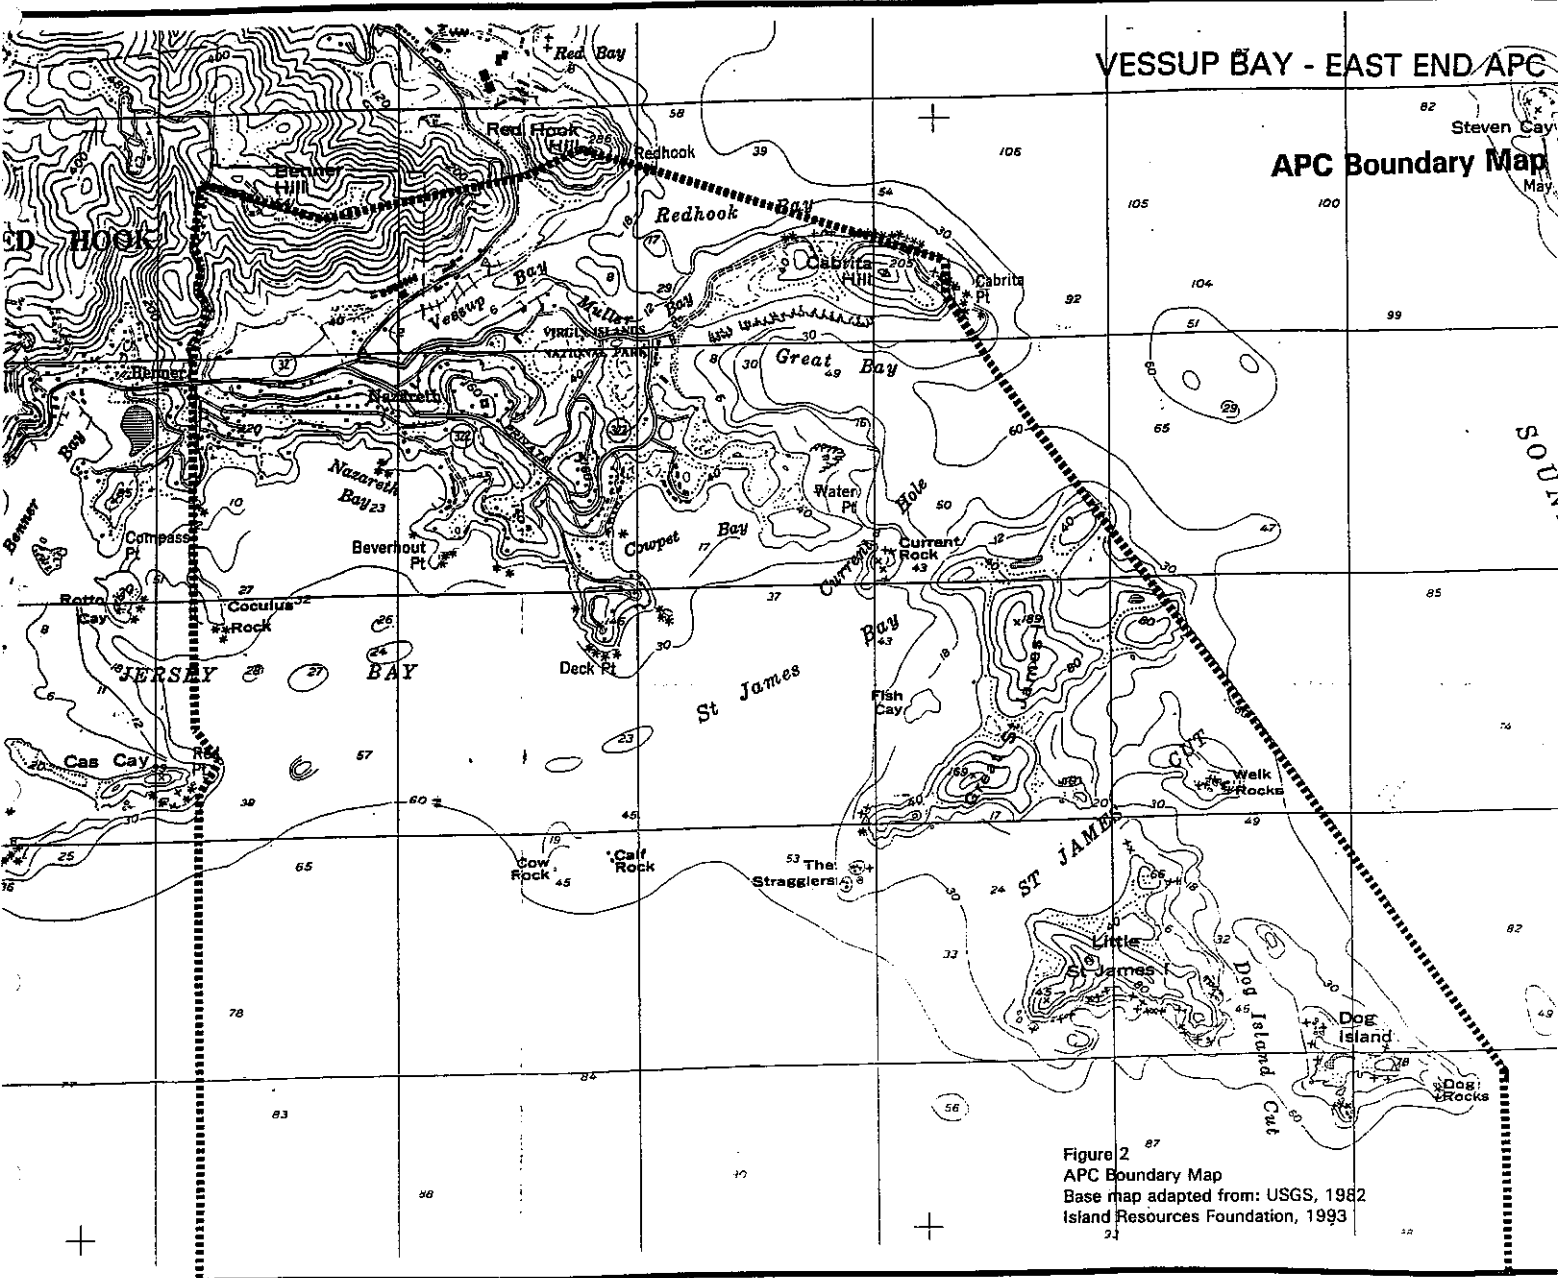
Figure 2  
APC Boundary Map  
Base map adapted from: USGS, 1982  
Island Resources Foundation, 1993

APC Boundary Map

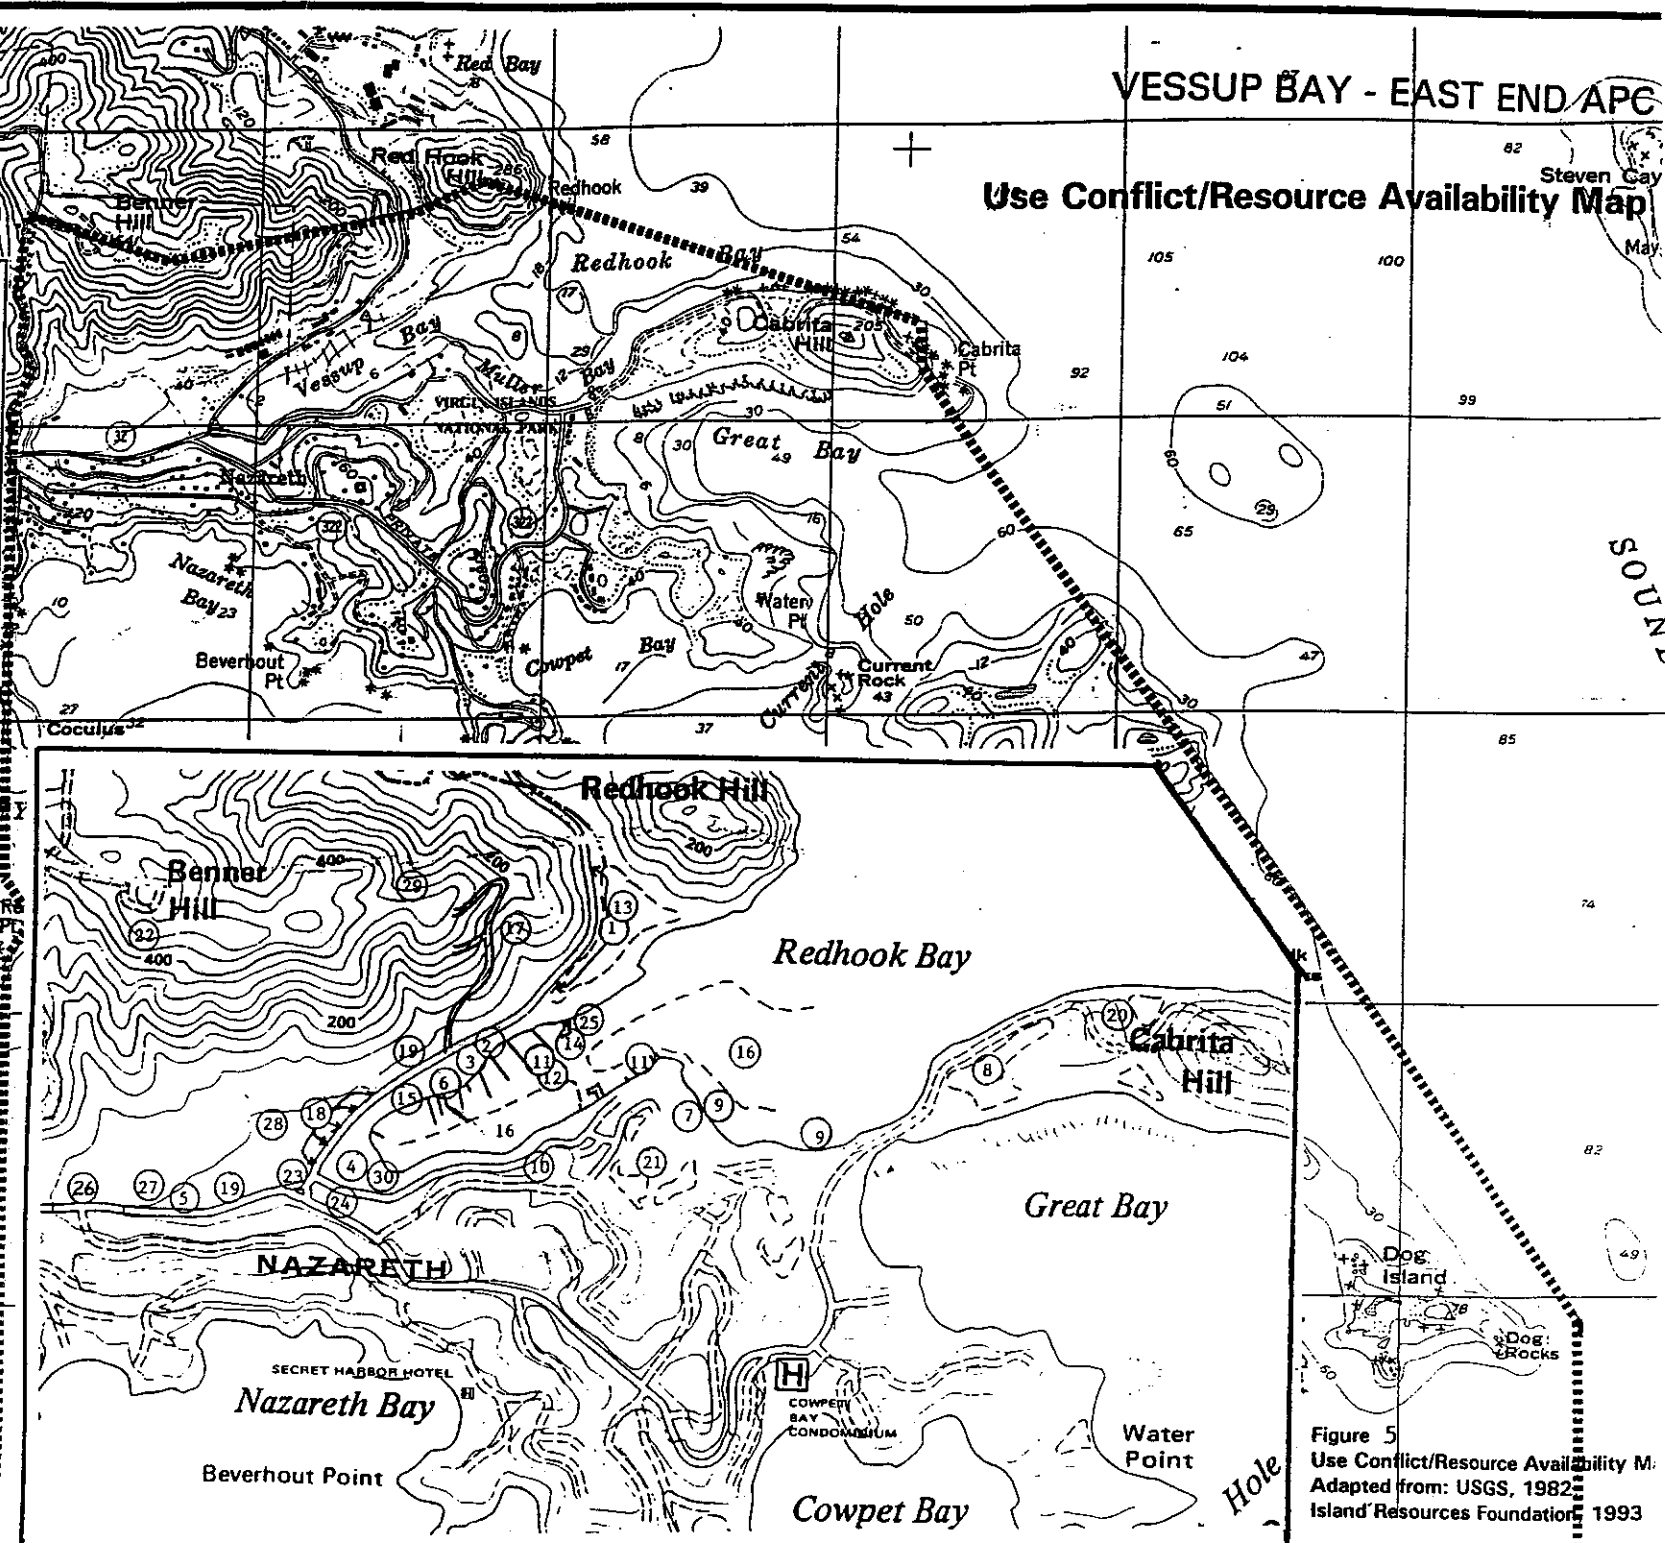
Figure 5  
Use Conflict/Resource Availability Map  
Adapted from: USGS, 1982  
Island Resources Foundation, 1993

27. Location for proposed St. Thomas Community Aquatic Center.
28. New gymnasium for Ivanna Eudora Kean High School
29. Abbey Hill housing development proposal.

30. Wrecked boats in mangroves from Hurricane Hugo - removal required.

The safety of the ferry dock at Red Hook was already in question before its recent collapse in the spring of 1991 (Figure 5, #14). Following the repairs of the outer portion of the dock, the structure was returned to service at the end of June 1991, in time for the expected rush of traffic bound for the St. John carnival. Concern remains about the integrity of that portion of the original dock structure remaining which appears corroded and generally in poor repair.

The American Yacht Harbor (AYH) Marina built a boat launching ramp at the western edge of its property (Figure 5, #6) to replace the previous boat ramp located near the center of the property. AYH blocked the "old" boat ramp during the construction of the boardwalk for its "new" marina dock project in 1990.

Several small businesses are located in the mangrove fringe along the north side of Vessup Bay (Figure 5, #15). For some of the businesses, there could be potential problems associated with sewage disposal (i.e., inadequate systems) and/or encroachment into the mangroves (cutting and filling for more work space). These shoreline sites should be regularly investigated for compliance with CZM regulations pertaining to structures in the wetlands.

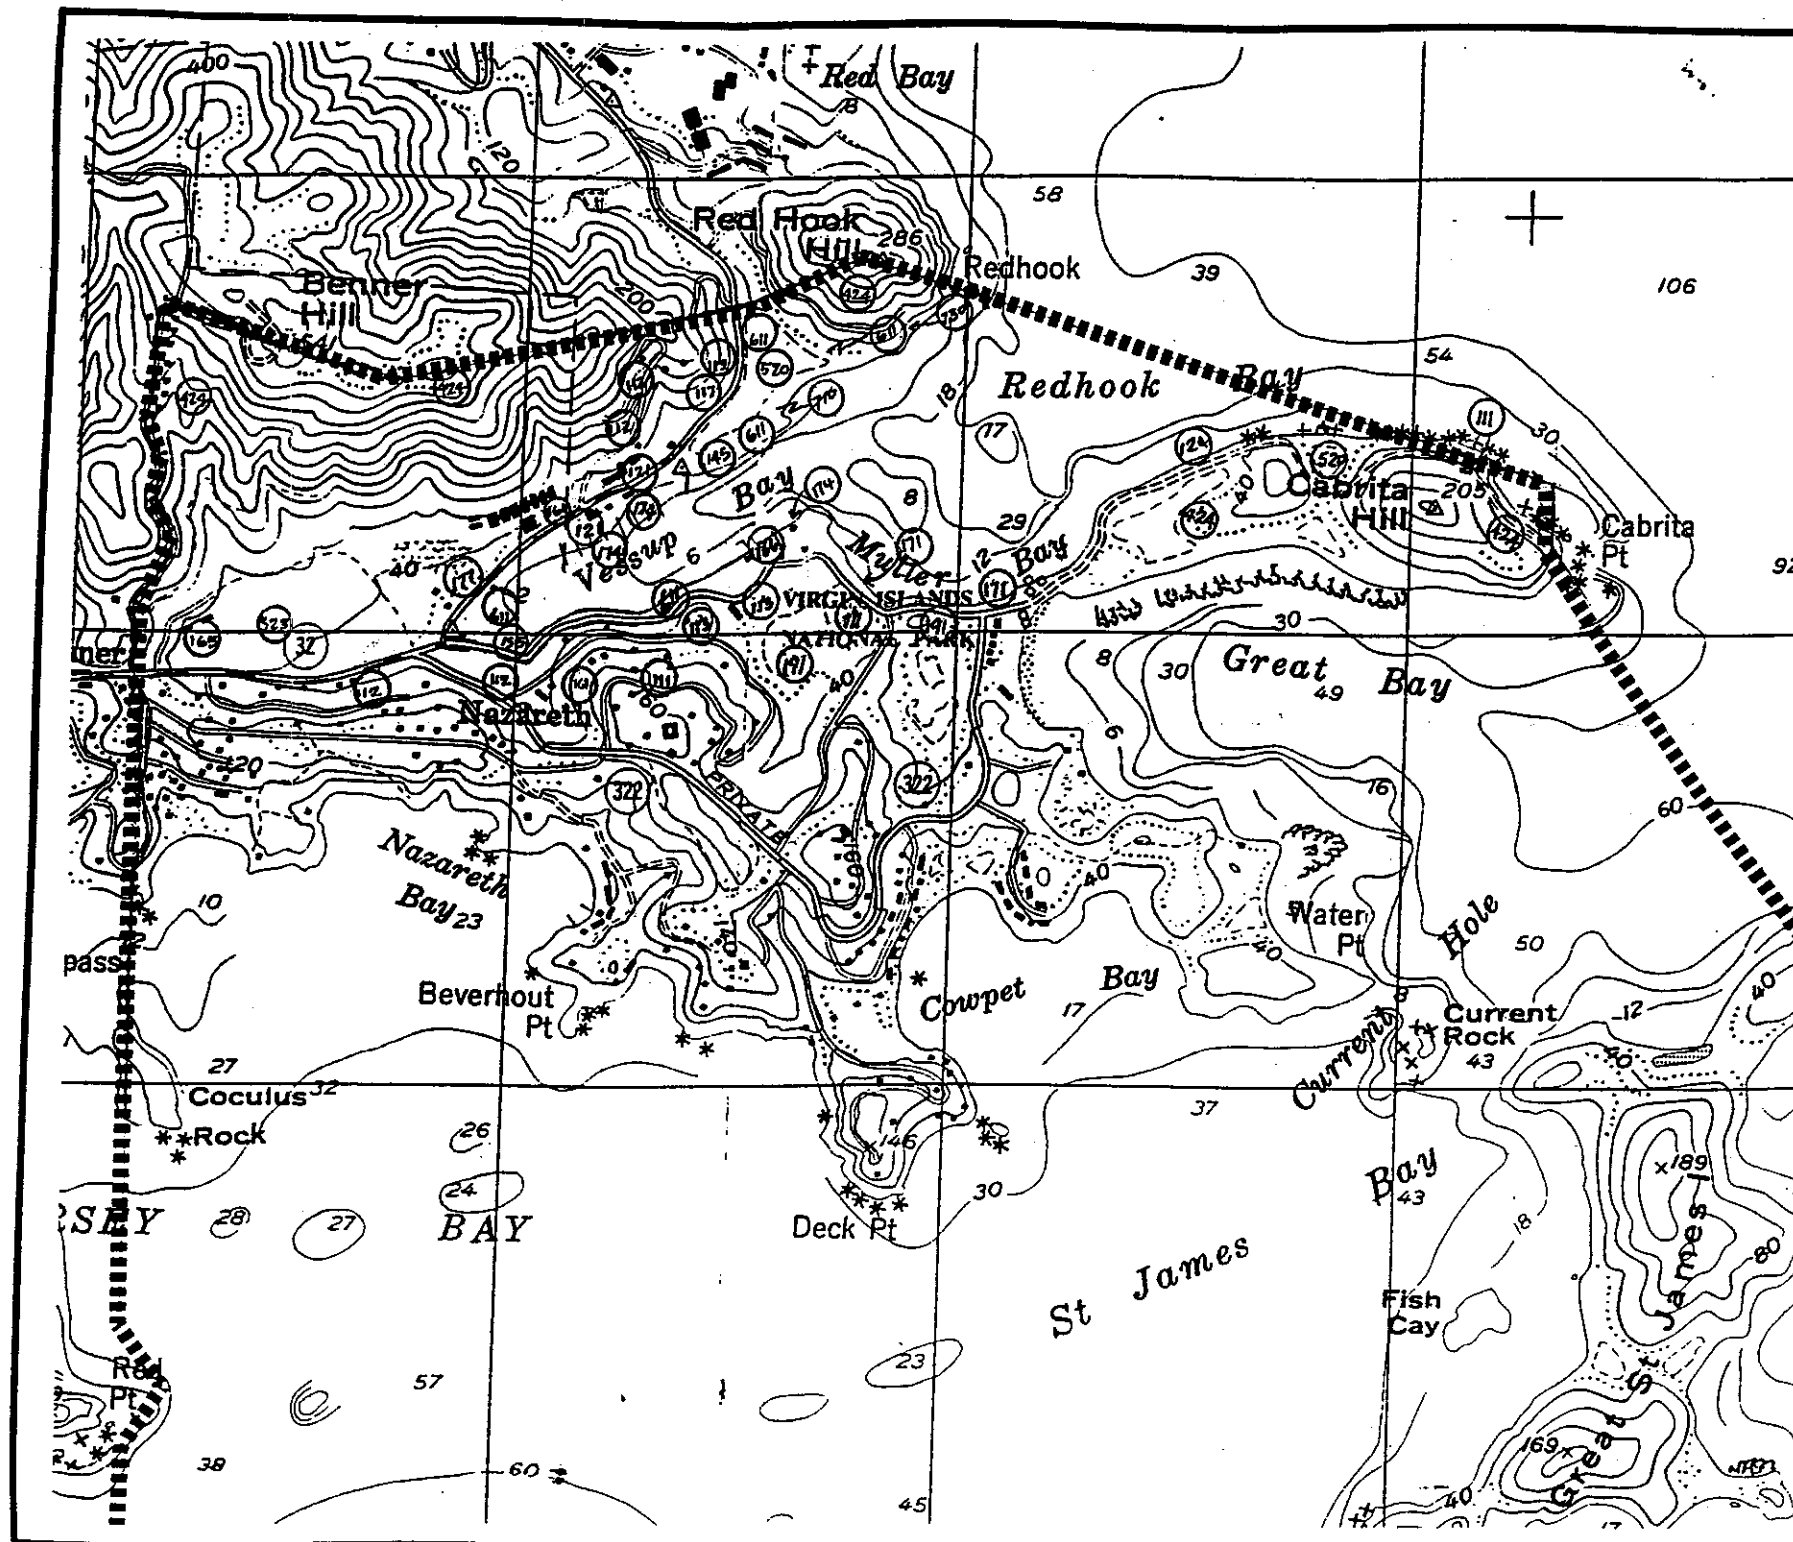
Figure 6  
Coastal Barrier Resources System  
Adapted from: USFWS, 1990  
Island Resources Foundation, 1993

U.S. FISH AND WILDLIFE SERVICE  
VESSUP BAY -  
EAST END APC

Coastal Barrier Resource System

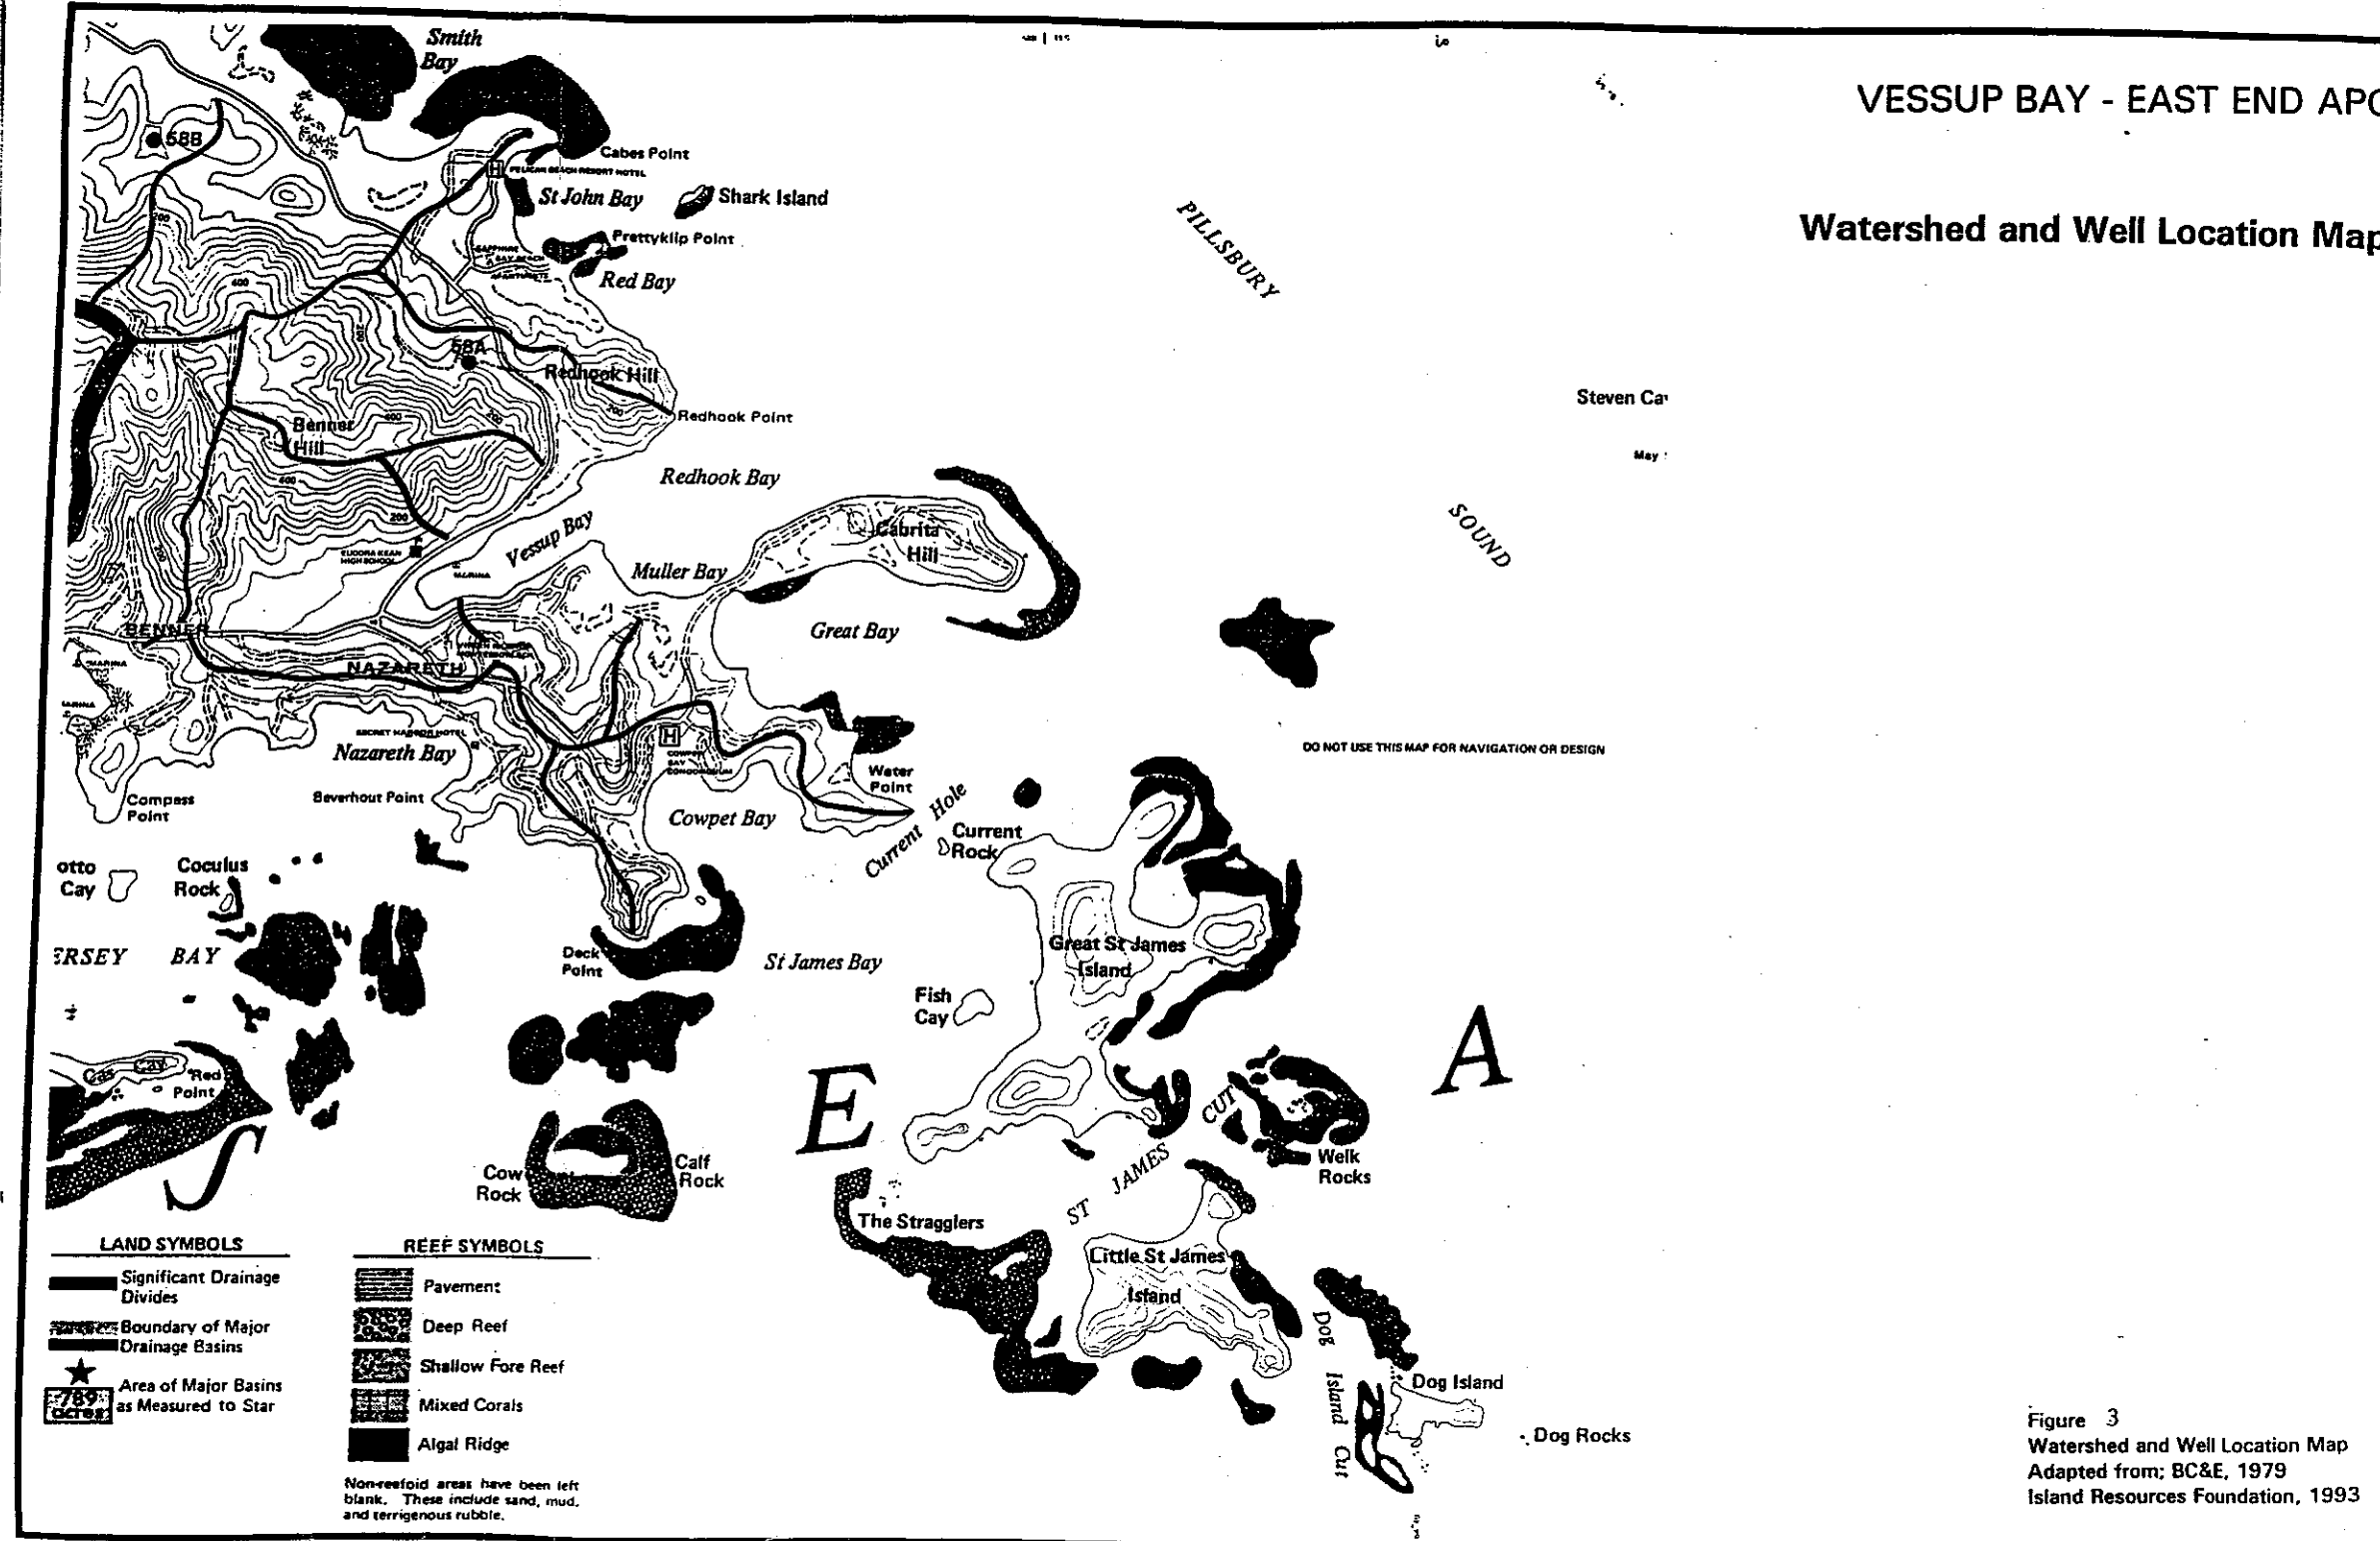
Figure 3  
Watershed and Well Location Map  
Adapted from: BC&E, 1979  
Island Resources Foundation, 1993

Watershed and Well Location Map

**Wells** - The U.S. Geological Survey has identified at least eleven wells within the watershed areas affecting this APC (Figure 3). Two test wells were drilled near the armory by the U.S. Geological Survey (USGS) during the summer of 1991 to prospect for usable water sources. The first was backfilled because of unstable ground conditions. The second well (Figure 3, #2) struck water, but the pumping yield was low because the aquifer is mostly clay material. This well will likely be used as a monitoring well for water quality and water table height, but because of the yield, the well will not become a production well (Judy Steiger, USGS, 1991, written communication).
